INVESTIGATION NO. 2924

THE BALTIMORE AND OHIO RAILROAD COMPANY

REPORT IN RE ACCIDENT

AT PHILIPPI, W. VA., ON

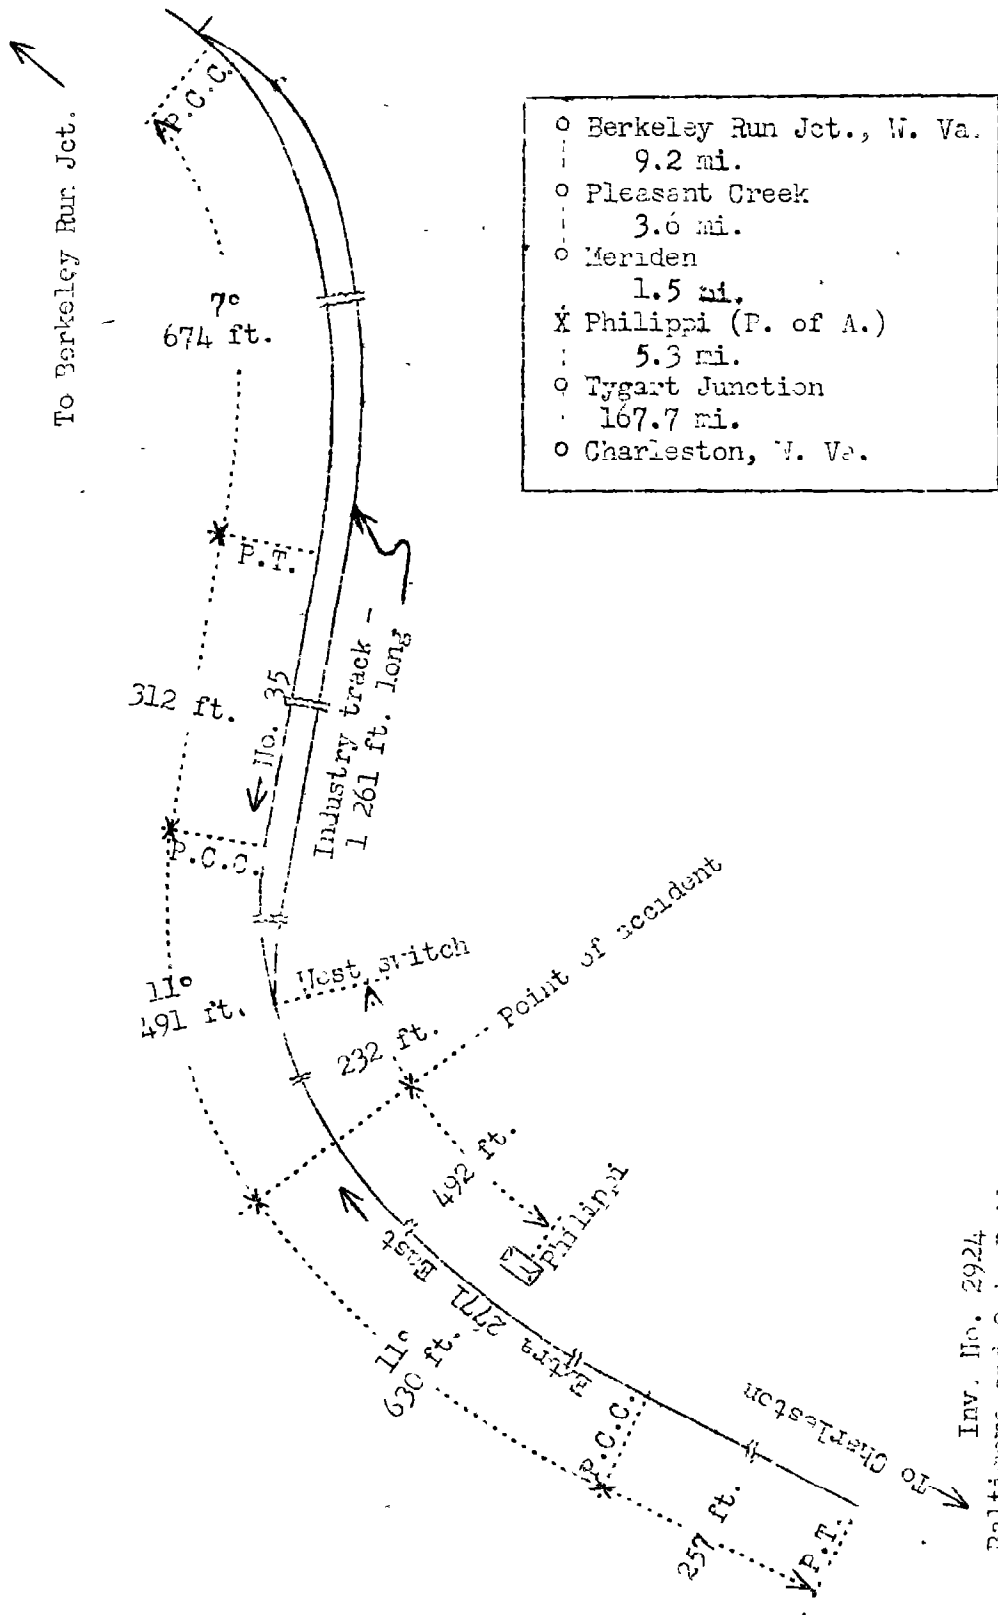
Inv. No. 2924
 Baltimore and Ohio Railroad
 Philippi, W. Va.
 August 17, 1945

This accident occurred on the Grafton and Charleston Sub-Division, which extends between Berkeley Run Jct. and Charleston, W. Va., 187.3 miles, a single-track line in the vicinity of the point of accident, over which trains are operated by timetable and train orders, and a manual-block system for trains following passenger trains. At Philippi, 14.3 miles west of Berkeley Run Jct., an industry track 1,261 feet in length parallels the main track on the south. The west switch of this track is 724 feet east of the station. The accident occurred on the main track 232 feet west of the west switch of the industry track. From the east there are, in succession, a compound curve to the right 674 feet in length, the maximum curvature of which is 7°, a tangent 312 feet and a compound curve to the left, the maximum curvature of which is 11°, extending 491 feet to the point of accident and 630 feet westward. From the west there is a tangent 257 feet in length, which is followed by the curve on which the accident occurred. The grade is 0.35 percent descending westward.

No. 35, a west-bound first-class passenger train, consisted of engine 5120, three baggage-mail cars and one coach, in the order named. All cars were of steel construction. This train departed from Pleasant Creek, 5.1 miles east of Philippi and the last open office, at 9:41 a. m., on time, departed from Meriden, 1.5 miles east of Philippi, at 9:48 a. m., on time, and while moving at an estimated speed of 15 miles per hour it collided with Extra 2771 East at a point 232 feet west of the west industry-track switch and 492 feet east of the station at Philippi.

9:53 a. m. it collided with Extra 2771 East at a point 232 feet west of the west industry-track switch and 492 feet east of the train-order signal at Philippi.

As No. 35 was approaching Philipoi the speed was about 20 miles per hour, the throttle was closed and the enginemen were maintaining a lookout ahead. Because of buildings and vegetation on the inside of the curve, the view had by the enginemen of the track ahead was materially restricted. The first these employees knew of anything being wrong was when they saw the approaching engine about 200 feet distant. Then the engineer moved the brake valve to emergency position. The speed of No. 35 was about 15 miles per hour when the collision occurred.

The crew of Extra 2771 East consisted of an engineer, a fireman and a brakeman. This train departed from Tygart Junction, 5.3 miles west of Philipoi, at 9:35 a. m. The crew understood that if their train proceeded to the industry track at Philippi for No. 35 it was required to be into clear on the industry track not less than 5 minutes prior to the time No. 35 was due to leave Meriden, and that flag protection was required to be furnished against No. 35 east of the west industry-track switch if their train was not clear of the main track at the required time. The engineer said that as his train was approaching the station at Philippi he looked at his watch and read the time as 9:46 a. m. He was confident that sufficient time remained for his train to enter the industry track at the west switch and to clear for No. 35 not later than 9:48 a. m. Neither the fireman nor the brakeman observed the time, and they did not question the engineer as to the authority of their train to proceed. The engineer had compared his watch with a standard clock about 5 hours prior to the occurrence of the accident, and his watch was 5 seconds fast at that time. After the accident he found that his watch had stopped at 9:47. The first these employees were aware that No. 35 was approaching was when they saw the engine about 200 feet distant. Then the engineer moved the independent brake valve to application position. The speed of Extra 2771 was about 10 miles per hour when the collision occurred.

It is found that this accident was caused by an inferior train occupying the main track on the time of an opposing superior train.

It is recommended that the Baltimore and Ohio Railroad Company install an adequate block system on the line on which this accident occurred.
