INVESTIGATION NO. 3097  
ILLINOIS CENTRAL RAILROAD COMPANY  
REPORT IN RE ACCIDENT  
NEAR CHAMPAIGN, ILL., ON.  
APRIL 19, 1947

Accident near Champaign, Ill., on April 19, 1947, caused by a train entering a crossover at a high rate of speed, as a result of approach and home signals of an interlocking displaying false proceed indications.

Inv. No. 3097  
 Illinois Central Railroad  
 Champaign, Ill.  
 April 19, 1947

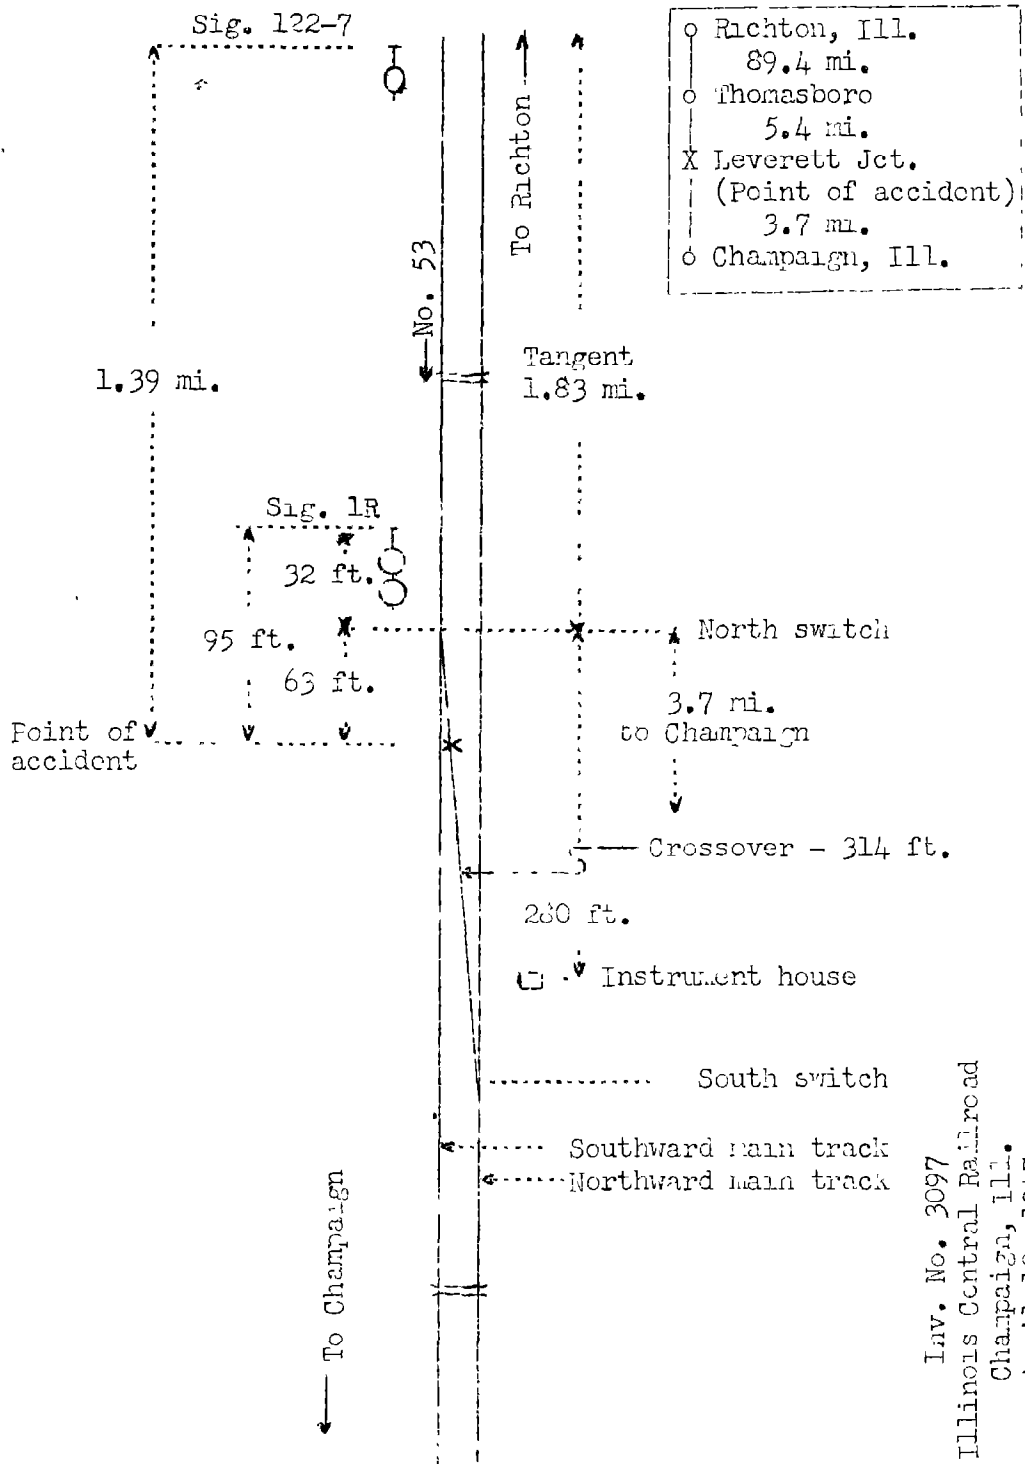
The engine stopped practically upright, across the main tracks and at an angle of about 60 degrees to them, with the front end 978 feet south of the north crossover switch. The first car stopped on its left side, across the southward

main track and at an angle of about 75 degrees to it, with the roof against the side of the engine. The second to seventh cars, inclusive, stopped practically upright and in various positions across the main tracks and in line with them. The engine and the first car were badly damaged, and the remainder of the equipment was considerably damaged.

In tests after the accident it was found that an error had been made in making the connections to the switch-control-lever repeating-relay. As a result of this condition, together with the transposing of the connections of the switch repeating-relay, the north crossover switch was in position for entry to the crossover when the lever in control of this switch was in normal position, and false proceed indications were displayed by signals 122-7 and 1R for No. 53.
