INVESTIGATION NO. 3139

MINNEAPOLIS, ST. PAUL & SAULT STE. MARIE
RAILROAD COMPANY

REPORT IN RE ACCIDENT

OCTOBER 22, 1947

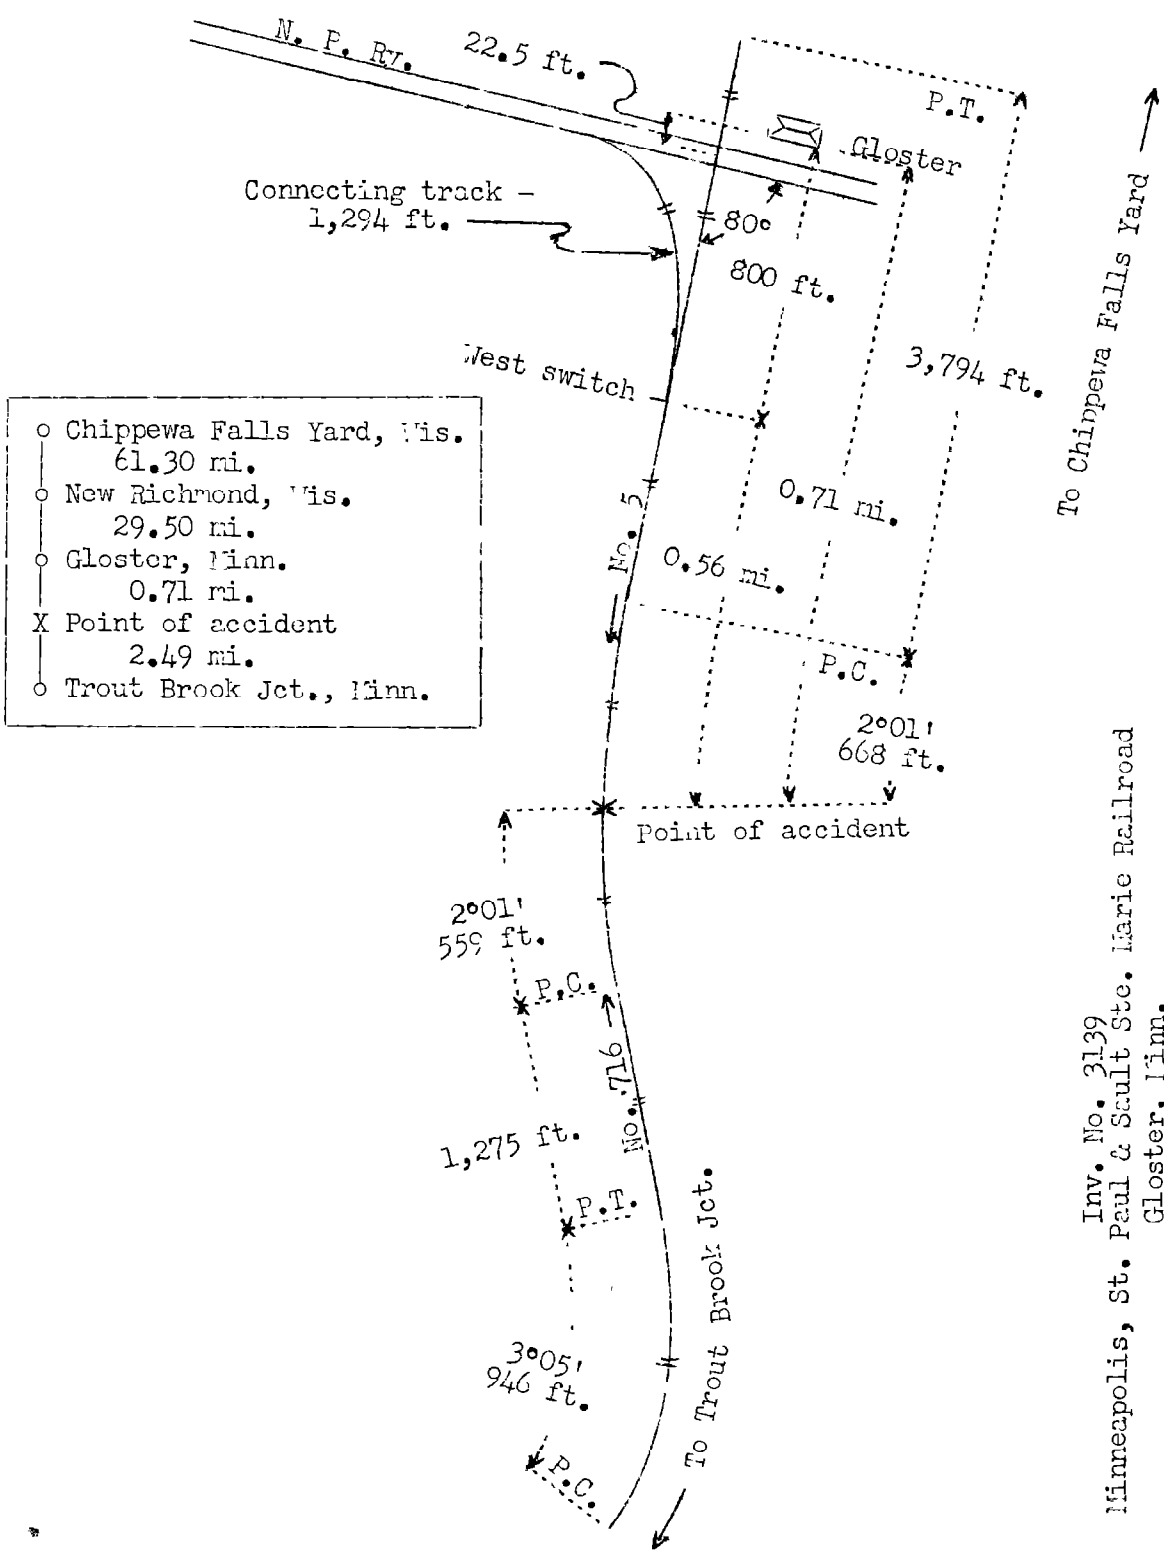
Inv. No. 3139
 Minneapolis, St. Paul & Sault Ste. Marie Railroad
 Gloster, Minn.
 October 22, 1947

This accident occurred on that part of the Stevens Point Division extending between Chippewa Falls Yard, Wis., and Trout Brook Jct., Minn., 94 miles. In the vicinity of the point of accident this is a single-track line, over which trains are operated by timetable and train orders, and a manual-block system for following movements only. At Gloster, 90.8 miles west of Chippewa Falls Yard, this line intersects a double-track line of the Northern Pacific Railway at an angle of about 80° at a point 22.5 feet west of the station. A connecting track 1,294 feet in length, which connects the M.St.P.& S.S.M. main track and the N.P. southward main track, is in the northwest angle of the crossing. The west connecting-track switch is 800 feet west of the station. Trains of the N.P. Ry. are regularly operated over that portion of the M.St.P.& S.S.M. R.R. extending between Trout Brook Jct. and the west connecting-track switch at Gloster, 3.2 miles. The accident occurred on the M.St.P.& S.S.M. main track at a point 0.56 mile west of the west connecting-track switch and 0.71 mile west of the station at Gloster. From the east on the M.St.P.& S.S.M. main track there are, in succession, a tangent 3,794 feet in length and a 2°01' curve to the left 668 feet to the point of accident and 559 feet westward. From the west there are, in succession, a 3°05' curve to the left 946 feet in length, a tangent 1,275 feet and the curve on which the accident occurred. The grade is 0.96 percent descending westward.

No. 5 consisted of engine 2712, one mail car, one baggage car, one coach and one sleeping car, in the order named. All cars were of steel construction. This train departed from Gloster, the last open office, at 7:56 a. m., 46 minutes late, passed the west connecting-track switch, and while moving on the main track at an estimated speed of 40 miles per hour it collided with No. 716 at 7:58 a. m., at a point 2,945 feet west of the west connecting-track switch.

As No. 5 was approaching the point where the accident occurred the speed was about 40 miles per hour. The engine-men were maintaining a lookout ahead. Because of an embankment and vegetation on the inside of the curve on which the collision occurred, the view had by the engine-men of the track ahead was materially restricted. The first these employees knew of anything being wrong was when the fireman saw the approaching train about 400 feet distant and called a warning to the engineer. Then the engineer moved the brake valve to emergency position, but the collision occurred before the speed was materially reduced. The brakes of this train had been tested and had functioned properly en route.

It is recommended that the Minneapolis, St. Paul & Sault Ste. Marie Railroad Company establish an adequate block system on the line on which this accident occurred.
