INVESTIGATION NO. 3256

CHICAGO GREAT WESTERN RAILWAY COMPANY
AND
ILLINOIS CENTRAL RAILROAD COMPANY

REPORT IN RE ACCIDENT

MAY 26, 1949

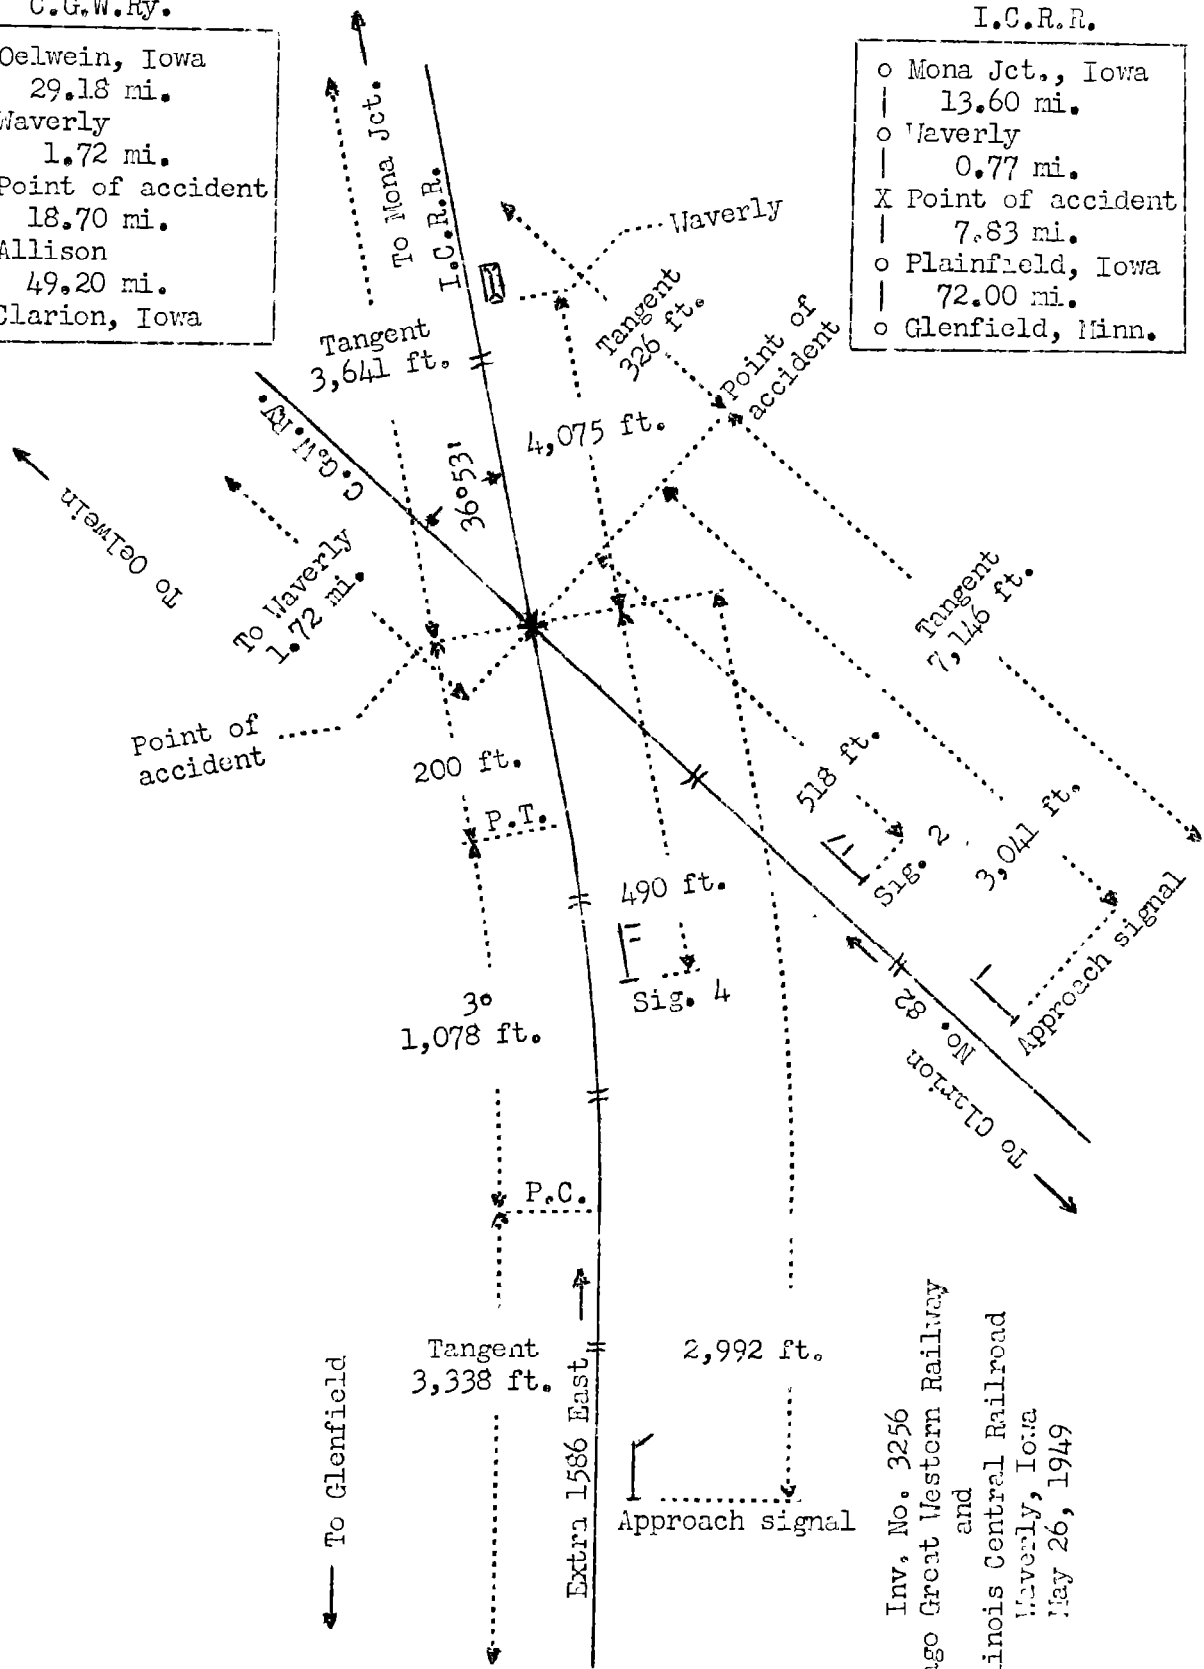
Chicago Great Western Railway
and
Illinois Central Railroad
Waverly, Iowa
May 26, 1949

This accident occurred at the intersection of the Chicago Great Western Railway and the Illinois Central Railroad at Waverly, Iowa. The crossing is located on that part of the Minnesota Division of the C.G.W. extending between Clarion and Oelwein, Iowa, 98.8 miles, and on that part of the Iowa Division of the I.C. extending between Glenville, Minn., and Vona Jct., Iowa, 94.2 miles. The crossing is 67.9 miles east of Clarion and 1.72 miles west of the C.G.W. station at Waverly, and 79.83 miles east of Glenville and 4,075 feet west of the I.C. station at Waverly. In the vicinity of the point of accident both are single-track lines, over which trains are operated by timetable and train orders. There is no block system in use on either line. The C.G.W. track extends east and west. The I.C. track extends southeast and northwest, and intersects the C.G.W. track at an angle of $36^{\circ}53'$. Timetable directions on both roads are eastward and westward, and are used in this report. The C.G.W. track is tangent a distance of 7,146 feet west of the point of accident, and 326 feet eastward. Throughout a distance of 5,535 feet immediately west of the point of accident the grade for east-bound trains varies between 0.08 percent and 0.64 percent descending, and is 0.64 percent descending at the point of accident. From the west on the I.C. there are, in succession, a tangent 3,338 feet in length, a 3° curve to the left 1,078 feet, and a tangent 200 feet to the point of accident and 3,641 feet eastward. Throughout a distance of 6,010 feet immediately west of the point of accident the grade for east-bound trains varies between 0.14 percent and 1.06 percent descending, and averages 0.74 percent. It is 0.63 percent descending at the point of accident.

Movements over the crossing are governed by an automatic interlocking. East-bound movements on the C.G.W. are governed by an inoperative approach signal and home signal 2, located, respectively, 3,041 feet and 518 feet west of the crossing. The approach signal is of the one-arm semaphore type, fixed in the horizontal position to indicate Caution. It is continuously lighted. Home signal 2 is of the two-arm, semaphore type. The top arm operates in two positions in the lower quadrant and the bottom arm is fixed in the horizontal position. It is approach lighted. The involved aspects and corresponding indications of these signals are as follows:

The eastward approach clearing circuit on the C.G.W. extends westward to the approach signal. East-bound movements on the I.C. are governed by an inoperative approach signal and home signal 4, located, respectively, 2,992 feet and 490 feet west of the crossing. The approach signal is of the one-arm semaphore type, fixed at 45° in the upper-quadrant to indicate Approach. It is continuously lighted. Home signal 4 is of the two-arm, semaphore type. The top arm operates in two positions in the upper quadrant and the bottom arm is fixed in the horizontal position. It is approach lighted. The involved aspects and corresponding indications of these signals are as follows:

The eastward approach clearing circuit on the I.C. extends westward to the approach signal. Each home signal normally indicates Stop. The controlling circuits are so arranged that the train first to enter its approach circuit automatically actuates the governing home signal to indicate Proceed. This prevents either home signal on the conflicting route from displaying an aspect to proceed until the first train either has completed its movement through the interlocking or until a predetermined time interval has elapsed after the first signal has been caused to indicate Stop by the manual operation of a time release.
