REPORT NO. 3377
THE PENNSYLVANIA RAILROAD COMPANY
IN RE ACCIDENT
NEAR ANOKA, IND., ON
NOVEMBER 9, 1950

Date: November 9, 1950

Accident near Anoka, Ind., on November 9, 1950, caused
by an open switch.

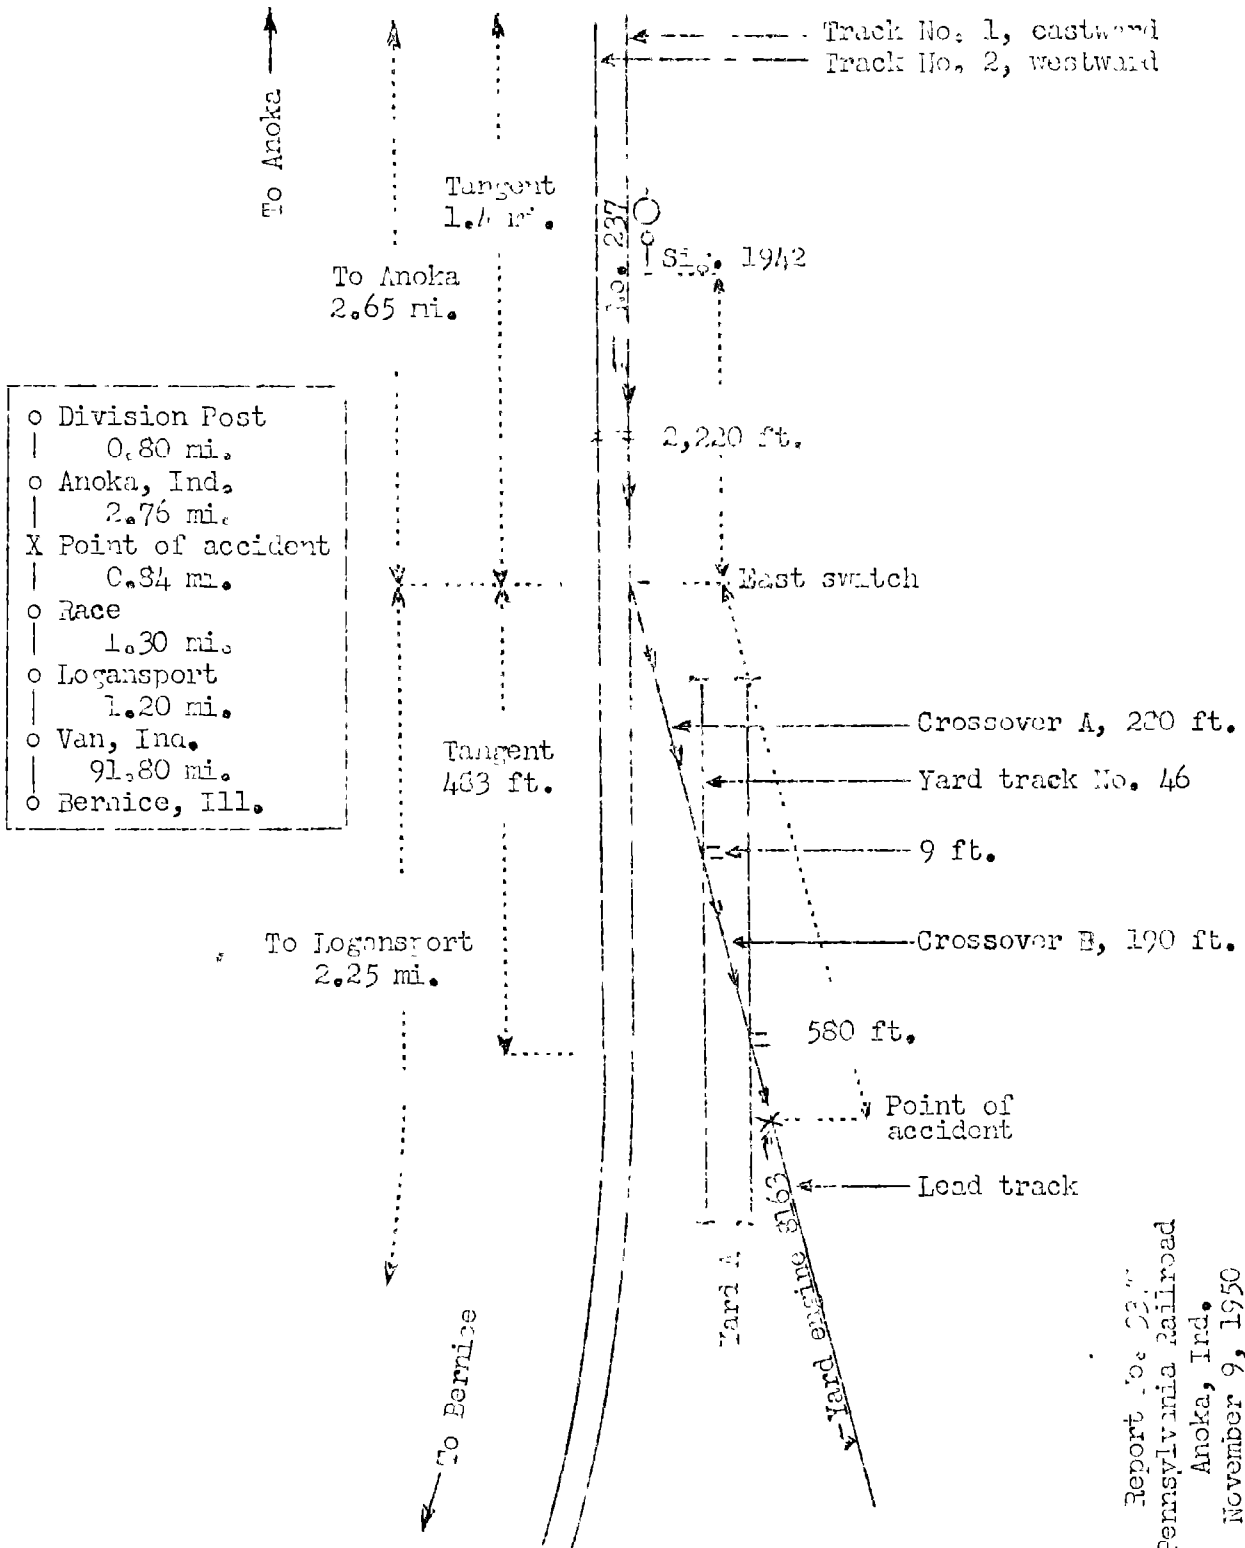
Report No. 227
 Pennsylvania Railroad
 Anoka, Ind.
 November 9, 1950

The crew also received block authority on track No. 1 between Anoka and Race. This train passed Anoka at 5:52 a. m., 3 hours 2 minutes late. While it was moving on track No. 1 it entered crossover A, then was diverted through crossover B to the lead track, and while moving at a speed of 45 miles per hour it struck yard engine 8163 at a point 580 feet west of the east switch of crossover A.

The first Diesel-electric unit of No. 237 was derailed to the north and stopped with the front end of the unit 206 feet west of the point of accident. The front end and the rear end of this unit were, respectively, 72 feet 6 inches and 23 feet 6 inches north of the center-line of the lead track. The unit leaned toward the north at an angle of about 40 degrees. The front truck of the first Diesel-electric unit was displaced and stopped near the rear end of the unit. The second Diesel-electric unit was derailed to the north and stopped with the front end against the rear of the first unit and the rear end on the lead track. The first Diesel-electric unit was badly damaged and the second Diesel-electric unit was somewhat damaged. No other equipment of No. 237 was derailed. The first and the fifth to the eighth cars, inclusive, were slightly damaged.

Engine 8163 was derailed to the north and stopped upright, with the front end on the lead track and 361 feet west of the point of accident. The rear of the tender was 38 feet 6 inches north of the center-line of the lead track. The engine was considerably damaged and the tender was demolished.
