RAILROAD ACCIDENT INVESTIGATION

Report No 3834

HUDSON AND MANHATTAN RAILROAD COMPANY

DECEMBER 14, 1958

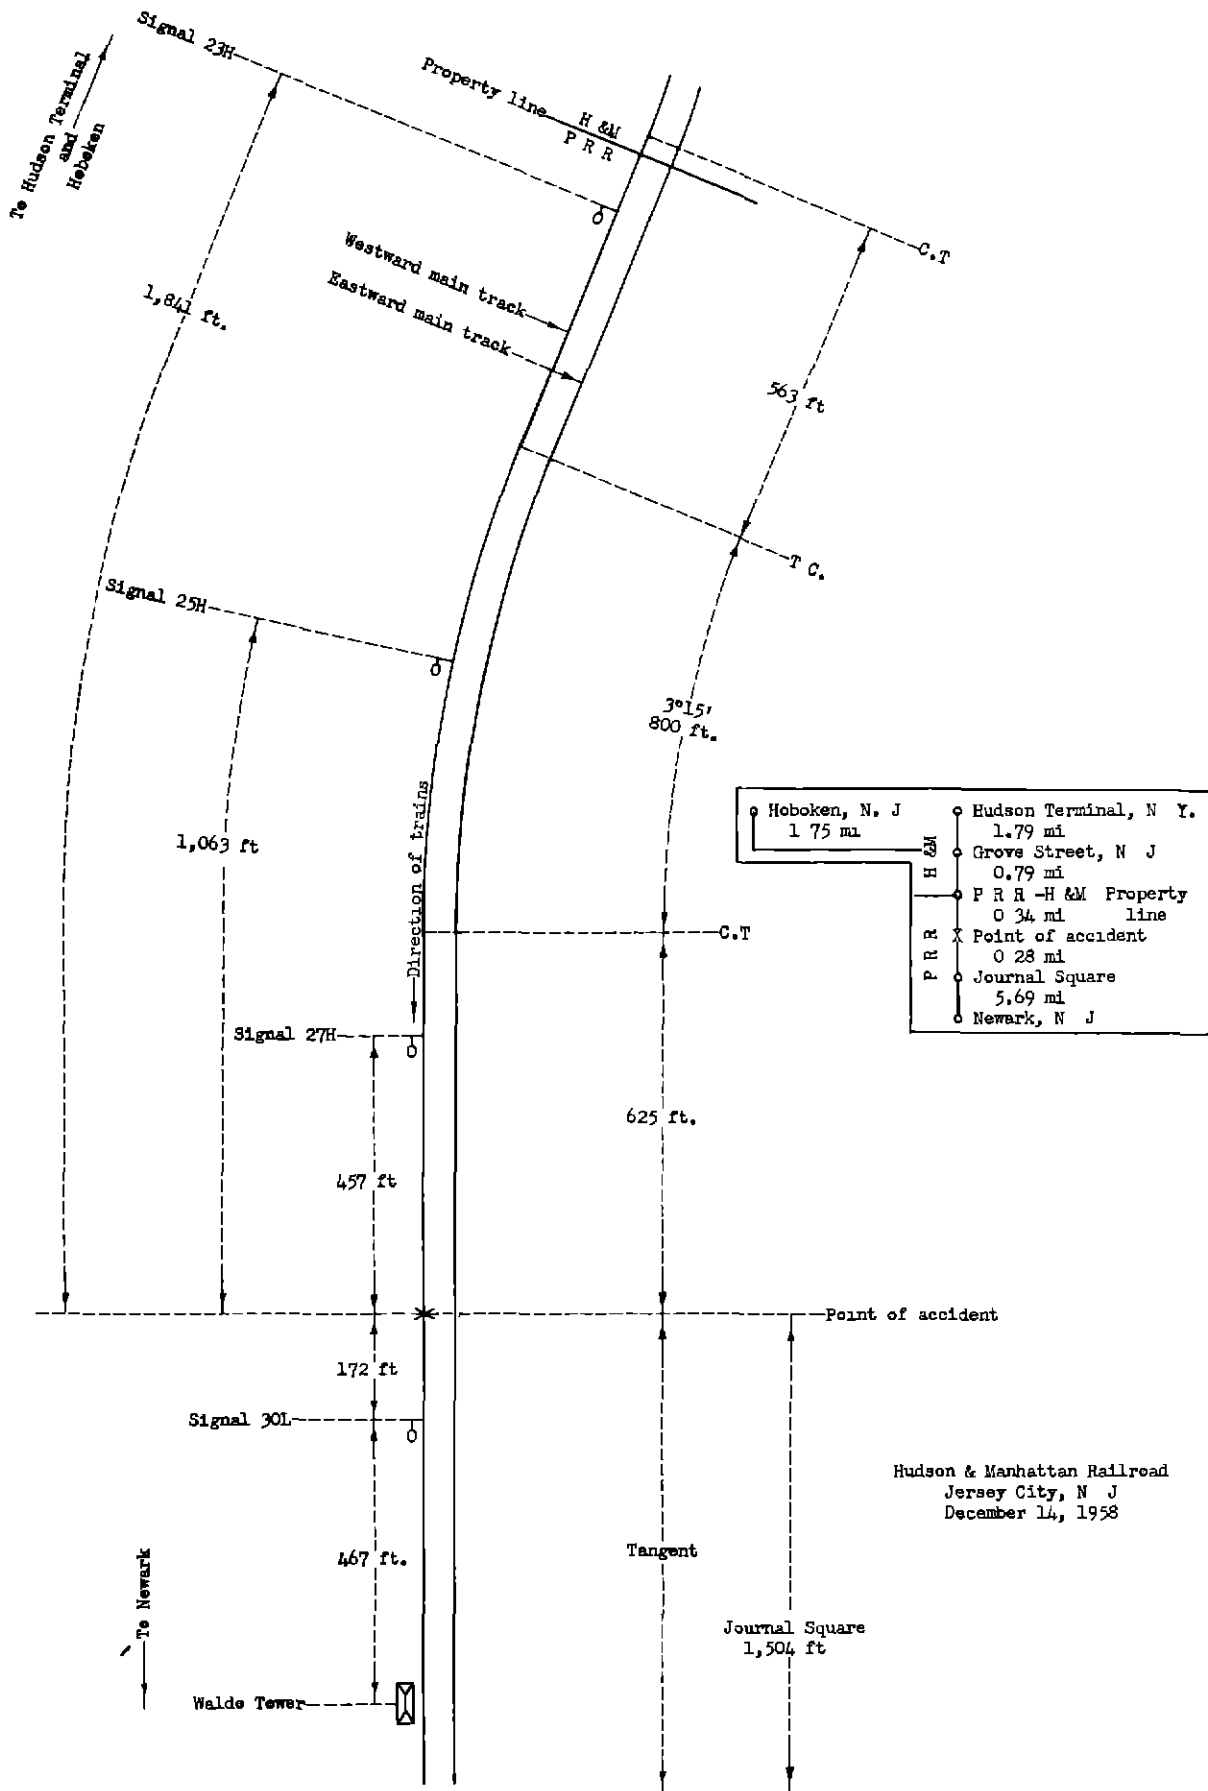
Hudson & Manhattan Railroad
 Jersey City, N. J.
 December 14, 1958

The accident occurred on the westward main track, 1,504 feet east of Journal Square and 1.12 miles west of Grove Street Station. From the east there are, in succession, a tangent 563 feet in length, a $3^{\circ}15'$ curve to the left 800 feet, a tangent 625 feet to the point of accident and a considerable distance westward. In this vicinity the average grade is 0.24 percent ascending westward.

P. R. R. automatic signals 23H, 25H, 27H, and semi-automatic signal 30L, governing westbound movements on the westward main track are located 1,841 feet east, 1,063 feet east, 457 feet east, and 172 feet west of the point of accident, respectively. The first three signals named are of the position-light dwarf type. Signal 30L is of the position-light bridge-mounted type, and is controlled by the operator at Waldo Tower, 467 feet west of the signal. The four signals are continuously lighted and each displays 4 aspects. A mechanical-trip automatic train-stop tripping device is associated with, and about 8 feet west of, each signal. Cut-sections are provided within the blocks of signals 23H and 27H. The insulated joints of the cut-section between signals 27H and 30L are 294 feet west of signal 27H.
