INTERSTATE COMMERCE COMMISSION

REPORT OF THE CHIEF OF THE BUREAU OF SAFETY, COVERING INVESTIGATION OF AN ACCIDENT WHICH OCCURRED ON THE RUTLAND RAILROAD NEAR RIVERSIDE, VT, ON MARCH 14, 1920

APRIL 16, 1920

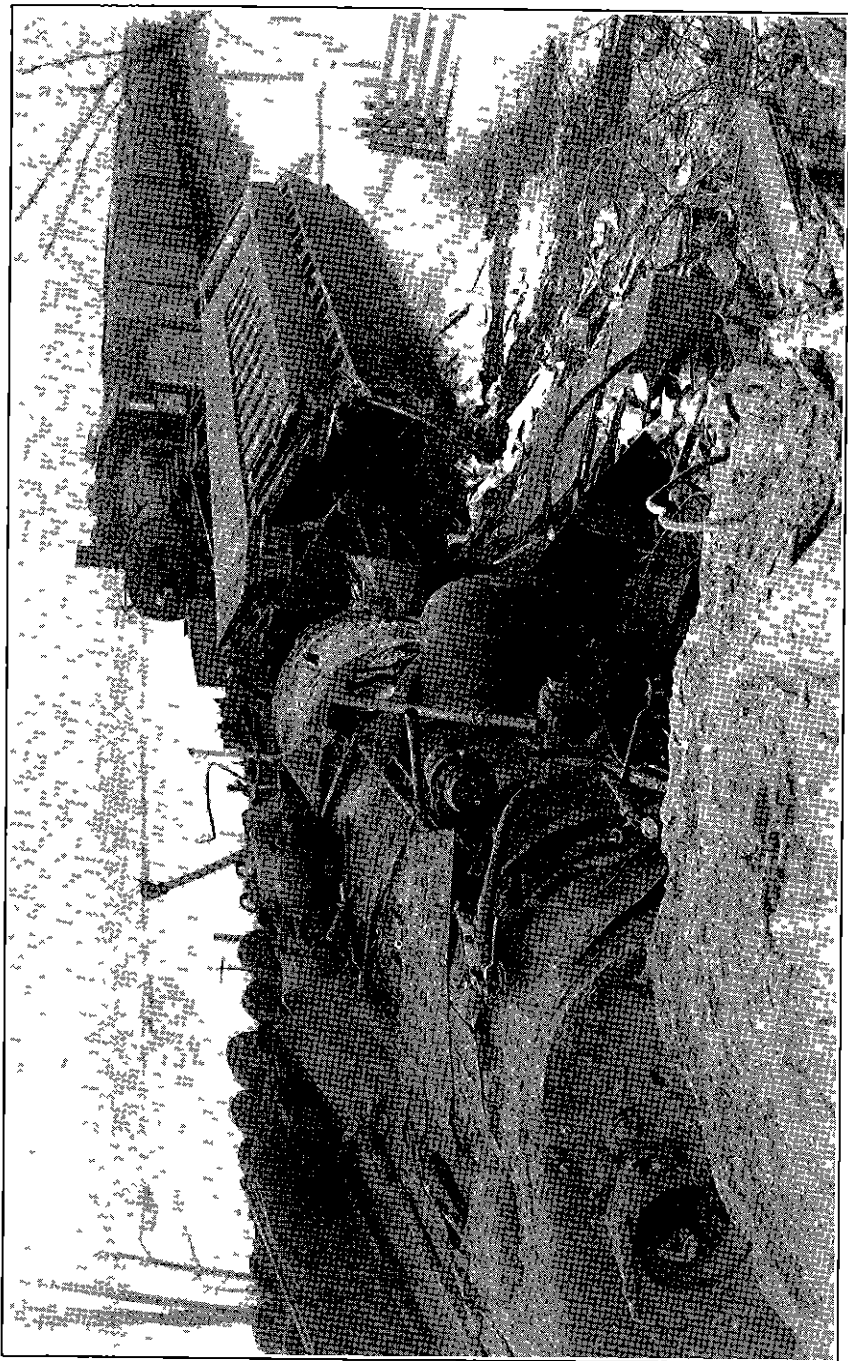
The impact of the collision resulted in the engine of train No 165 being thrown to the west side of the track and it came to rest in a reversed position, with its front end in the forward end of the combination car, as shown by illustration No 2 This engine was completely stripped, its boiler was torn from the frame, and the machinery practically destroyed The milk car was destroyed, while the forward end of the combination car was badly damaged The engine of extra 28 was thrown over the embankment on the east side of the track Twelve cars of the freight train were derailed, eight of which were practically destroyed Illustrations Nos 3 and 4 are general views of the wreckage of the freight train On the left in illustration No 3 may be seen the engine of the freight train The employees killed were the engineman, fireman, and one brakeman of train No 165, and the engineman and head brakeman of extra 28

FIG 2—Engine and second car of passenger train, engine in reversed position with its front end in head end of coach

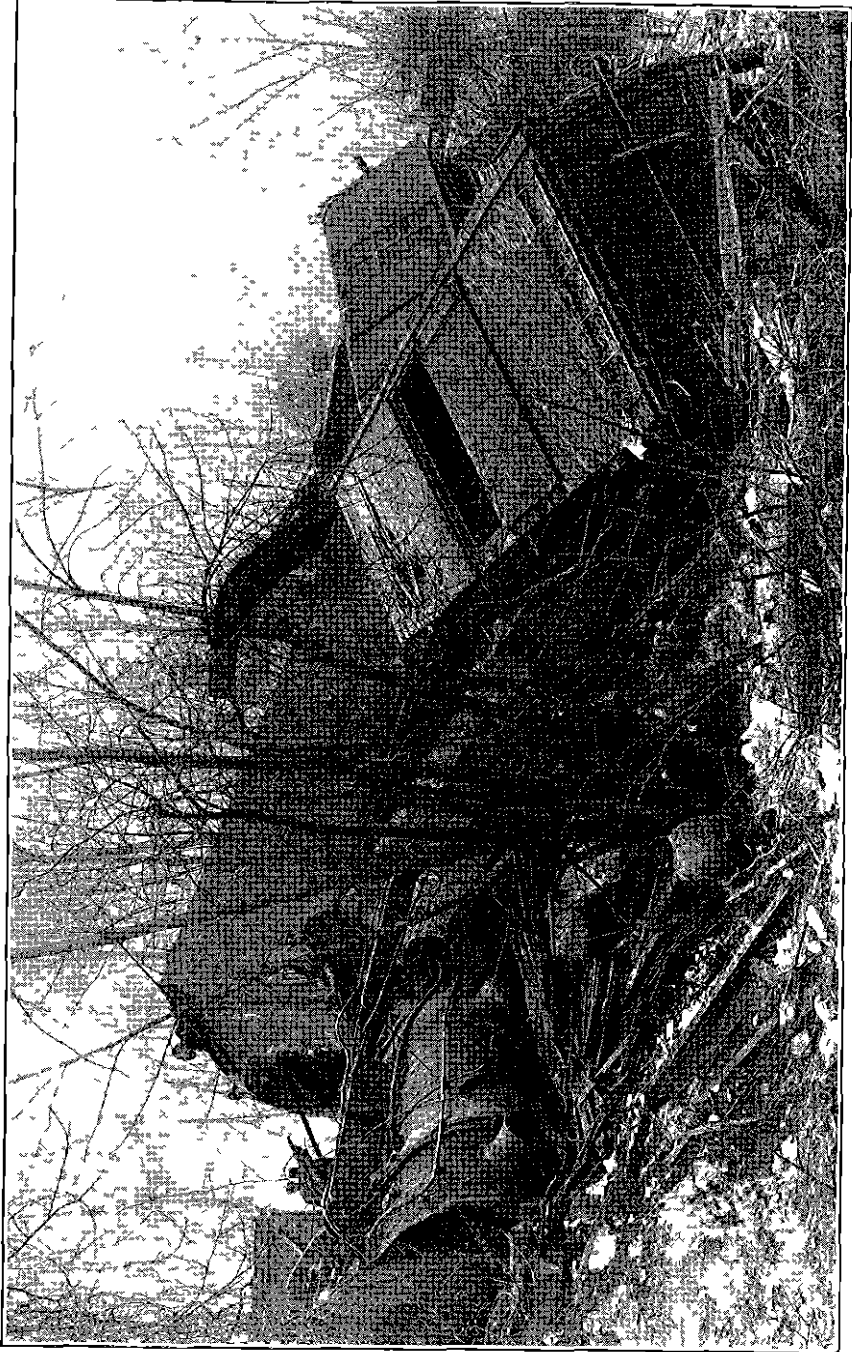
Fig 3 — General view of wreckage, engine of freight train on the left

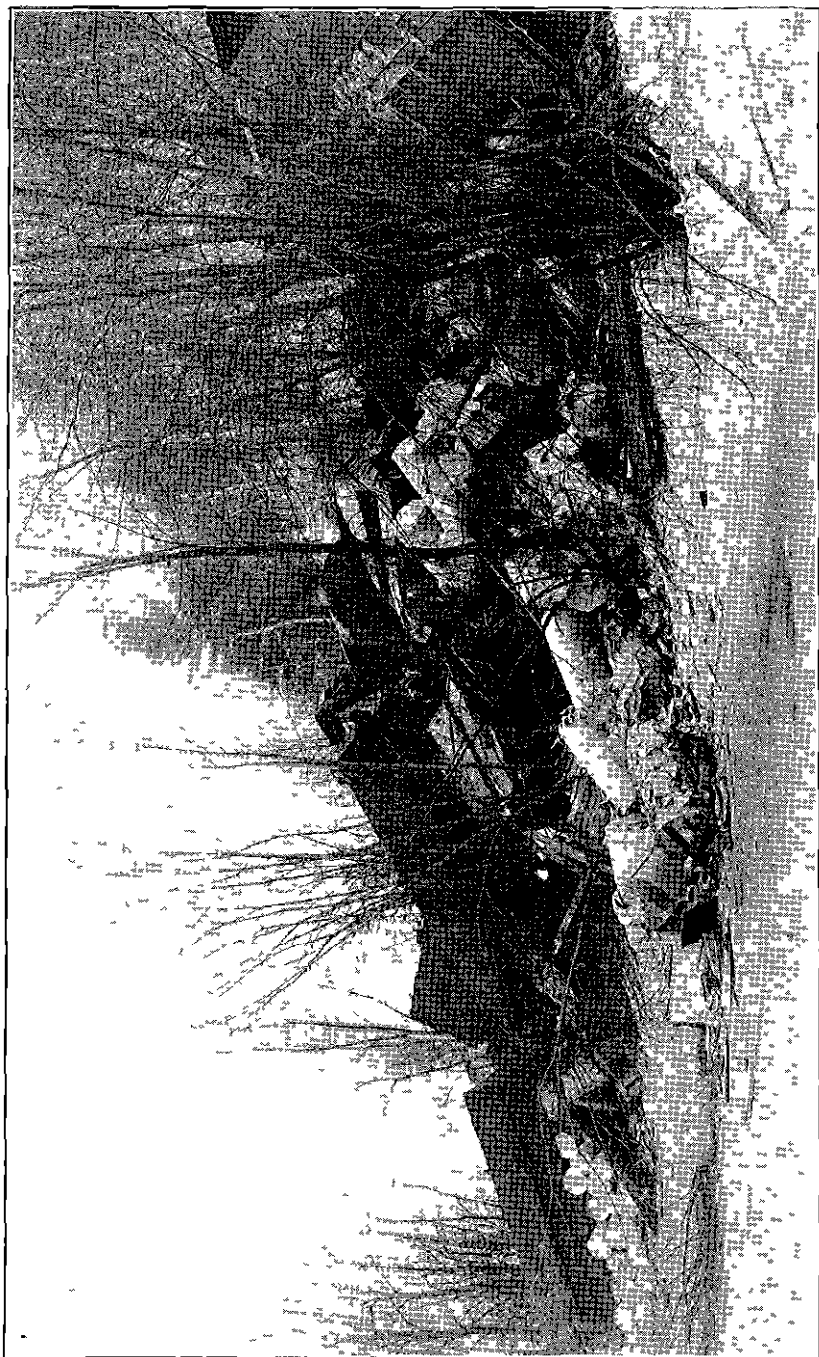
FIG 4—General view of wreckage
