INTERSTATE COMMERCE COMMISSION

**REPORT OF THE CHIEF OF THE BUREAU OF SAFETY COVERING
INVESTIGATION OF AN ACCIDENT WHICH OCCURRED ON THE
BALTIMORE & OHIO RAILROAD NEAR WOLF LAKE YARD
OFFICE, SOUTH CHICAGO, ILL., ON JUNE 14, 1920**

JULY 20, 1920

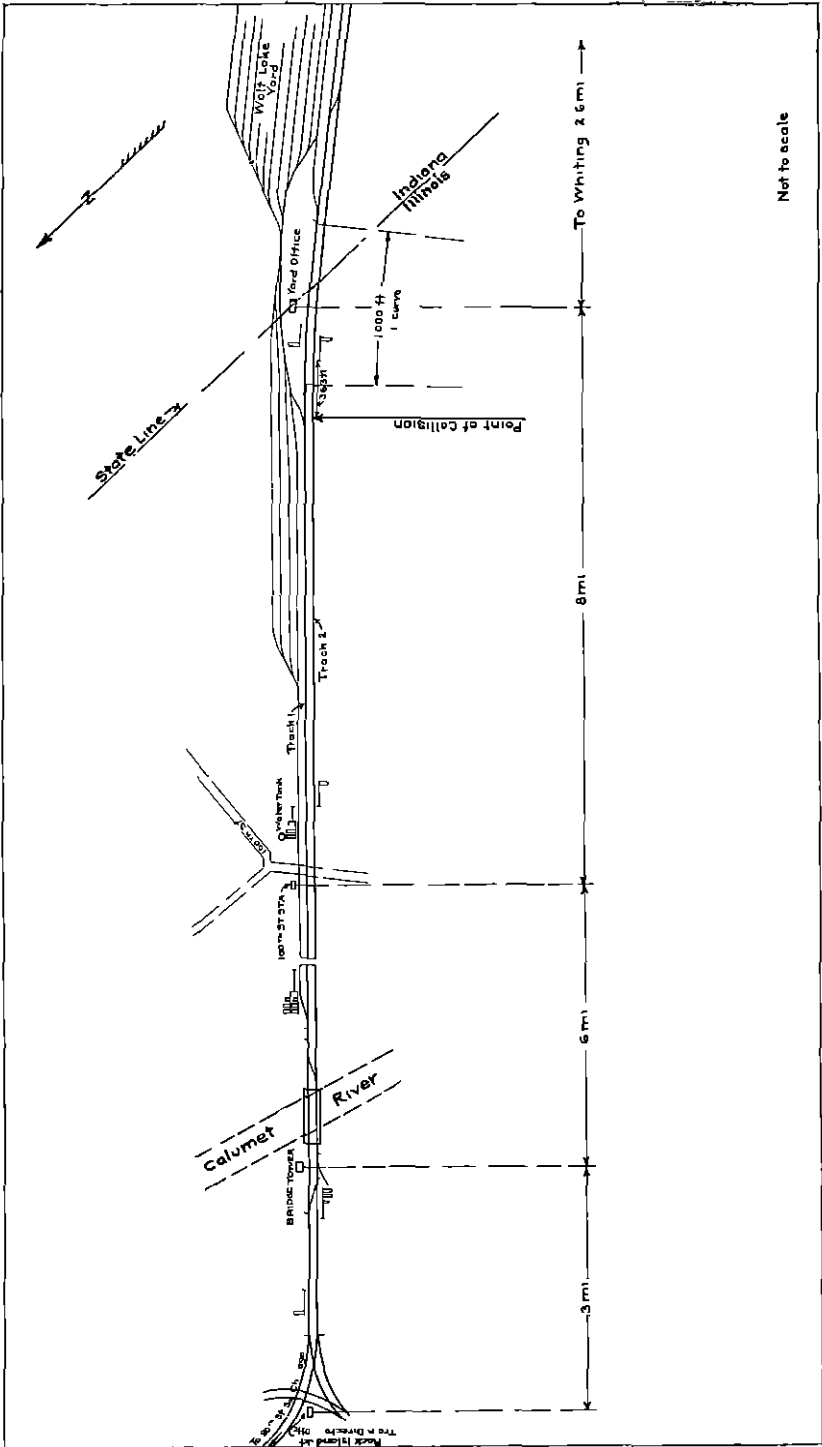
Fig 1—Diagram showing track layout in vicinity of point of accident.

the view was obscured on account of the curve and by a line of poles on the inside of the curve. The accompanying diagram shows the relative location of the tracks and stations in the vicinity of the point of accident. The weather was cloudy.

approaching this signal the engineman applied the brakes. The employees on the engine saw the passenger train approaching but did not know that it was on the eastbound track until it came around the curve and was only a short distance away. The engineman then applied the brakes in emergency, and all of them jumped off the engine before the trains collided. The point of accident was 363 feet west of the block signal.

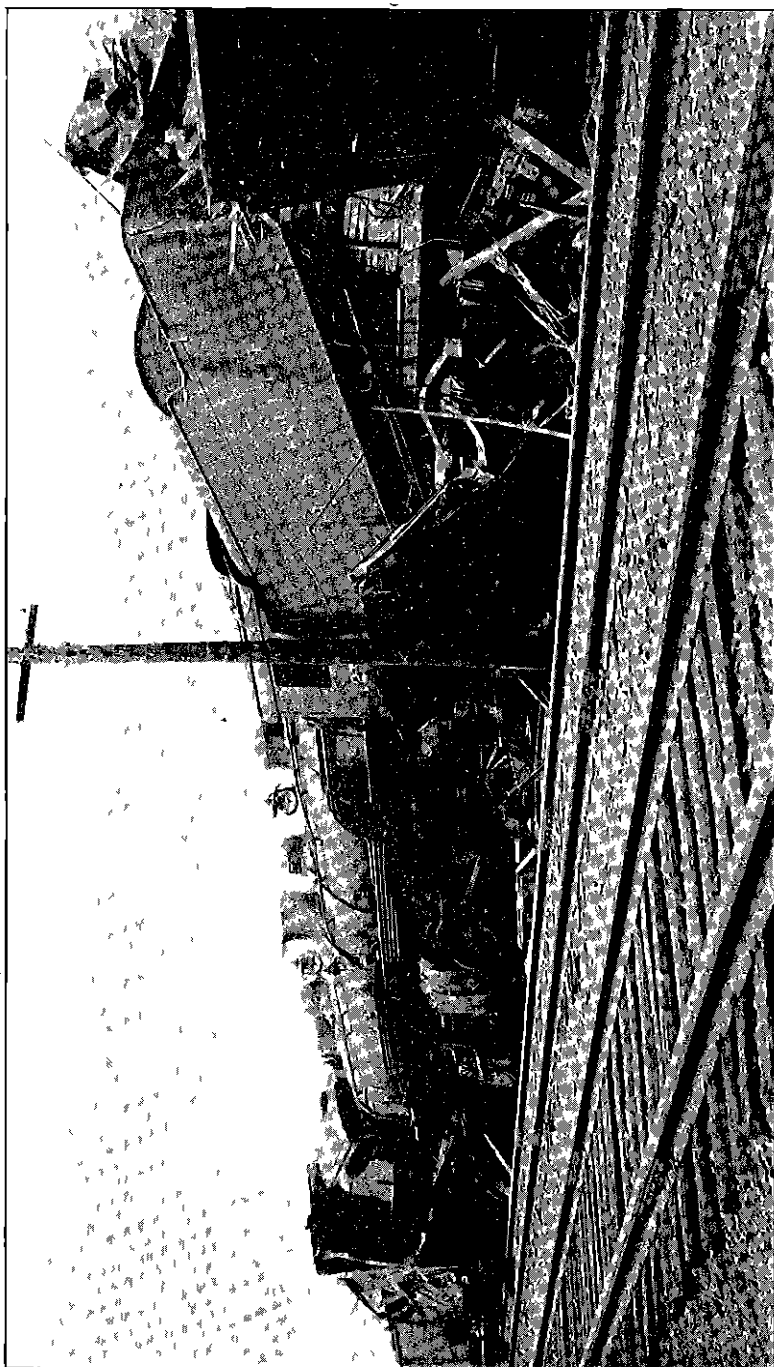
FIG 2—View of engines and tenders at point of accident

As a result of the impact the engines were locked together, the front end of the smoke box on the passenger engine was driven into the smoke box of the freight engine and the frames and cylinders were broken. The engines remained upright, with the pony trucks of both engines under engine 725. The accompanying illustration shows the position of the two engines after the accident. The tender of engine 725 was pushed its full length into the baggage car behind it the opposite end of this car telescoping the first coach about half its length, tearing the roof and one side entirely off for this distance. The four sleeping cars and the club car were not derailed or damaged. The tender of engine 1005 was pushed into the box car behind it the sixth, seventh, seventeenth, eighteenth, nineteenth, twentieth, and twenty-first cars were badly damaged or destroyed. Four rails were damaged, each having a short bend downward evidently caused by the impact or by the engines rearing up and dropping back. Conductor Batema of train No. 61 was killed.
