# National Transportation Safety Board

## Railroad Accident Brief

### Metro-North Railroad Derailment

<b>Accident No.:</b>	DCA14MR002
<b>Location:</b>	Bronx, New York
<b>Date:</b>	December 1, 2013
<b>Time:</b>	7:19 a.m. eastern standard time
<b>Railroad:</b>	Metro-North Railroad
<b>Property damage:</b>	\$9 million
<b>Injuries:</b>	61
<b>Fatalities:</b>	4
<b>Type of accident:</b>	Derailment

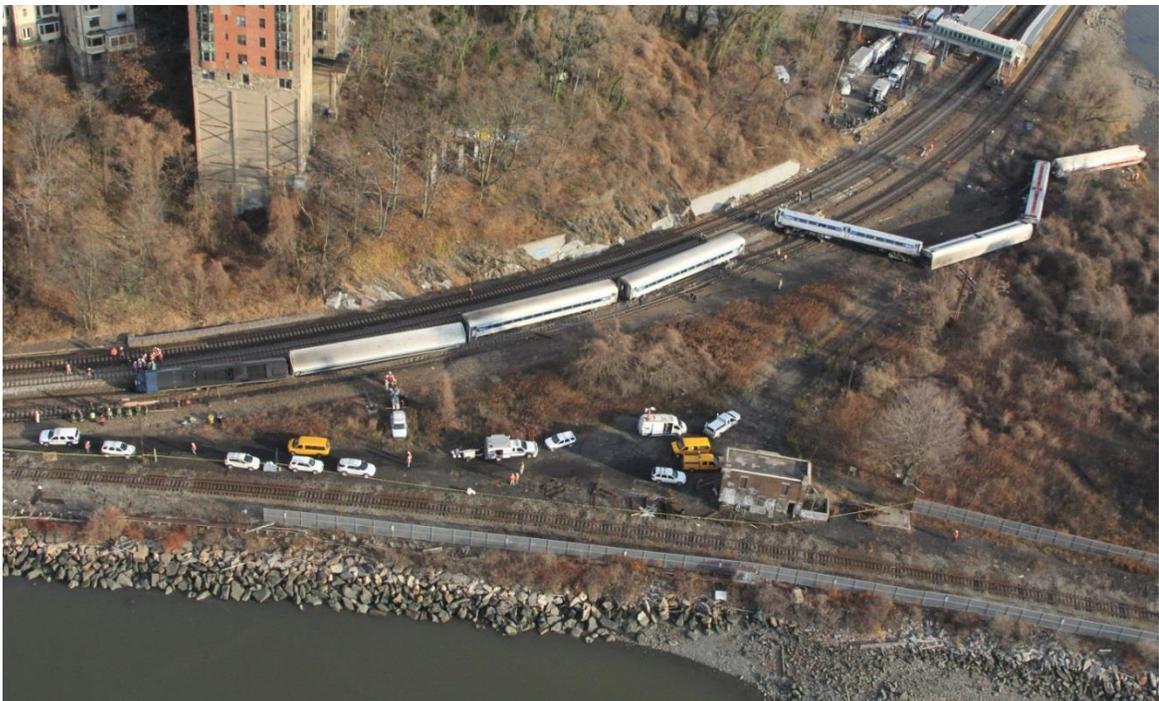
Upon passing Riverdale, about 2 1/2 miles north of the accident site, the engineer increased the train speed to 70 mph. The engineer maintained full throttle, and the train speed increased to 82 mph. As the train entered a 30-mph curve at milepost 11.4, the train derailed. During the derailment sequence many of the cars slid on their right sides in the direction of travel, and window glazing (panes) detached from the cars. Based on the locations of the four passengers who died at the end of the accident sequence, the extent of dirt and plant material in wounds and the nature of their injuries, all four were completely or partially ejected from the train through window openings. In addition, two of the seriously injured passengers sustained severe injuries consistent with contacting the ground outside the train as the cars slid along the ballast.

**Figure 1. Accident scene.**
