Derailment of CN Freight Train U70691-18 With Subsequent  
Hazardous Materials Release and Fire  
Cherry Valley, Illinois  
June 19, 2009

NTSB/RAR-12/01  
PB2012-916301

# Railroad Accident Report

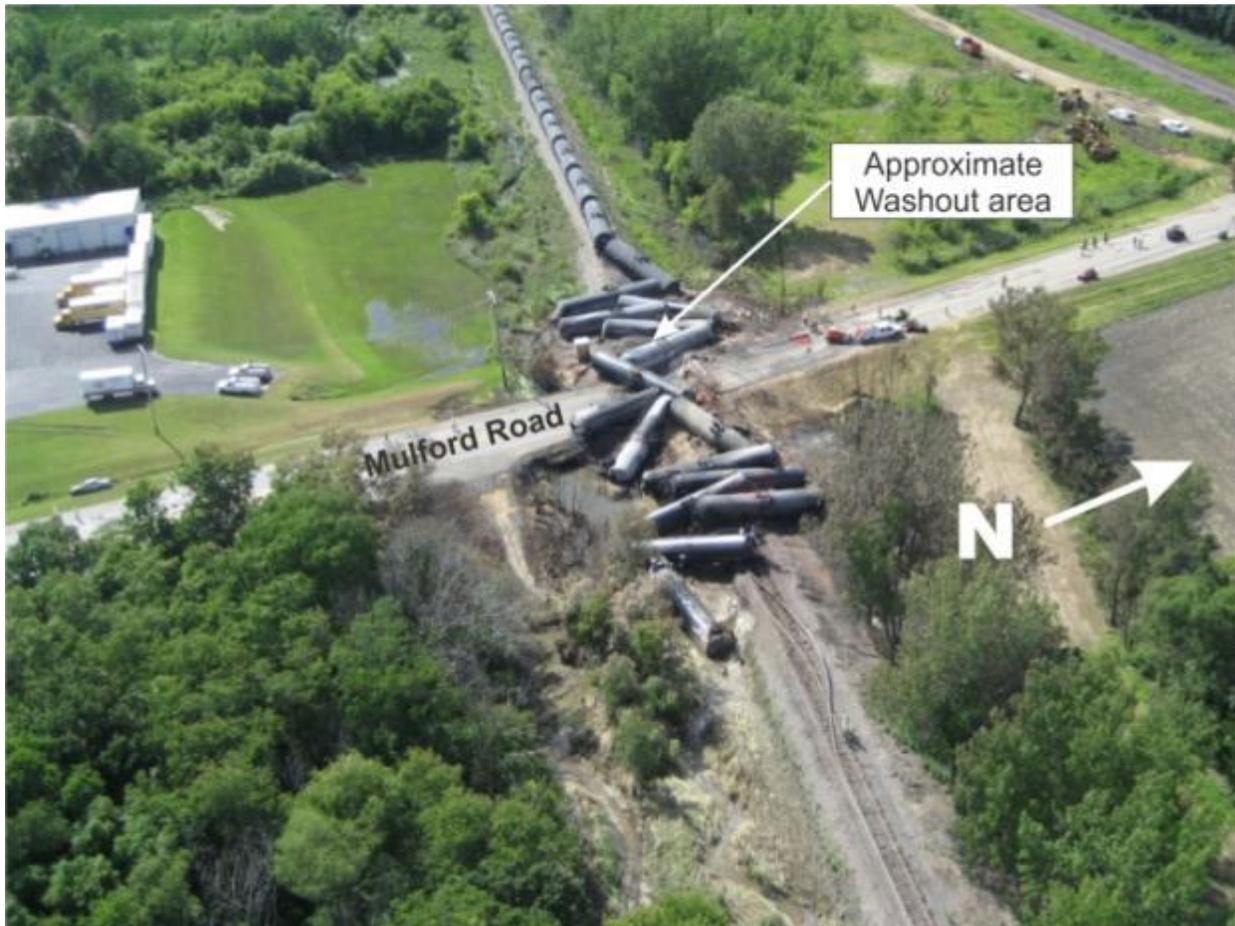
**Figure 3.** Aerial view, looking northwest, of derailed tank cars after locomotives and first 58 cars have been pulled away from wreckage.

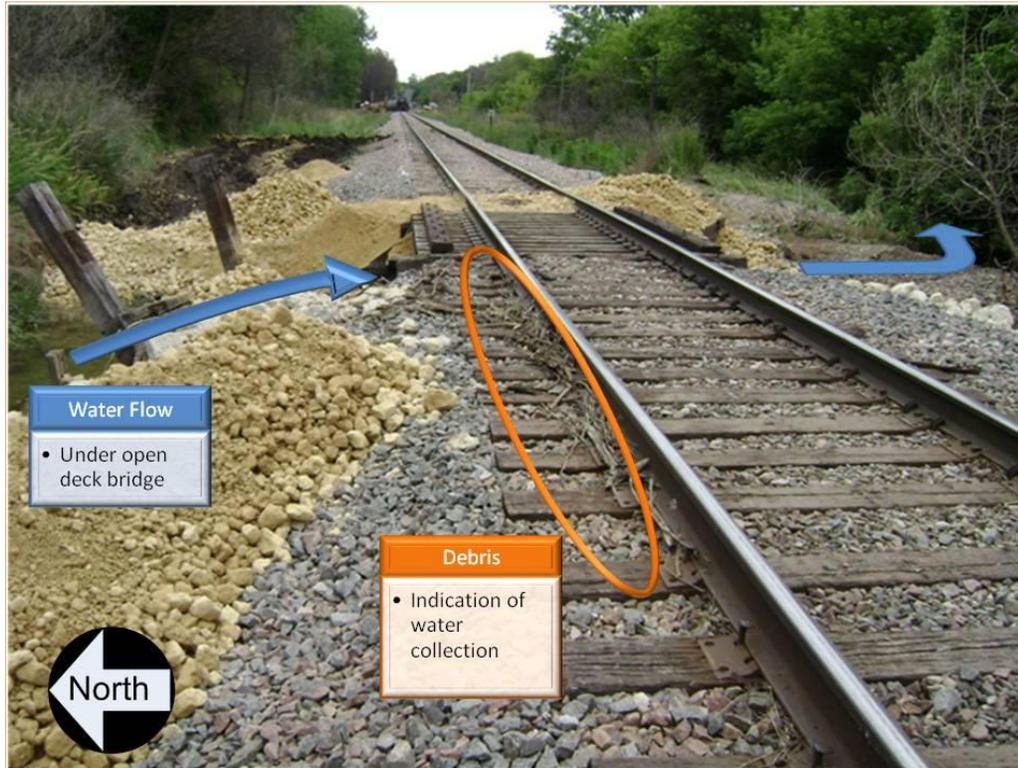
**Figure 5.** Photo shows storm water debris on the track, near the open deck bridge (0.1 mile west of the accident site). Water flow under open deck bridge is also indicated as flowing in southeast direction.

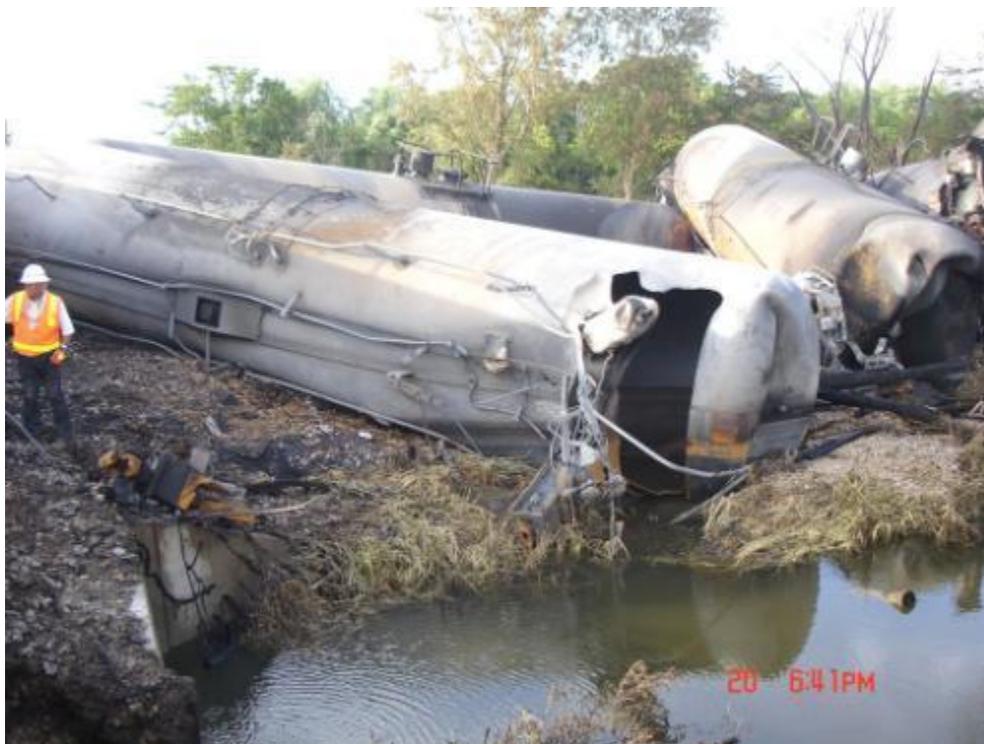
**Figure 10.** Breach in tank car NATX 303504. (Federal Railroad Administration photo)

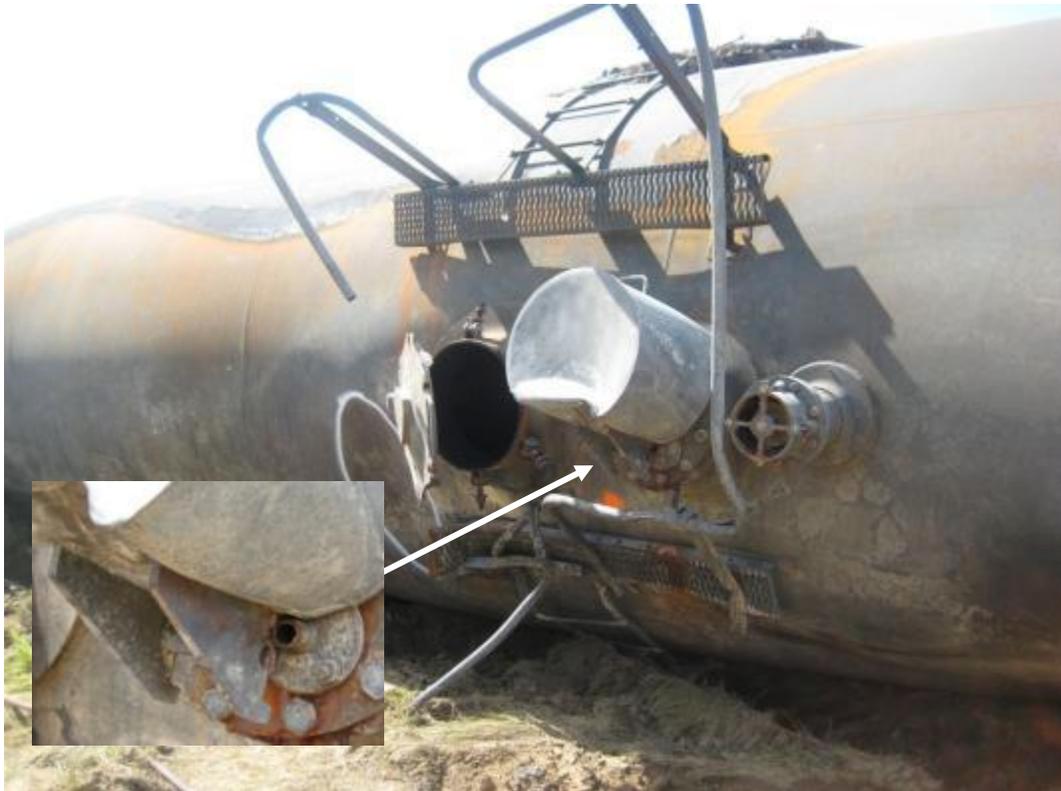
Three top valves were also found to be damaged and either partially or fully open. In the case of one car, CTCX 224236, the protective housing separated from the car, and both the liquid and the vapor valves were sheared from their threaded pipes, causing the car to lose about 26,357 gallons of product. The protective housing cover of car TILX 193772 (figure 13) was knocked askew in the derailment, breaking the vapor valve from its fitting and contributing to the release of product from that car. While the protective housing did prevent damage to fittings in the case of one car (CTCX 731600), which came to rest lying upside down in a muddy stream channel, the top fittings were damaged in other instances where the protective housings contacted harder objects.

**Figure 13.** Top fitting damage, car TILX 193772. (Overall photo by Trinity Tank Car. Inset photo by the CN.)

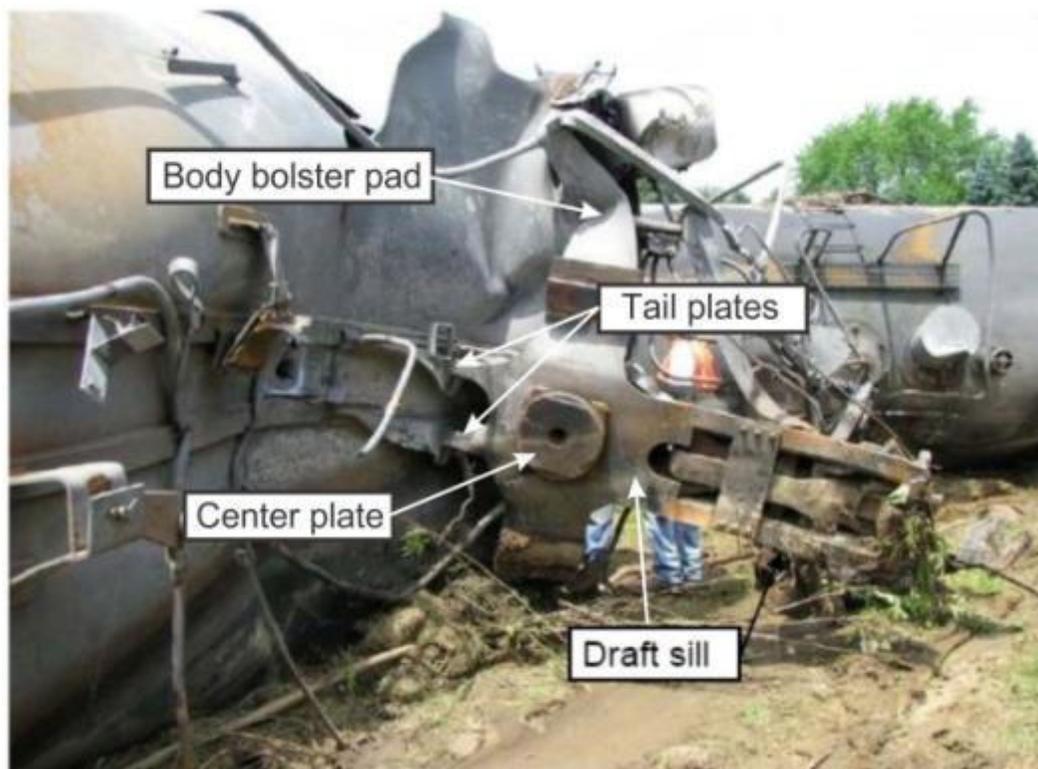
**Figure 21.** Underside of B end of tank car NATX 303504 as viewed from A end.

Examination of the lower side of the tank at the front sill pad attachment area showed that the fillet weld attaching the sill pad to the tank shell had fractured through weld metal. The weld fractures occurred in various planes from parallel to the tank outer surface to almost perpendicular to the tank surface. The fracture features had a matte gray appearance with a light orange oxide, consistent with ductile overstress fracture with some postfracture oxidation. The fracture features were generally uniform in color and texture, with no evidence within the welds of slag, undercuts, porosity, lack of fusion, or cracks. The portions of the weld metal remaining attached to the tank surface had features that were consistent with fracture propagation from front to rear along the sides of the front sill pad. The weld fractures at the edges of the front sill pad ended at the edge of the body bolster pad, a position also corresponding to the location of the circumferential fracture through the shell. At the lower surface of the tank car, the circumferential shell fracture occurred adjacent to the fillet weld for the body bolster pad and the butt weld attaching the front sill pad to the body bolster pad and bolster pad fillet weld. Investigators did not find evidence of preexisting damage such as fatigue cracking.
