Collision of Union Pacific Railroad Freight Train  
with BNSF Railway Freight Train  
Near Chaffee, Missouri  
May 25, 2013

NTSB/RAR-14/02  
PB2015-102084

# Railroad Accident Report

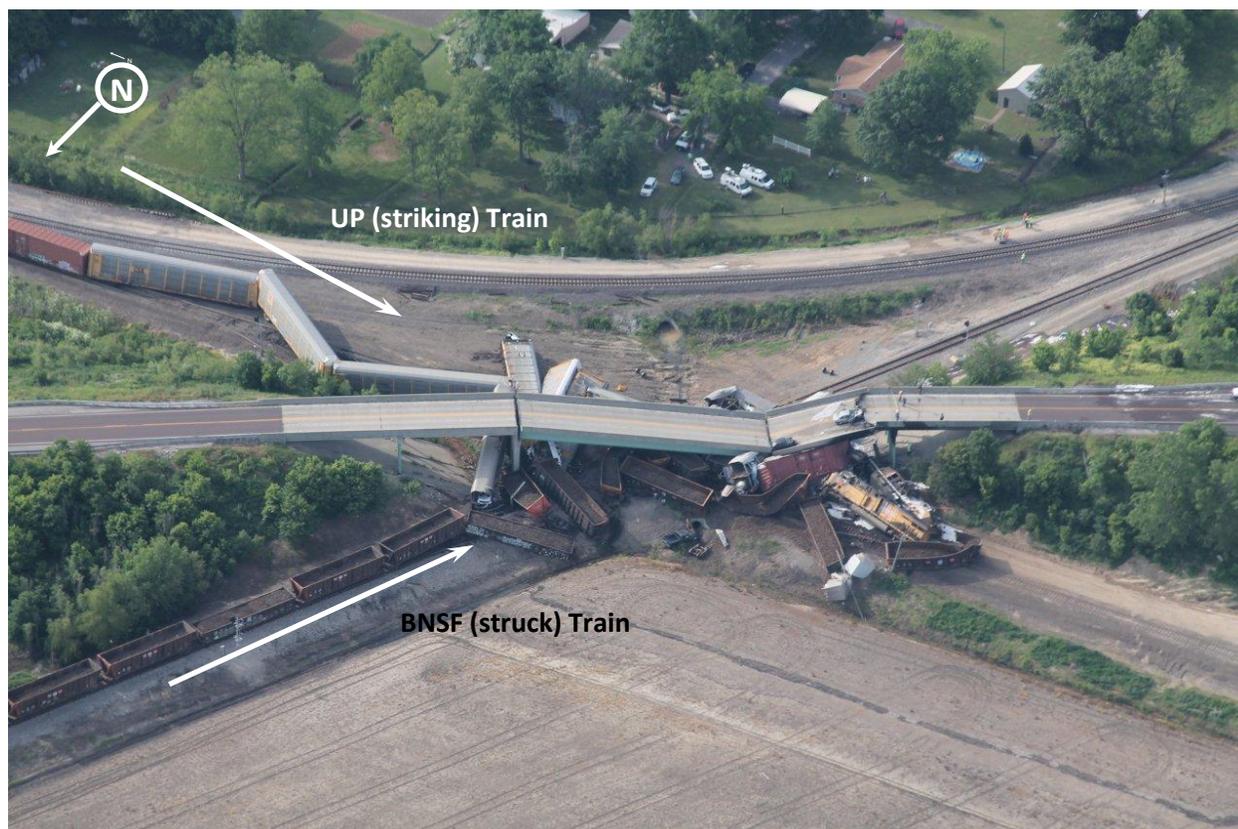
**Figure 1.** Aerial view of accident scene and wreckage.

The Missouri State Highway M bridge crossed over the Rockview Interlocking, and derailed train cars struck bridge supports and collapsed portions of the bridge. After the bridge collapsed, two motor vehicles struck damaged highway elements. Five occupants of the motor vehicles were transported to a local hospital.

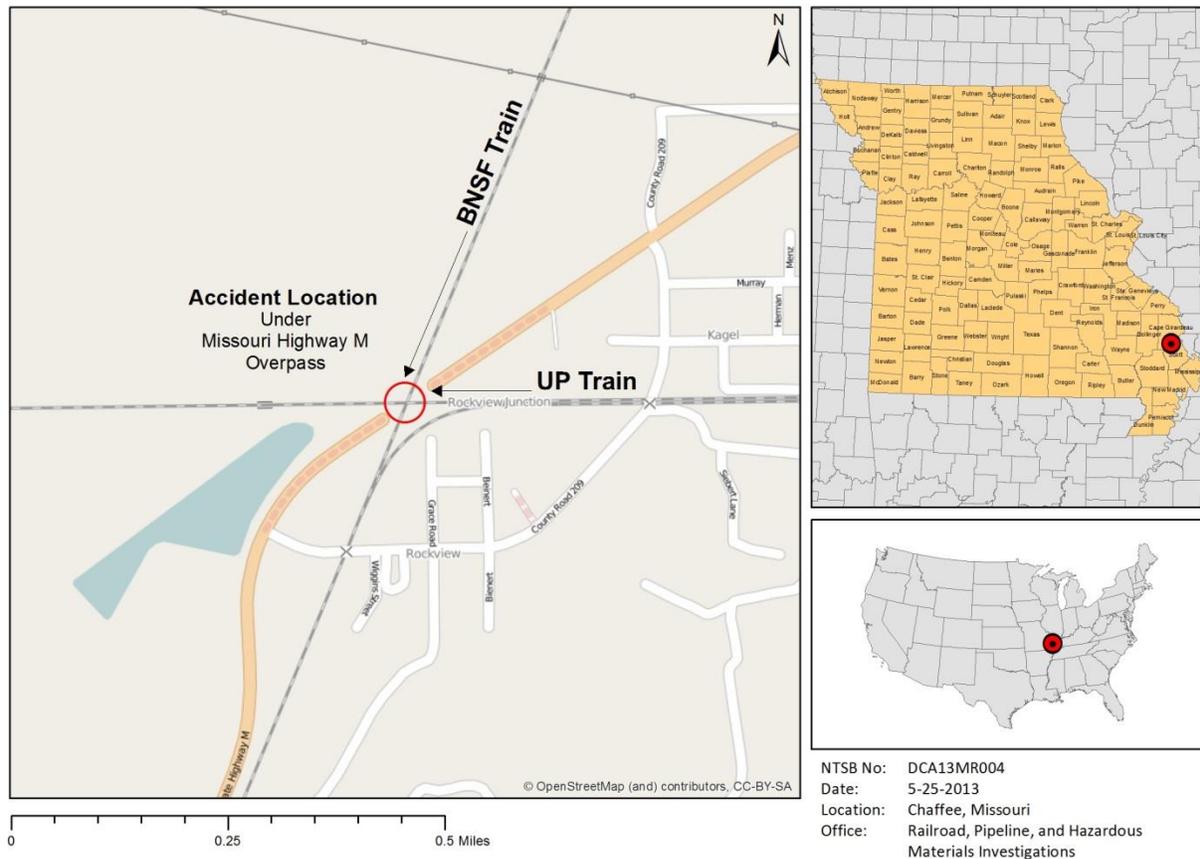
**Figure 2.** Accident location.

The conductor also told investigators that he did not notice anything out of the ordinary until the train got closer to the interlocking. He said that he was familiar with the Rockview Interlocking area, which has "a sweeping curve to the right, when you're heading south, and ... the signal is at the south end." He said that after the train went around the corner he saw the Restricting signal (flashing red aspect). At that point, he did not think the train was slowing down like it should have been, so he used the emergency brake valve to place the train into emergency braking. The UP train struck the passing BNSF train shortly thereafter. Event recorder data indicated that the speed at impact was 43 mph. (See figure 2 for accident location.)

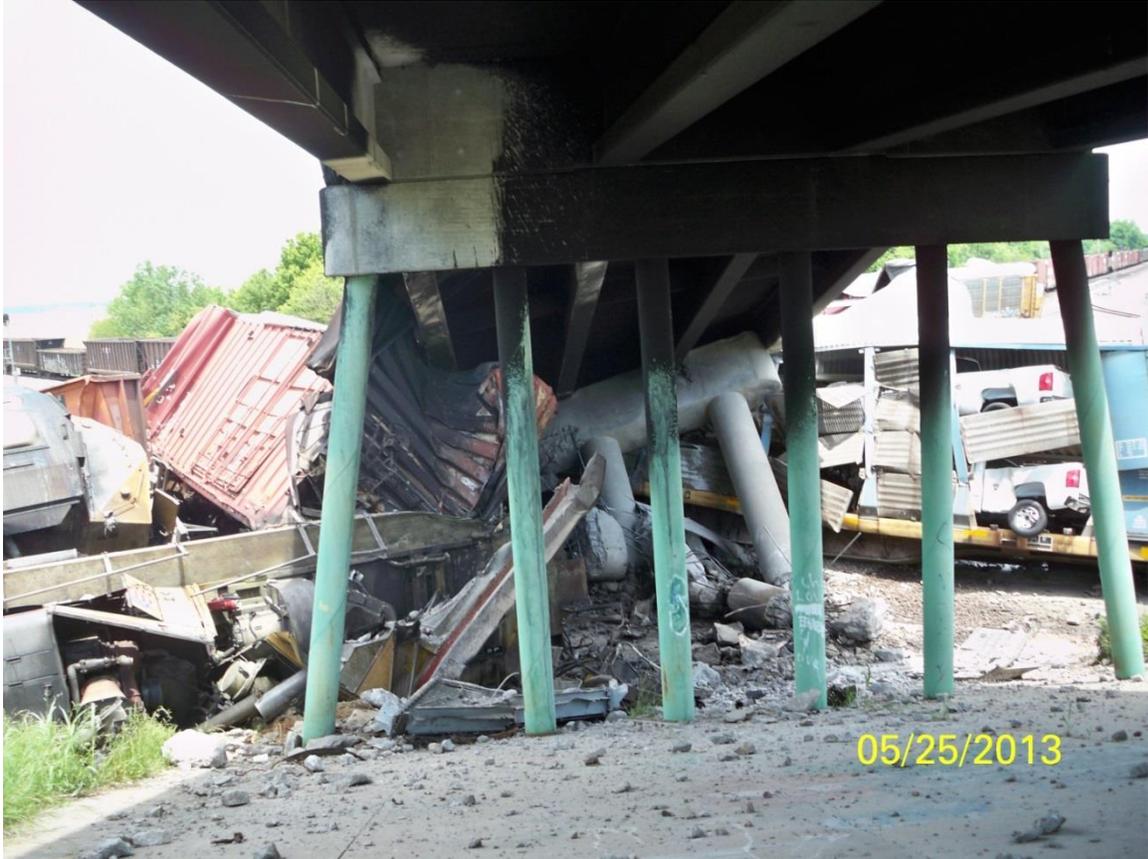
**Figure 3.** Derailed train cars and damaged bridge supports.

As a result of the train impact after the derailment, bent 3 was sheared off at the base of the footing. This loss of structure allowed spans 2 and 3 to collapse. (See figures 3 and 4.) The downward vertical movement of these spans was stopped by the wreckage of the derailed train cars underneath the structure. Several UP auto-rack cars came to rest against the fractured columns of bent 3. Also, oval-shaped impact damage 42 inches wide and 39 inches deep, consistent with an impact with one of the bent columns, was found on one BNSF car. This car was the 22nd car in the BNSF train, 10 cars behind the point where the UP train struck the BNSF train. The vertical clearance between the track elevation and the bottom of the girders was about 24.5 feet. The horizontal clearance from the center of the rails to bent 3 was 21 feet 9.75 inches. There was no crash-protection wall shielding the bents from impact with railroad equipment.
