# **NATIONAL TRANSPORTATION SAFETY BOARD**

## **RAILROAD ACCIDENT REPORT**

**HEAD-ON COLLISION BETWEEN  
BALTIMORE & OHIO RAILROAD COMPANY  
TRAIN NO. 88 AND THE BRUNSWICK HELPER  
NEAR GERMANTOWN, MARYLAND  
FEBRUARY 9, 1981**

**NTSB-RAR-81-6**

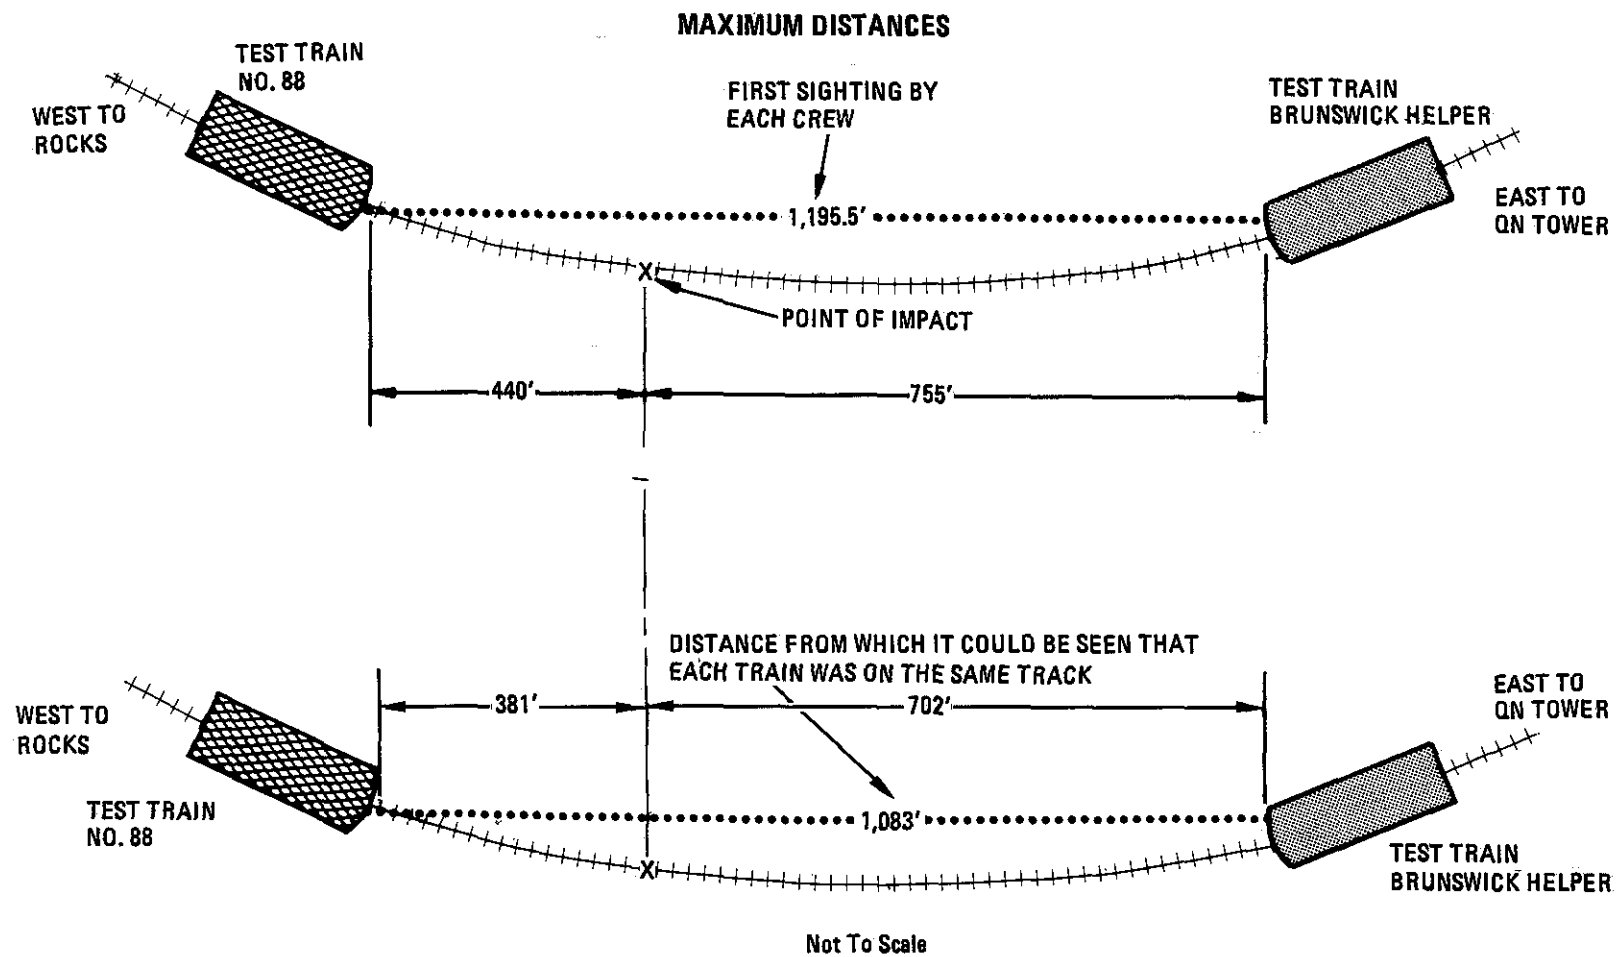
Figure 4.-- Sight distance as determined by test trains.

On February 19, tests were conducted to establish sight distances for the curve on which the trains collided. Locomotive units similar to the units involved in the collision were used and were oriented in the same position and direction as those of the accident trains. Tests simulated the view from each train to the other. (See figures 4 and 5.)
