# NATIONAL TRANSPORTATION SAFETY BOARD

## RAILROAD ACCIDENT REPORT<sub>ND.</sub>

REAR END COLLISION OF TWO  
CHICAGO TRANSIT AUTHORITY TRAINS  
NEAR THE MONTROSE AVENUE STATION  
CHICAGO, ILLINOIS  
AUGUST 17, 1984

NTSB/RAR-85/11.

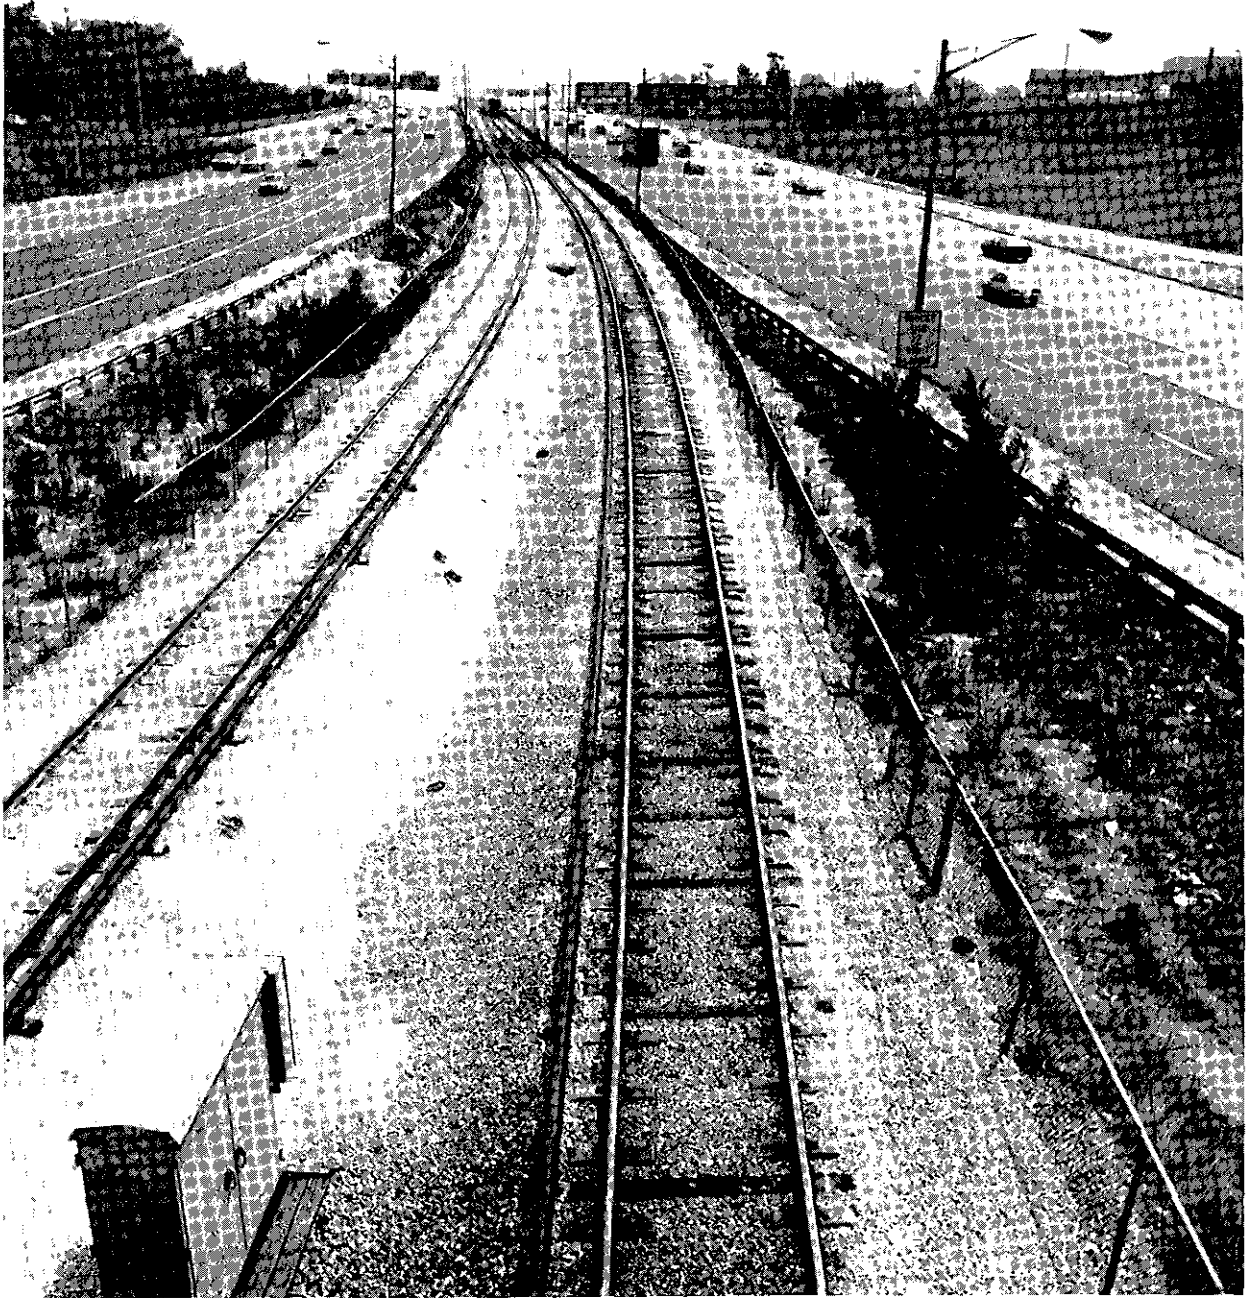
Figure 2.—View of the accident site south of the Montrose Avenue Station.

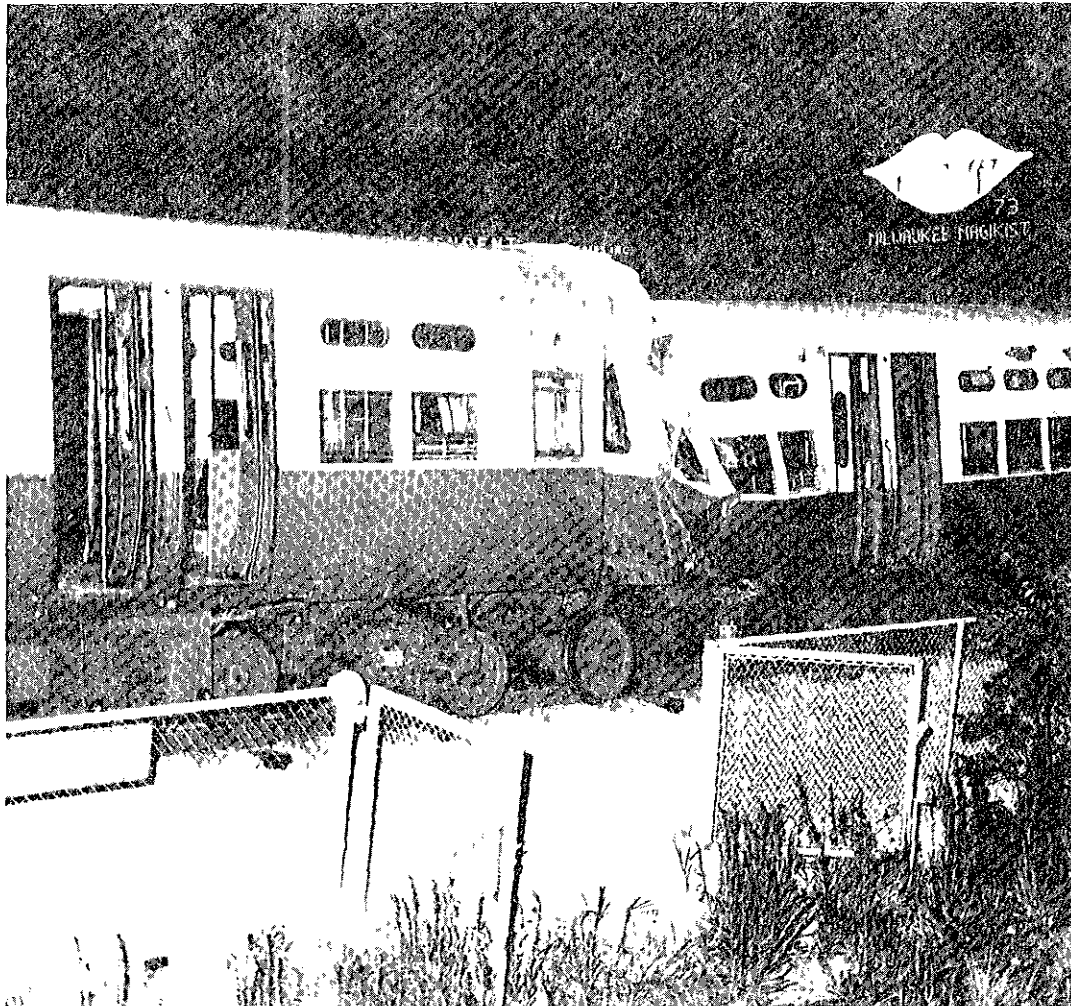
Figure 3.—View from the west side of the crushed end of car 6648.  
(Chicago Transit Authority photograph).

The No. 2 end of car 6648 that was coupled to car 6647 was damaged the most severely. The antilimbers engaged and crushed the car 4 feet inward at floor level across the full width of the car. The sidewalls of the car flared outward 15 inches on one side and 16 inches on the other side. The crushed end of the car also was forced upward, causing the roof to bulge upward 16 inches. The right side of the car was crushed upward, and the left side was crushed inward and ripped open in the area of the first four seats. (See figure 6.) The first four seats on each side and the floor under them were destroyed. That part of the end frame to which the antilimbers are attached bent downward, and the crushing caused the floor to split across the entire width of the car behind the third seats and buckle upward 53 inches. (See figure 7.) The end windows adjacent to the first seats were out; the end door was jammed and would not open. The No. 1 end of car 6648 retained its basic structural integrity and was not crushed inward; there was only slight damage to the antilimber. There was no examination of the structural members to determine whether any of the members had deteriorated.

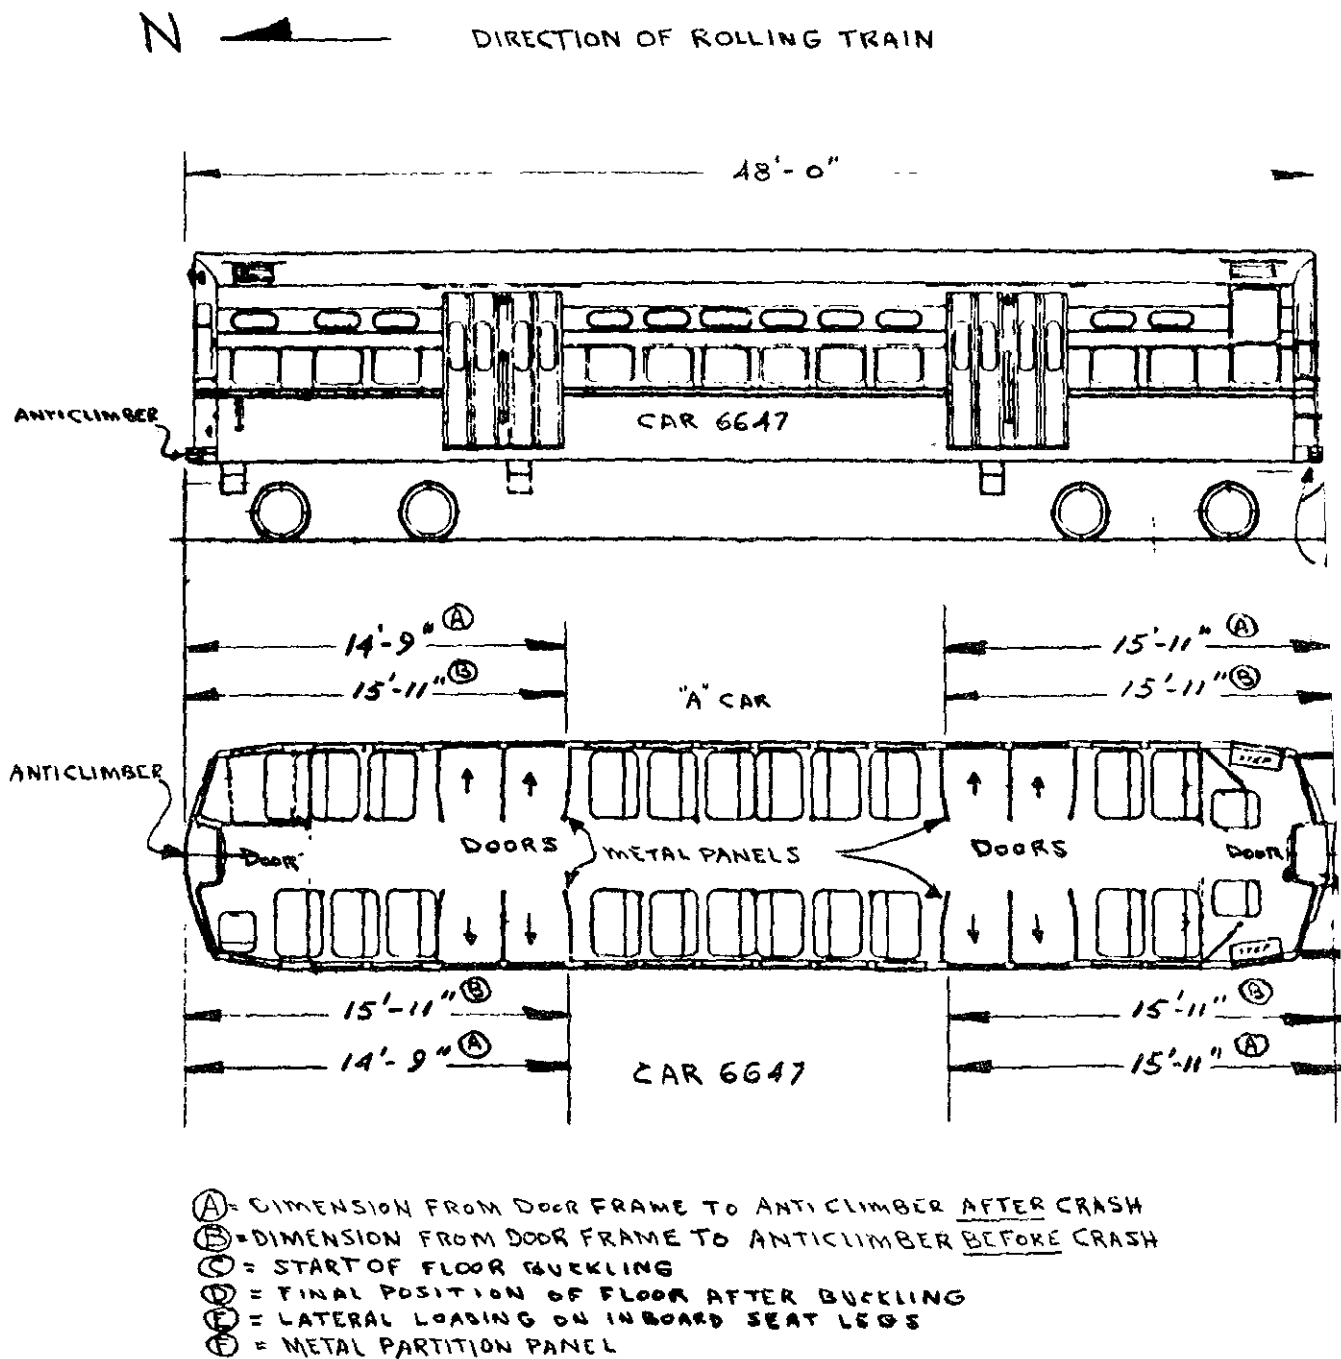
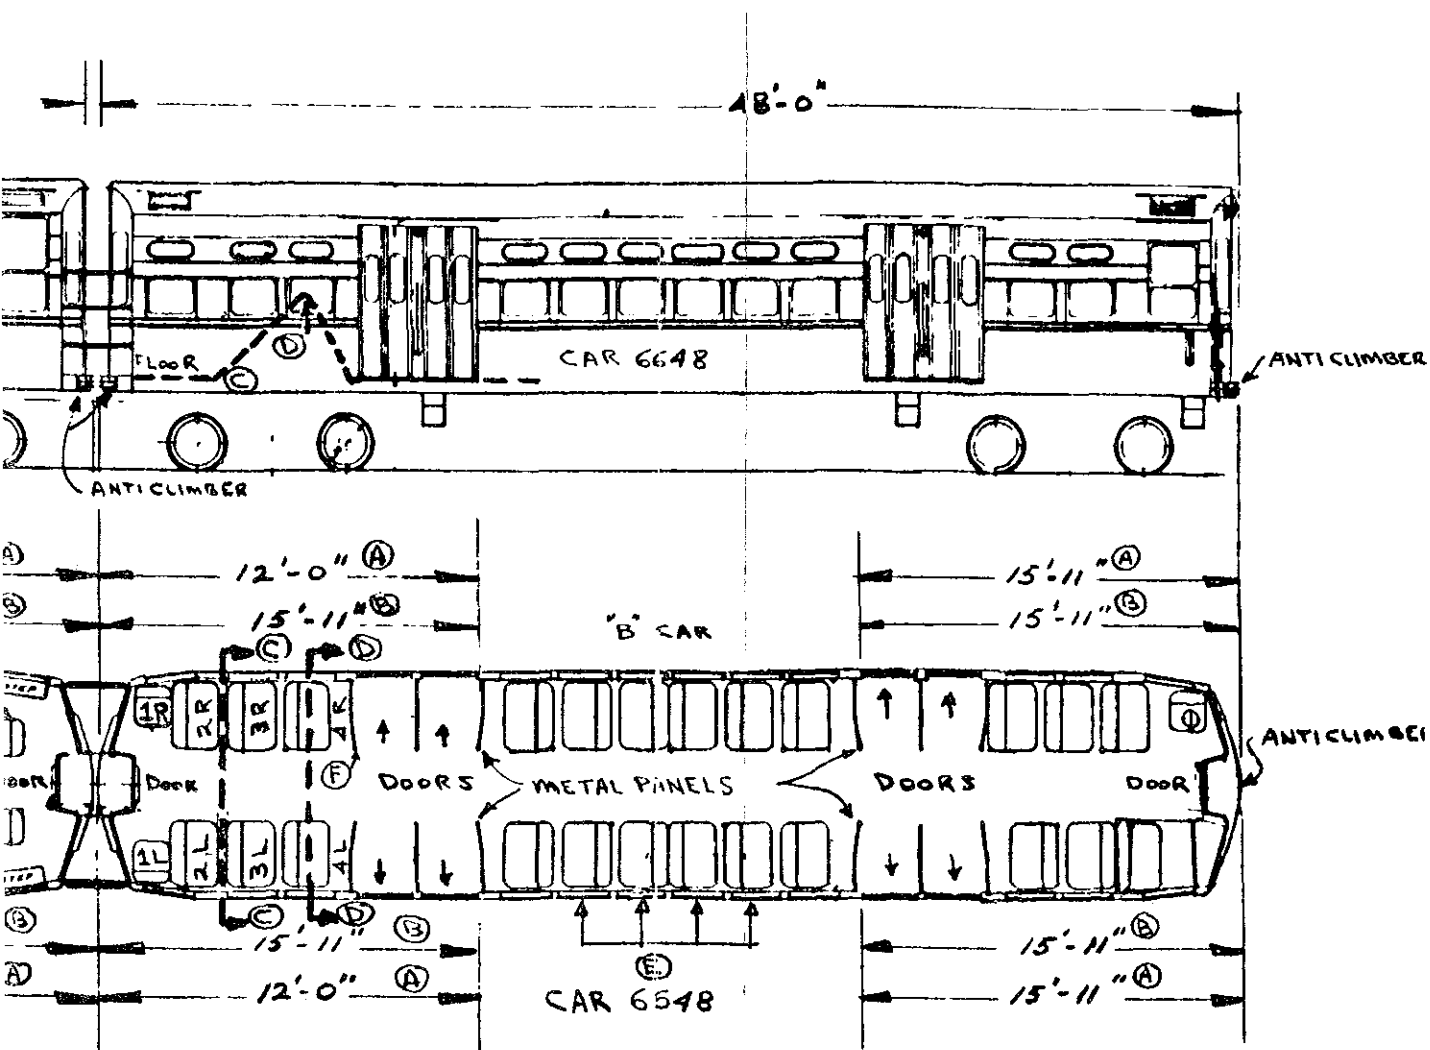
FIGURE 4 - - SKETCH

Train 135.--The No. 1 end of car 6647 of train 135 that struck standing train 143 was crushed inward 1 to 2 feet and downward across the full width of the car. (See figures 4 and 5.) The antilimber in the area of the end door was crushed inward and downward. The No. 2 end of the car that was coupled to the No. 2 end of car 6648 retained its basic structural integrity; however, the sheet metal at the top end of the roof was bent inward 1 1/2 inches and the antilimber was deformed upward. The interior paneling near the ceiling at the No. 1 end was deformed inward; the center door had jammed and could not be opened. The inboard seatback of the first seat behind the motorman's compartment was forced forward 5 inches. The first side seat opposite the motorman's compartment was not attached to the floor, and the front of the car was up

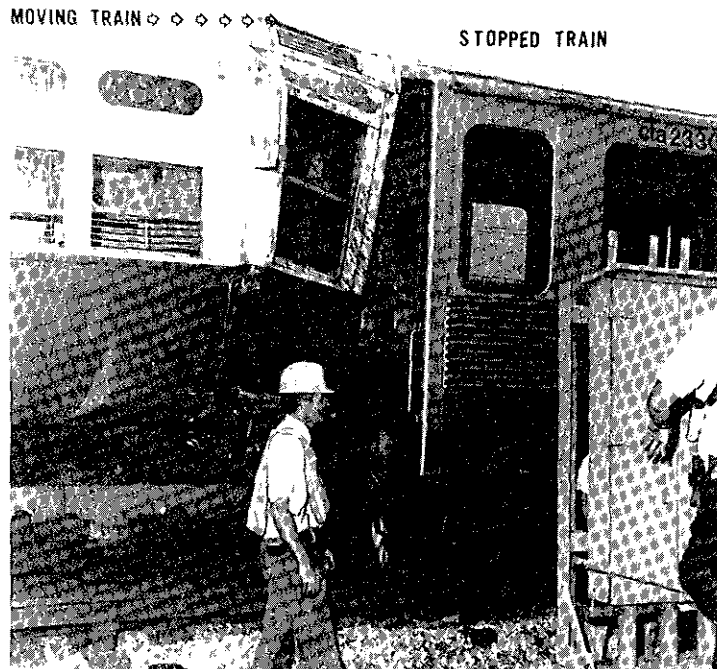
Figure 5.--Collision between last car (6647) of train 135 and first car (2330) of standing train 143.

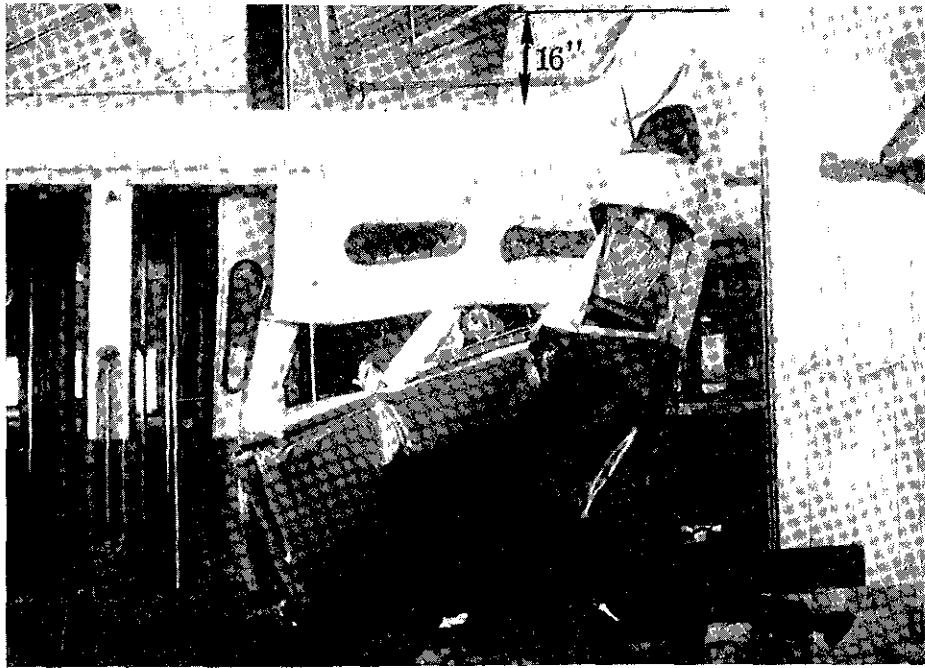
Figure 6.--East side view of crushed end of car 6648. Note upward bend of roof and upward crushing of floor under the passenger seats.

The deformation of all of the cars was as expected, except for car 6648, the second car from the rear in train 135. Although the manner in which the antilockers engaged afforded the No. 2 end of car 6648 a greater opportunity to crush, the damage was greater than a precrash analysis would indicate. The No. 2 ends of cars 6648 and 6647 were crushed inward 4 feet and 1 1/2 inches, respectively. The rearward collapse of the No. 2 end of car 6648 caused the 3/4-inch plywood floor to split across the entire width of the car just aft of the rear seat leg/floor attachment fittings of seats 3L and 3R. The fatally injured passenger was sitting in seat 4R. When the floor buckled upward 53 inches, his seat was forced upward and rearward. The modesty panel in front of this seat forced the seat and occupant into the side of the car.

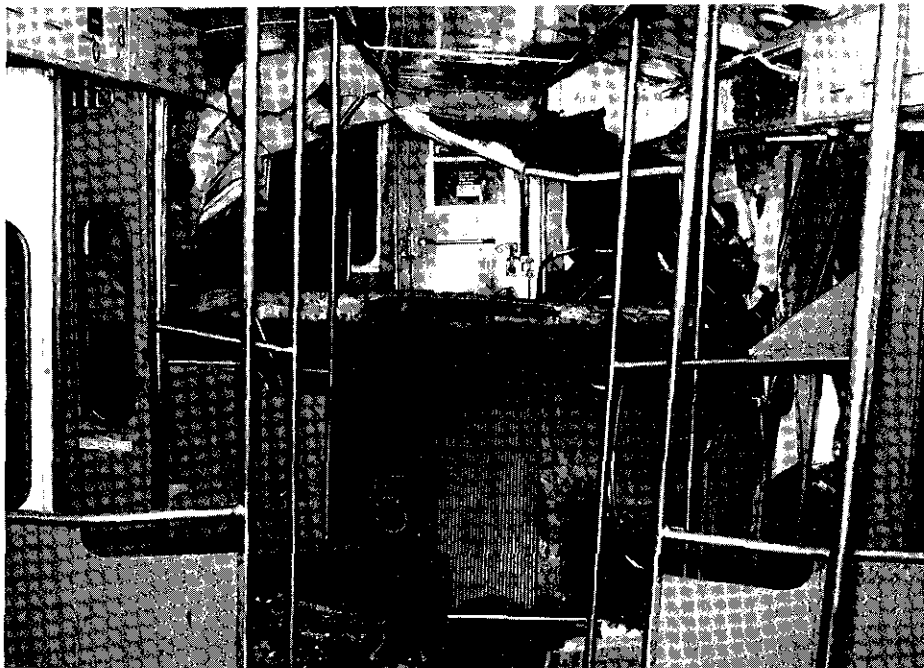
Figure 7.--End of car 6648 that was coupled to car 6647.  
Note buckled floor and ceiling.
