NATIONAL TRANSPORTATION SAFETY BOARD

RAILROAD ACCIDENT REPORT

**REAR END COLLISION BETWEEN
BOSTON AND MAIN CORPORATION
COMMUTER TRAIN NO. 5324 AND
CONSOLIDATED RAIL CORPORATION
TRAIN TV-14
BRIGHTON, MASSACHUSETTS
MAY 7, 1986**

NTSB/RAR-87/02

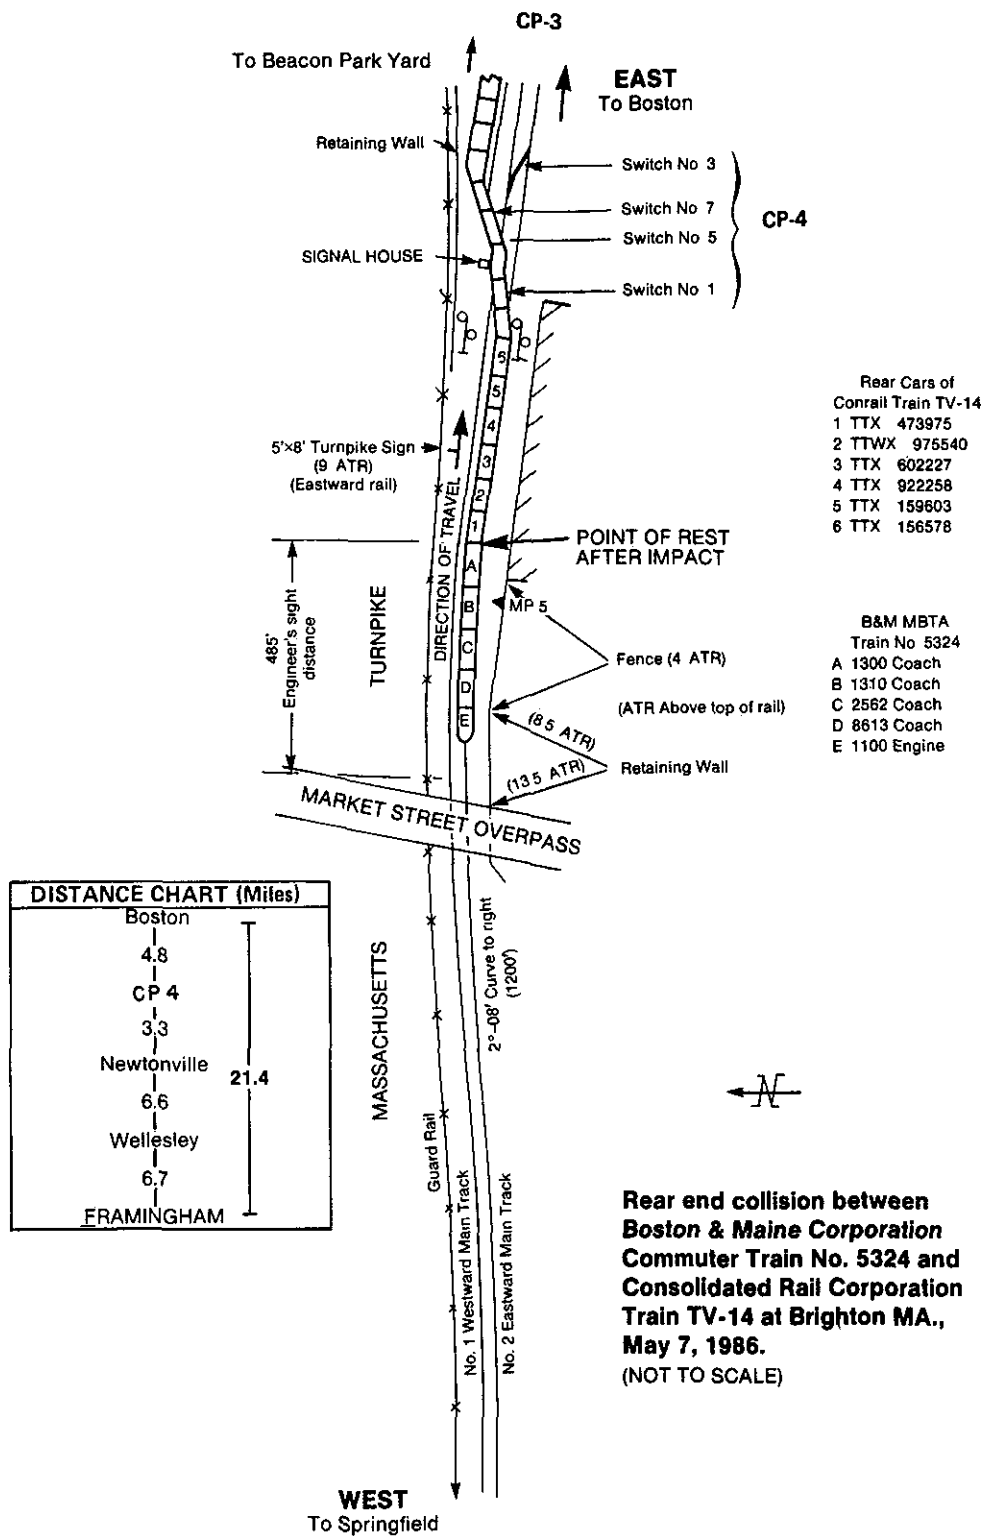
Figure 1.--Accident site.

Neither train was derailed. The accident occurred near MP 5 about 5,655 feet east of automatic block signal 6.2E. (See figure 1.) After the accident the automatic brake handle was found in the emergency position and the throttle was in the off position.

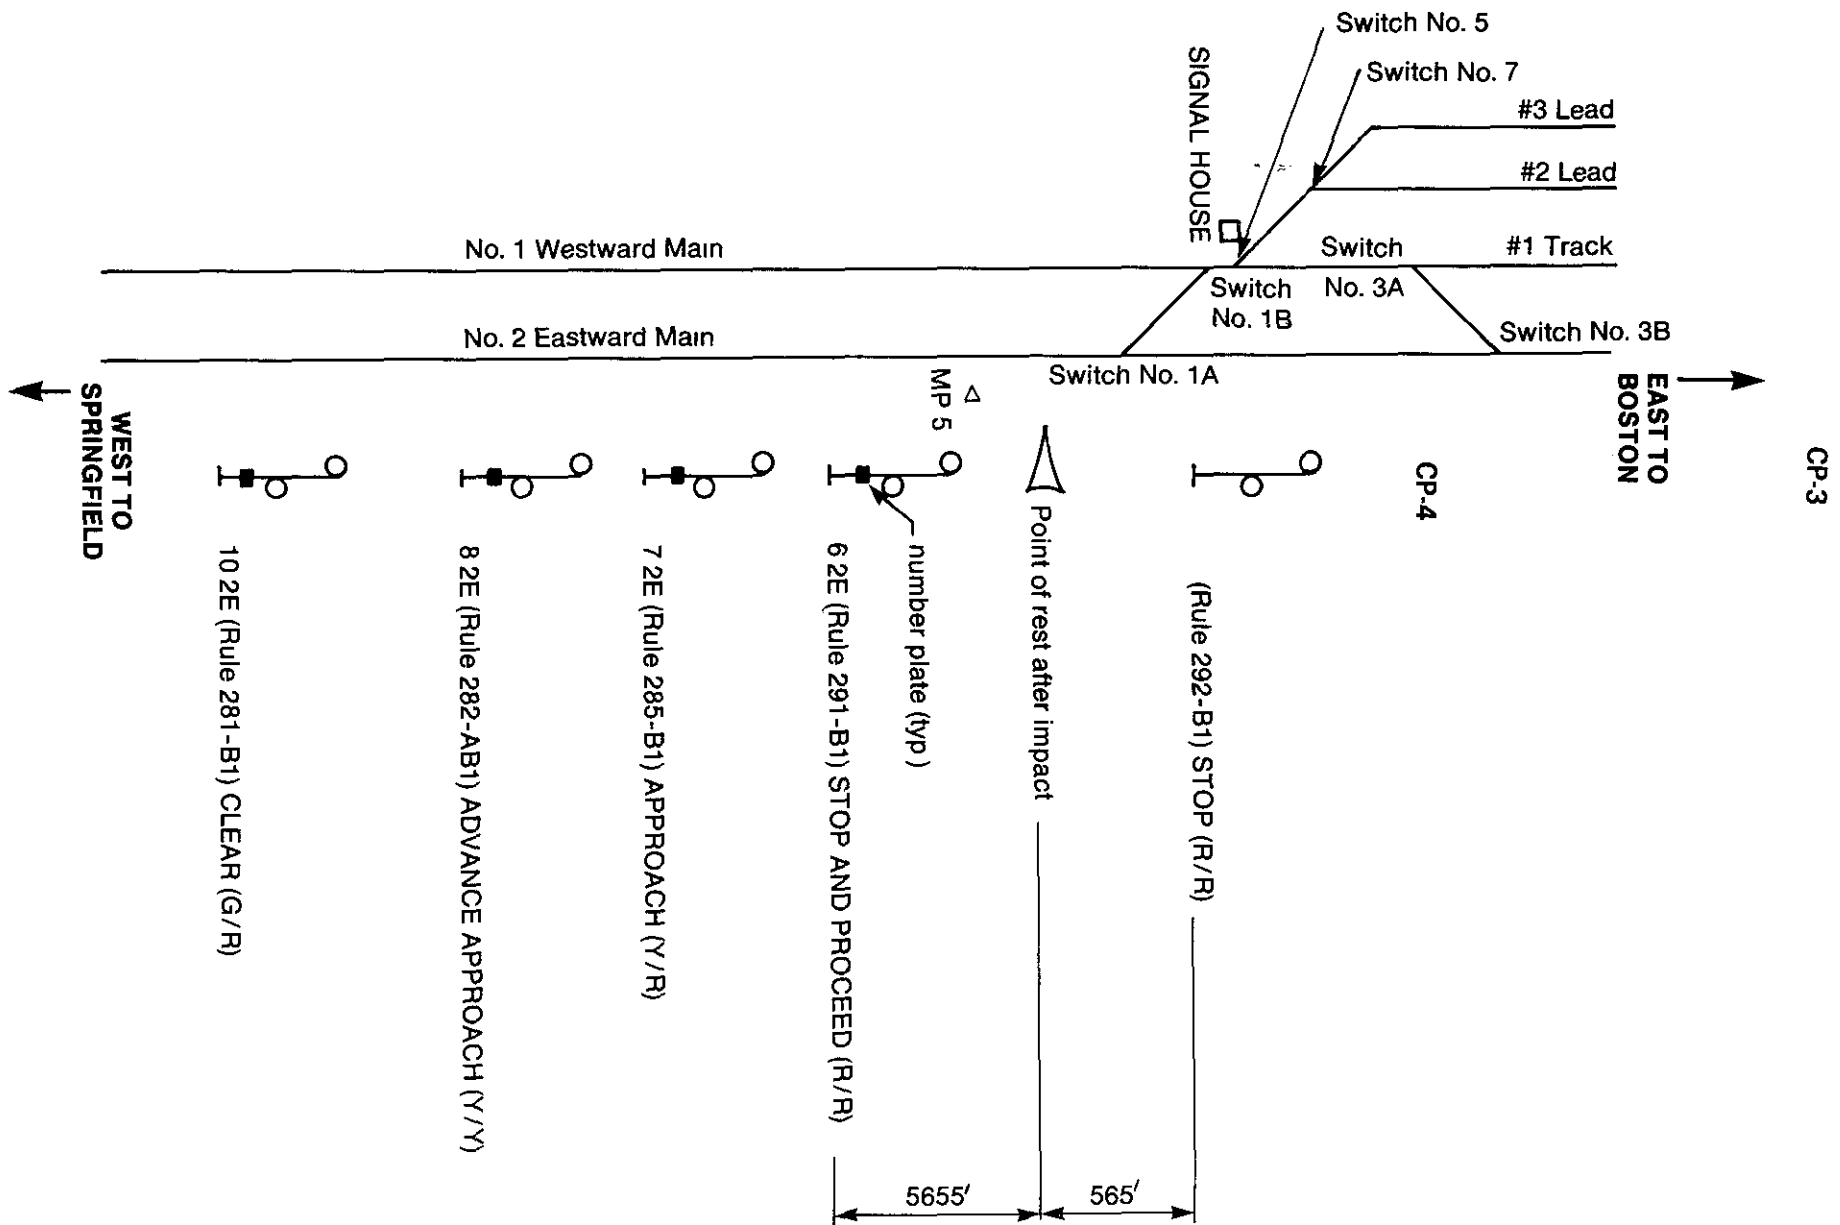
Figure 2.--Signal system indications observed following the accident.

The Signal System.—The signal system was checked in detail through the area where the accident occurred and no defects or faults were found. All testing and records required of Conrail by the FRA were up to date.

3. The signal aspects displayed to the rear of train TV-14 were correct; there were no deficiencies found within the signal system.
4. Although the engineer of train No. 5324 stated that he was not distracted by conversation with the railway and bus inspector, the manner in which the train was operated indicates inattentiveness on his part.

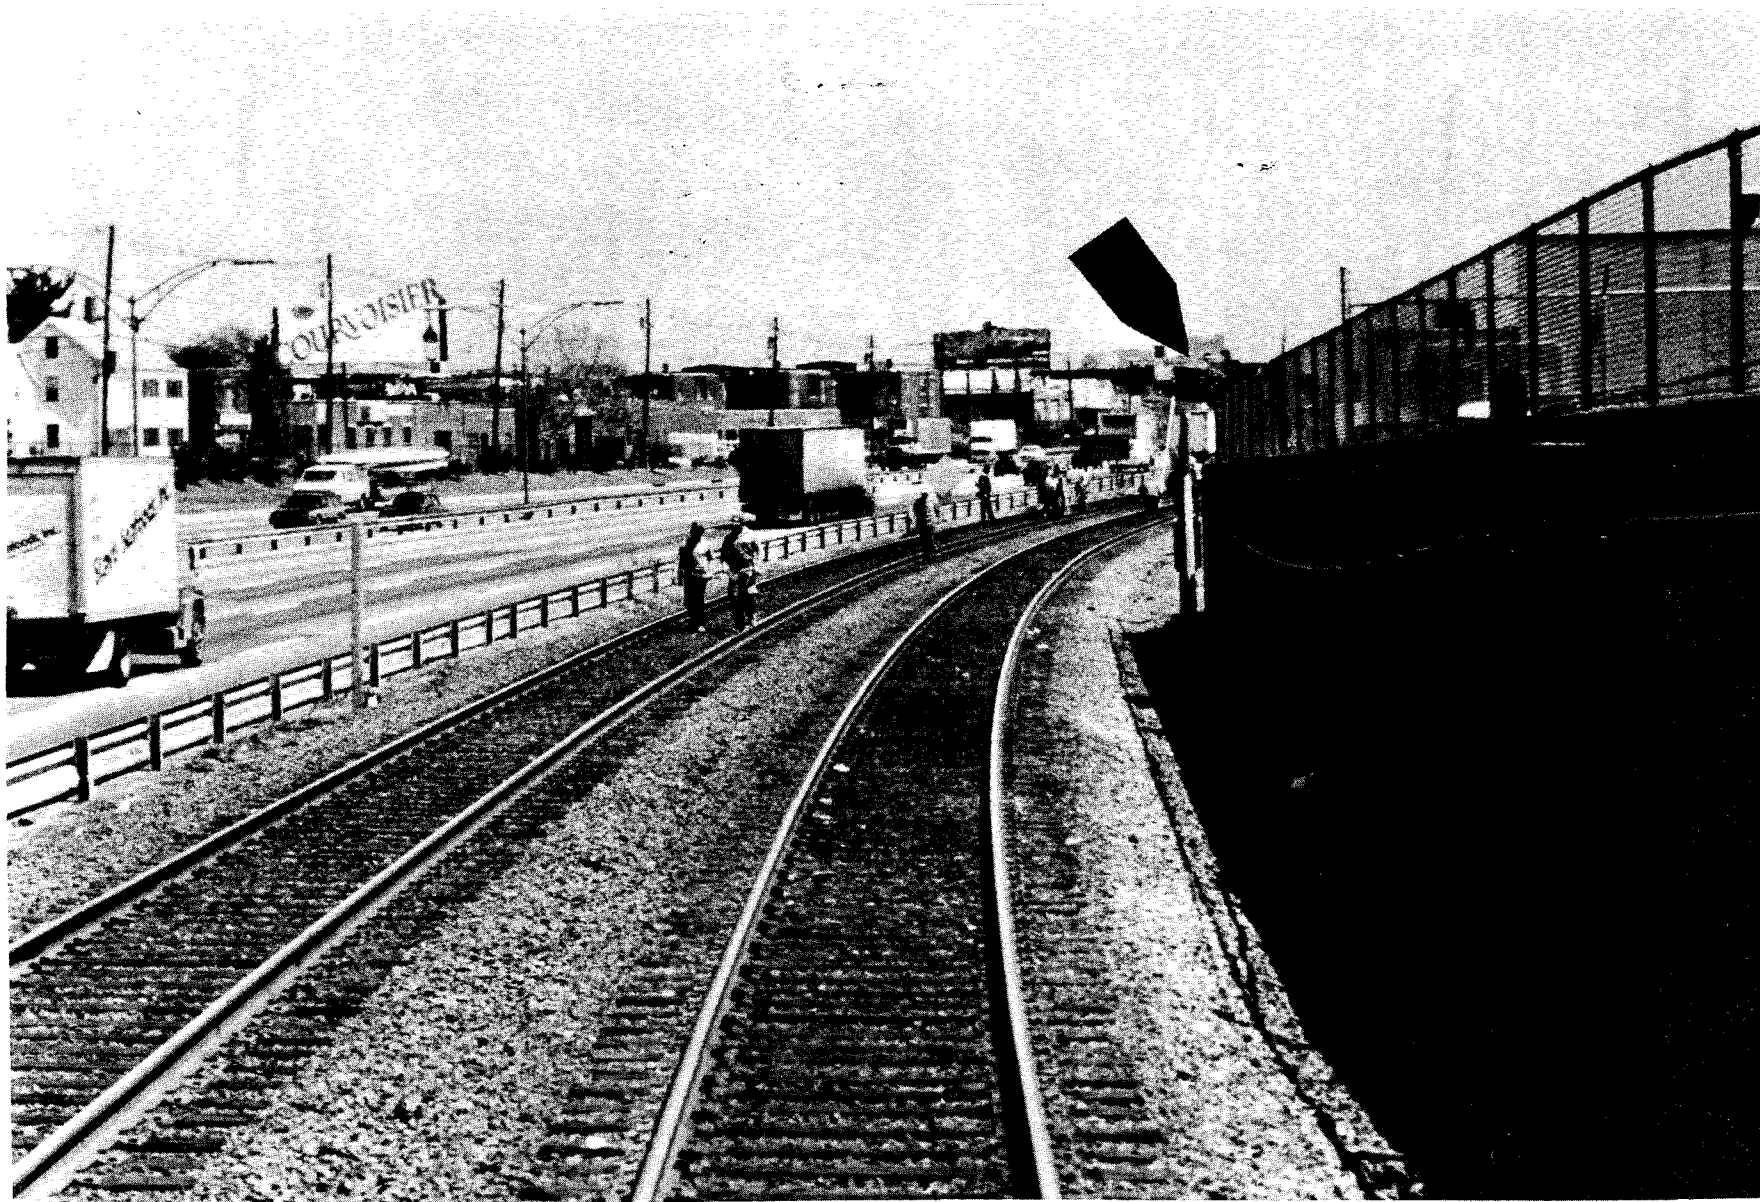
Figure 3.--Arrow indicates site of large plywood board placed at the location of the last car after impact with train TV-14.

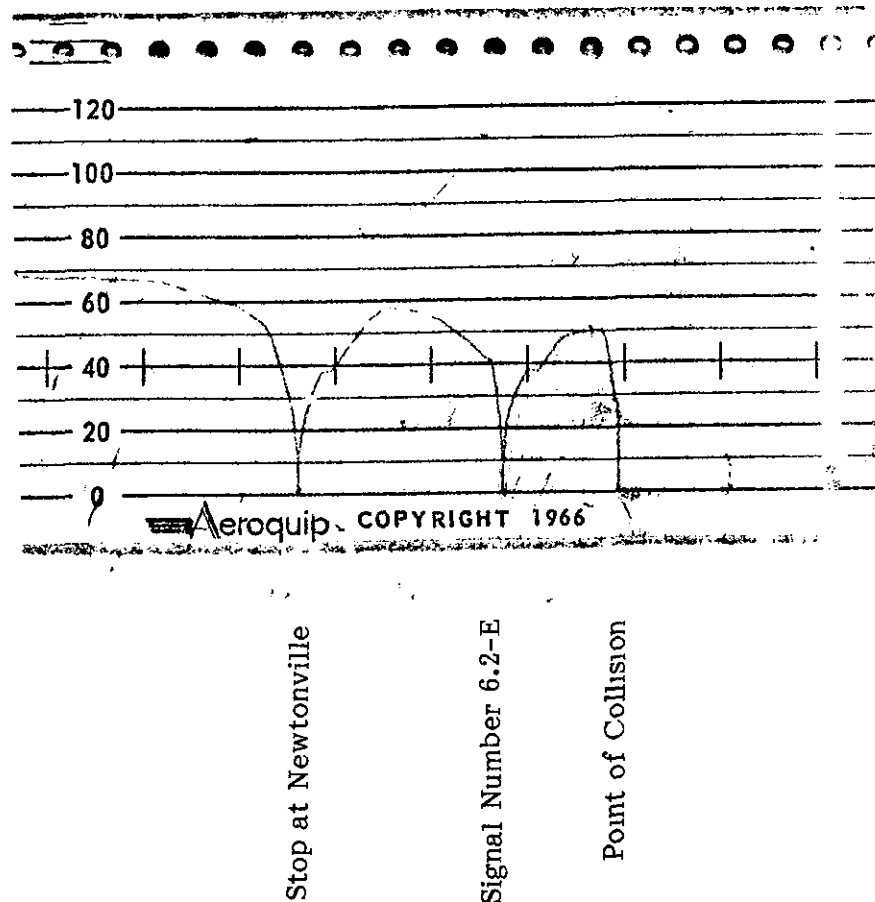
Figure 4.--Speed tape of train No. 5324.

The speed tape from control coach 1310 indicated that train No. 5324 had attained a maximum speed of 50 mph between signal 6.2E and the point of collision. Further, the speed tape indicated a speed of 25 mph just before impact occurred (see figure 4). The accuracy of the speed recorder from coach No. 1310 was tested by applying a prescribed frequency test signal, directly to the recorder unit which corresponded to a speed in miles

per hour and by-passing the sensor unit. The coach wheels were measured to determine the correction factor for wheel wear. The tests indicated that the speed recorder was accurate to plus or minus 2 mph over the speed range at which the commuter trains were operated.
