NATIONAL TRANSPORTATION SAFETY BOARD

RAILROAD ACCIDENT REPORT

**COLLISION AND DERAILMENT OF
SOUTHEASTERN PENNSYLVANIA
TRANSPORTATION AUTHORITY
SINGLE CAR TRAIN 167
69TH STREET TERMINAL
UPPER DARBY, PENNSYLVANIA
AUGUST 23, 1986**

NTSB/RAR-87/04

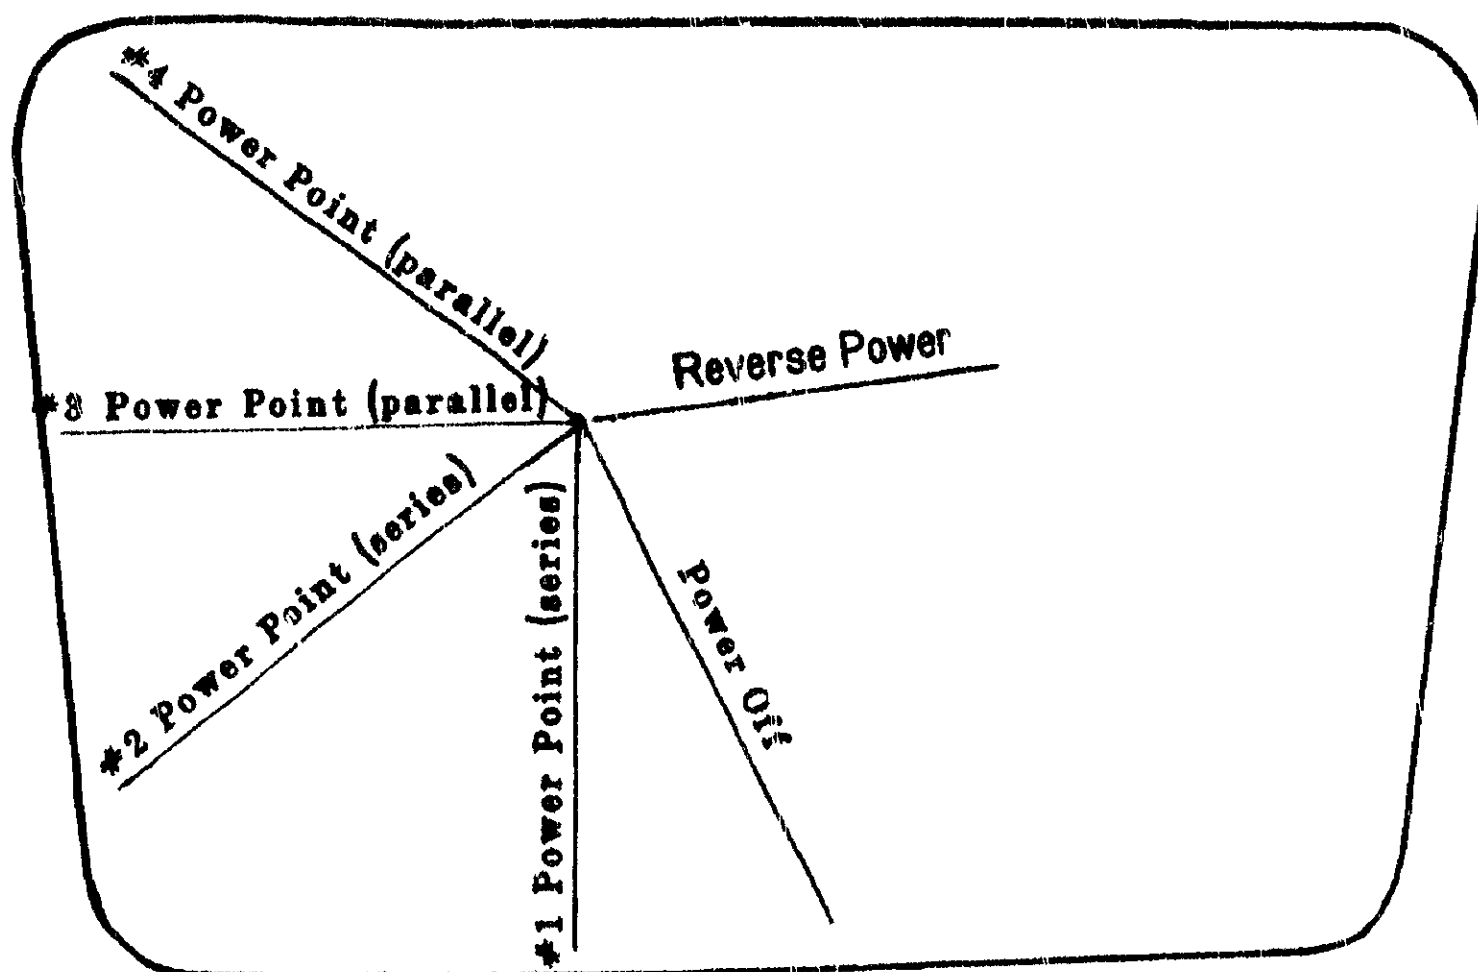
Figure 2.--Controller handle positions.

During the investigation, it was discovered that the controller handle from car 167 would sometimes stick on the raised projection of the controller plate and not return to the power off position. SEPTA mechanical supervisors stated that before the accident they were not aware that a controller handle could stick. Maintenance records indicate that before the accident, on July 2, 1986, car 164, and after the accident, on April 29, 1987, car 161 were reported defective due to a sticking controller. Both cars were 60-series cars. SEPTA records indicate that in the first incident 15 minutes were devoted to an inspection of the problem; no defects were found, and no repairs were made. Since the accident, SEPTA has modified the propulsion system to open the line switches during an emergency or deadman brake application and thus remove power. This precludes simultaneous brake and power applications.

In a letter dated March 6, 1987, the SEPTA general manager notified the Safety Board that SEPTA had arranged to "Modify controller plates on the 60 series cars so as not to allow any controller handles to mechanically 'hang up' in series or parallel circuit. This was complete as of August, 1986." In reviewing the maintenance records of the NHSL equipment for April 29, 1987, the Safety Board noted that car 161 was reported defective for "A-end controller sticks." The defect was diagnosed as a "stuck finger"; repairs made were reported as "filed finger." Apparently, SEPTA's modification of the controller plates to eliminate controller handle sticking was not successful in all cases, and the Safety Board urges SEPTA to review its modification program to ensure that the problem will be eliminated.

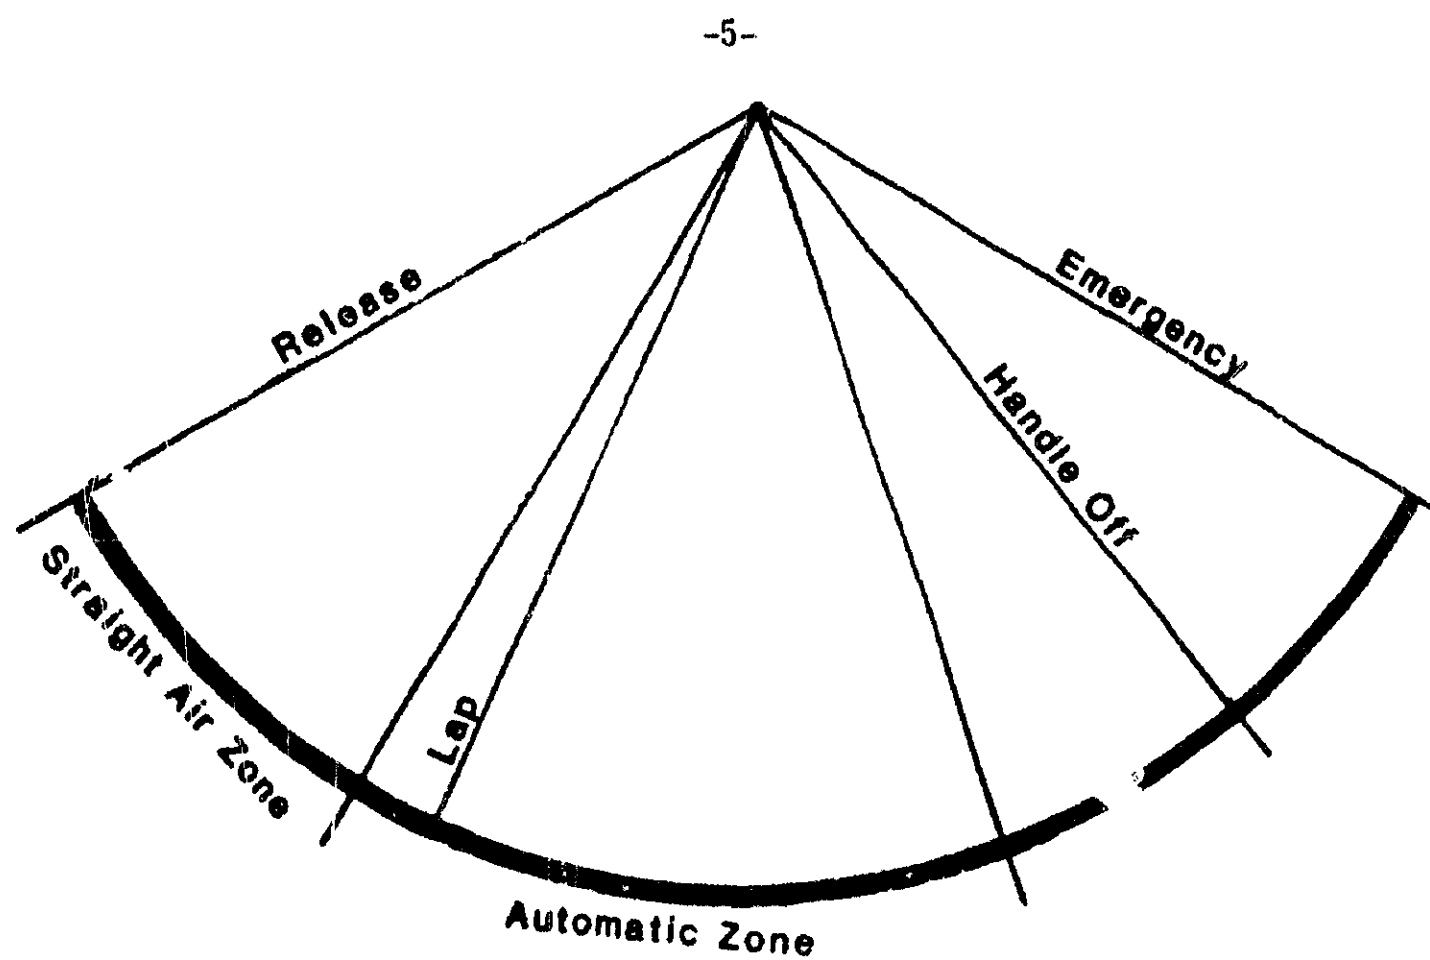
Figure 3.--Brake handle positions.

According to the operator, he then placed the brake handle in the emergency position. (See figure 3.) The operator stated that he still did not get any retarding effect and that he did not hear any air venting from the brakepipe or equalizing reservoir, as would be expected with an emergency brake application. He stated that he then placed the brake handle back in the release position so the air compressor could restore brakepipe pressure (nominally 70 psi operating pressure). This normally takes 8 to 12 seconds. The operator stated that when he did not see any brakepipe pressure increase on the gauge after about 3 seconds, he returned the brake handle to the emergency position. The operator stated that he repeatedly attempted to contact SEPTA central control by radio to request assistance, but that he was unsuccessful.
