PB90-916301  
NTSB/RAR-90/01

## **RAILROAD ACCIDENT REPORT**

**REAR-END COLLISION OF TWO  
NEW YORK CITY TRANSIT AUTHORITY TRAINS  
103RD STREET STATION  
NEW YORK, NEW YORK  
MARCH 10, 1989**

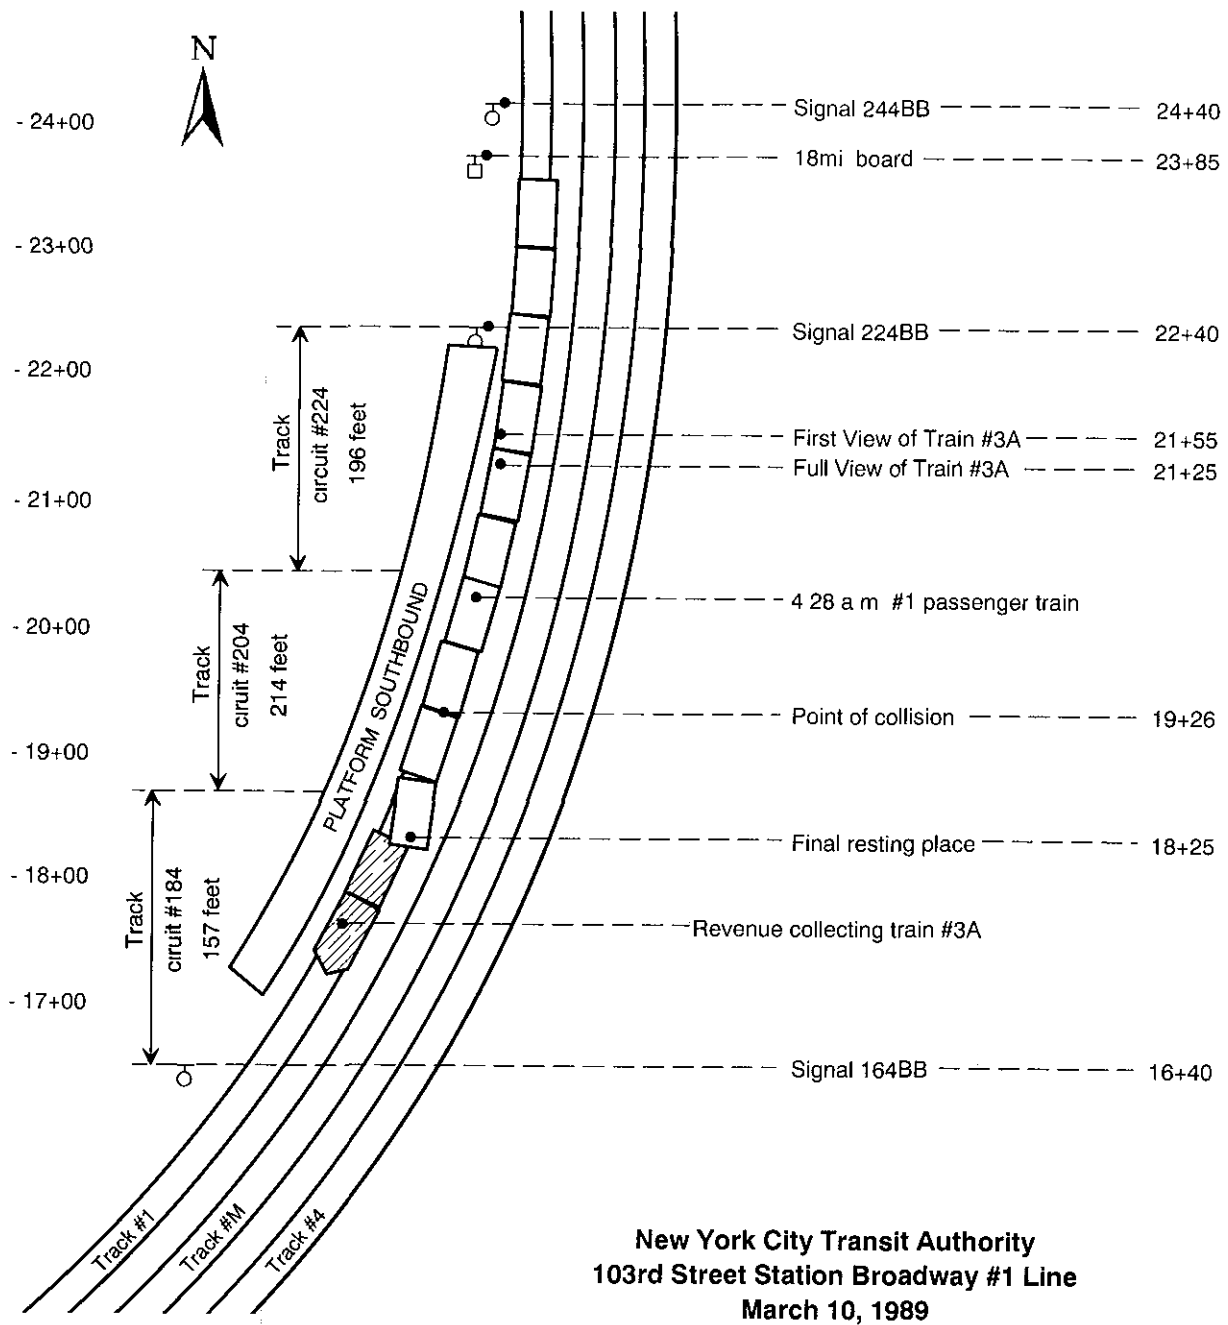
Figure 2.--Accident Site.

watching for a repeater signal on the left side of the track structure as the train moved along the station platform. Then, as the train rounded the 4-degree curve to the right, he saw a standing train 2 car lengths ahead (about 130 feet) and he put the train brakes in emergency using the brake valve handle. However, before he could stop the train it collided with the standing train (see figure 2).

Of the 10 cars of train 428, only the lead car sustained major structural damage. The end door was buckled, sheet metal was torn, and the door was pushed inward 6 inches. The left front of the car was deformed rearward 14 inches and the roof panel was separated from the left front corner. The sheet metal on the left corner was separated from the side, a vertical frame member was deformed and the left front window was displaced rearward 2 inches.

Damage to train 3A was confined to the rear end of the last car. The damage occurred to the undercarriage and floor near the center and extended from the rear end of the car inward 51 inches.

Seven load bearing columns in the station located adjacent to the track structure were heavily damaged. The columns are constructed of I-beams, measuring 10 inches in width and secured to concrete bases at the bottom. It was necessary for NYCTA to make temporary repairs, timbers measuring 12 inches by 12 inches were set in place adjacent to each side of the damaged columns, to support the street above. Subsequently, two columns were replaced and five repaired.

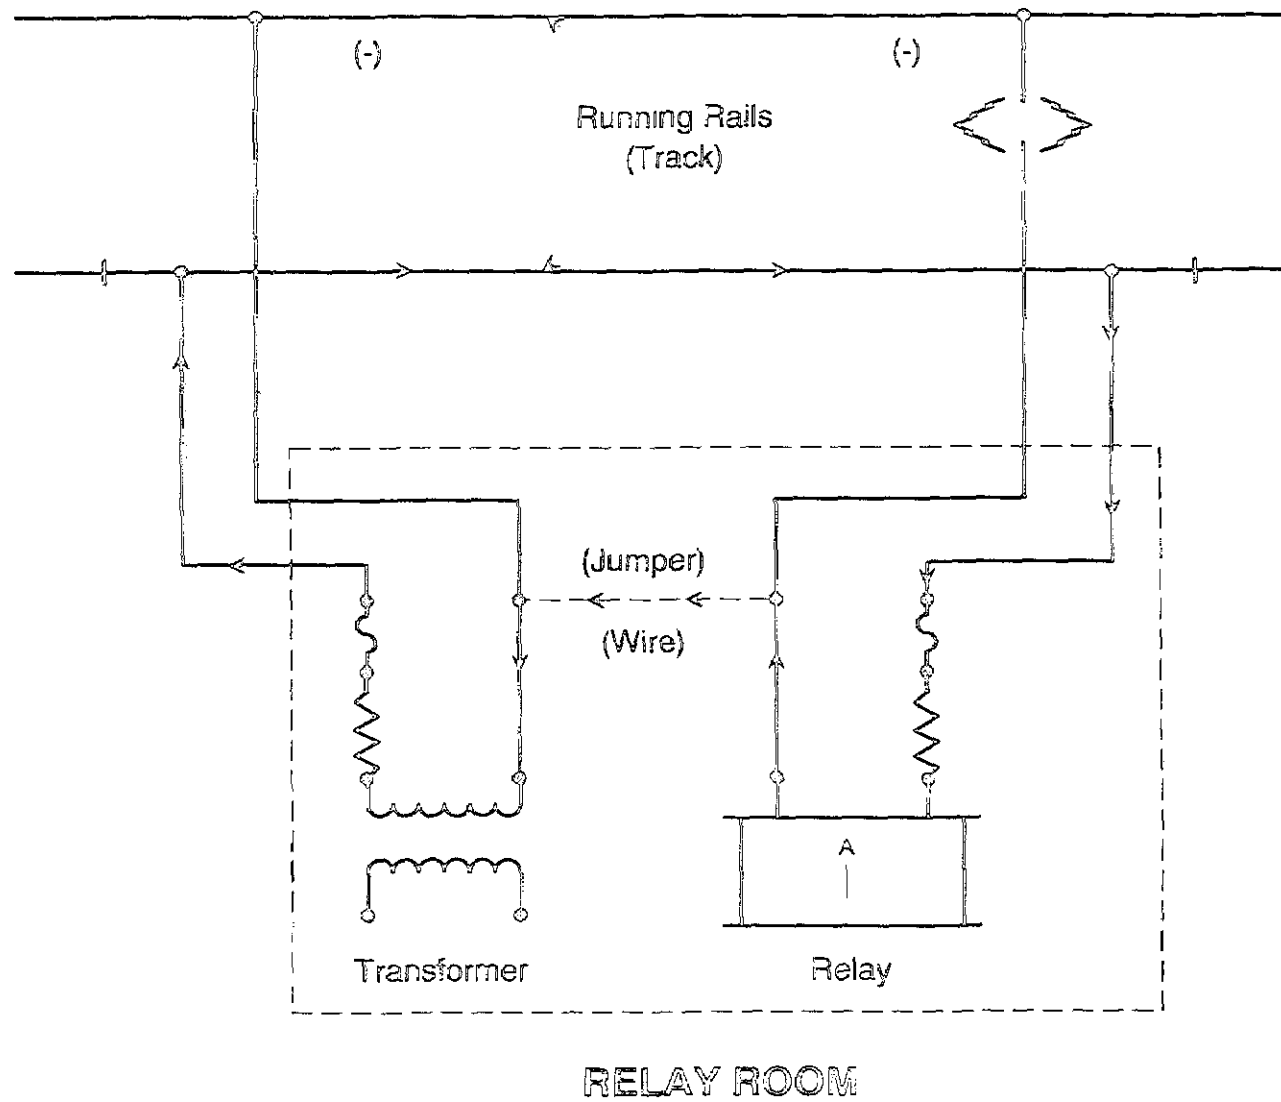
Figure 7 --Signal System Displays Clear With Jumper Wire Applied.

Inspection of the signal system at the 103rd street station following the accident revealed that a jumper wire had been installed between the transformer and the relay and tucked away (out of easy sight) in the circuit rack of the 204 circuit (the track circuit at which the train 3A was located at the time of the collision). With either of the negative relay or feed wires broken, current flow through the negative rail would be eliminated causing the relay to deenergize and the signal system to display a stop indication. However, with the jumper wire in place, current would still flow through the relay and the signal system would indicate clear when no train is

present (see Figure 7). Also, with the jumper wire in place, train wheels would still shunt the circuit removing the current to the relay, the relay would be deenergized and the signals would display a stop indication.

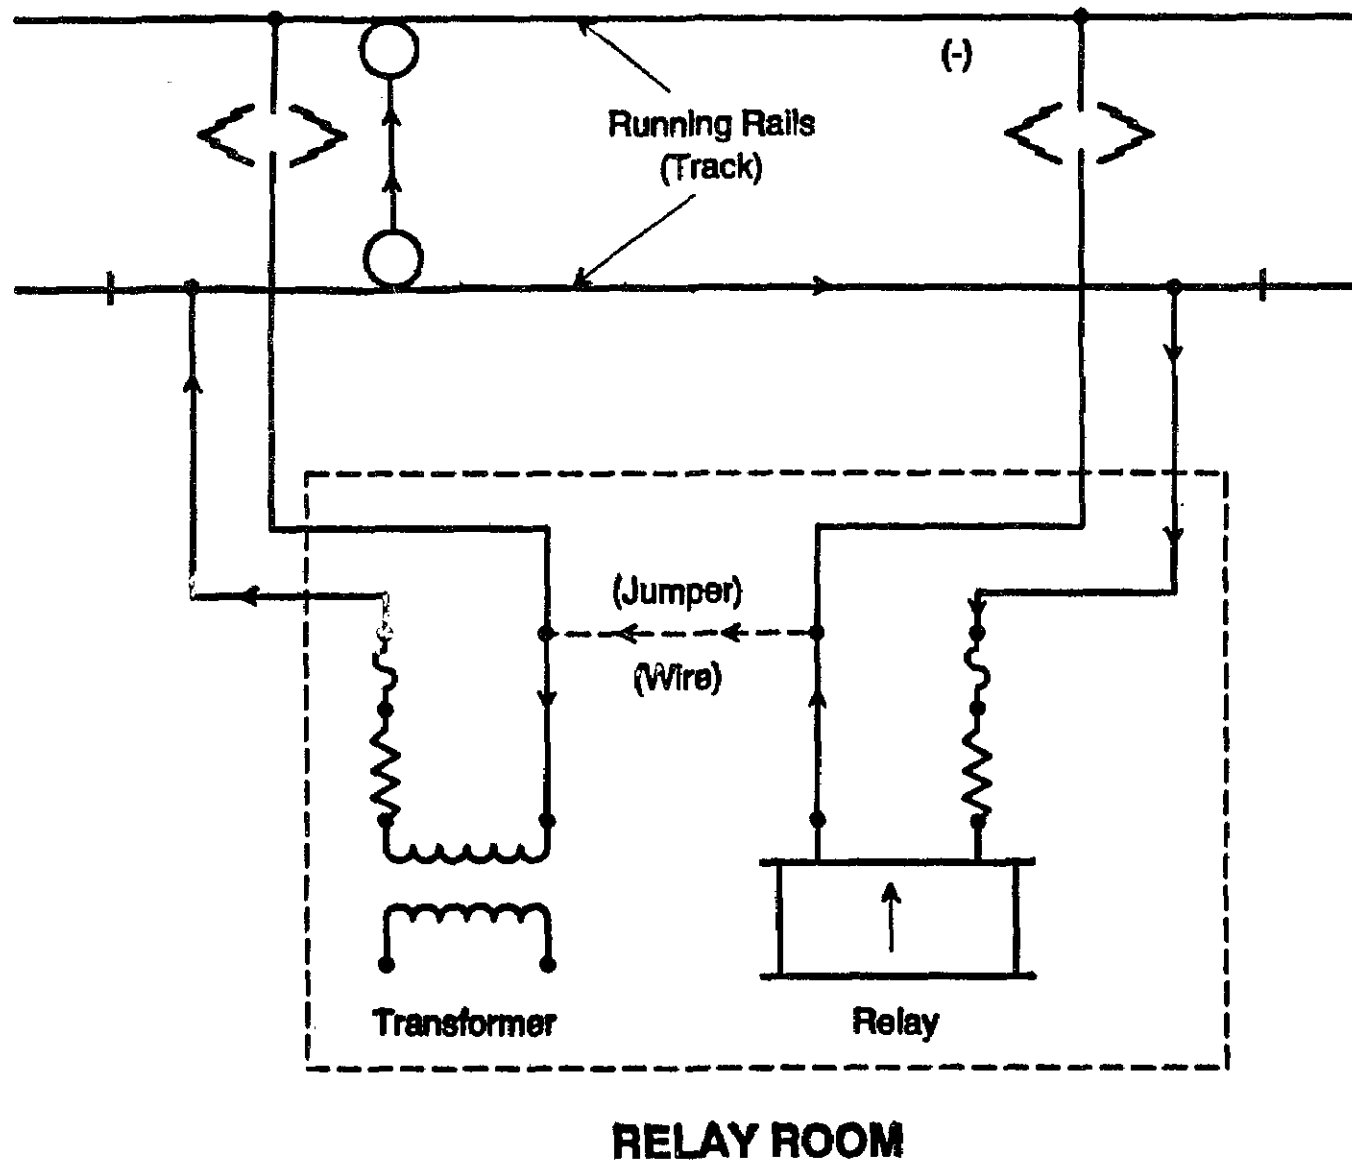
Figure 8.--Jumper Wire Applied, Train Wheel Not Shunting Signal System.

Further inspection revealed that both the negative feed wire and the negative relay wire were broken in the 204 track circuit, eliminating the connections between the relay and the negative rail and the transformer and the negative rail (see figure 8).

However, with both negative wires broken, any connection to the negative rail is eliminated and the current is directed through the jumper wire energizing the relay. Thus, with both negative rail wires broken and a jumper wire in place the wheels of a train would not shunt the current flow to the relay, the relay would remain energized, and the signals would display a clear indication (see figure 8). Following the accident a second jumper wire applied in the same manner as the one on circuit 204, was found on the next track circuit 224. Additionally another jumper wire, installed in the same manner, was found at the 116th Street station on track circuit 534. All three of these jumper wires were in the same signal maintenance district.

Although the fail safe protection was eliminated when the jumper wire was installed between the transformer and the relay, trains would still shunt the track and provide the required signal indication to protect a train with only one negative wire broken. Therefore, had the first broken wire been repaired when the work order was submitted in September 1987 this accident probably would not have occurred. But, because the broken wire remained unrepaired and the jumper wire remained in place when the second wire broke (sometime after the shunt test was performed on February 9, 1989), the signal system was unable to detect the presence of a train.
