PB92-916301  
NTSB/RAR-92/01

## RAILROAD ACCIDENT REPORT

DERAILMENT AND COLLISION OF  
AMTRAK PASSENGER TRAIN 66 WITH  
MBTA COMMUTER TRAIN 906  
AT BACK BAY STATION  
BOSTON, MASSACHUSETTS  
DECEMBER 12, 1990

**Abstract:** At 8:23 a.m. on December 12, 1990, National Railroad Passenger Corporation (Amtrak) passenger train 66, consisting of a two-unit locomotive, two material handling cars, five passenger cars, one dining car, and two baggage cars, derailed and struck Massachusetts Bay Transit Authority (MBTA) commuter train 906, consisting of one locomotive, six passenger cars, and one control car, as both trains entered Back Bay station in Boston, Massachusetts.

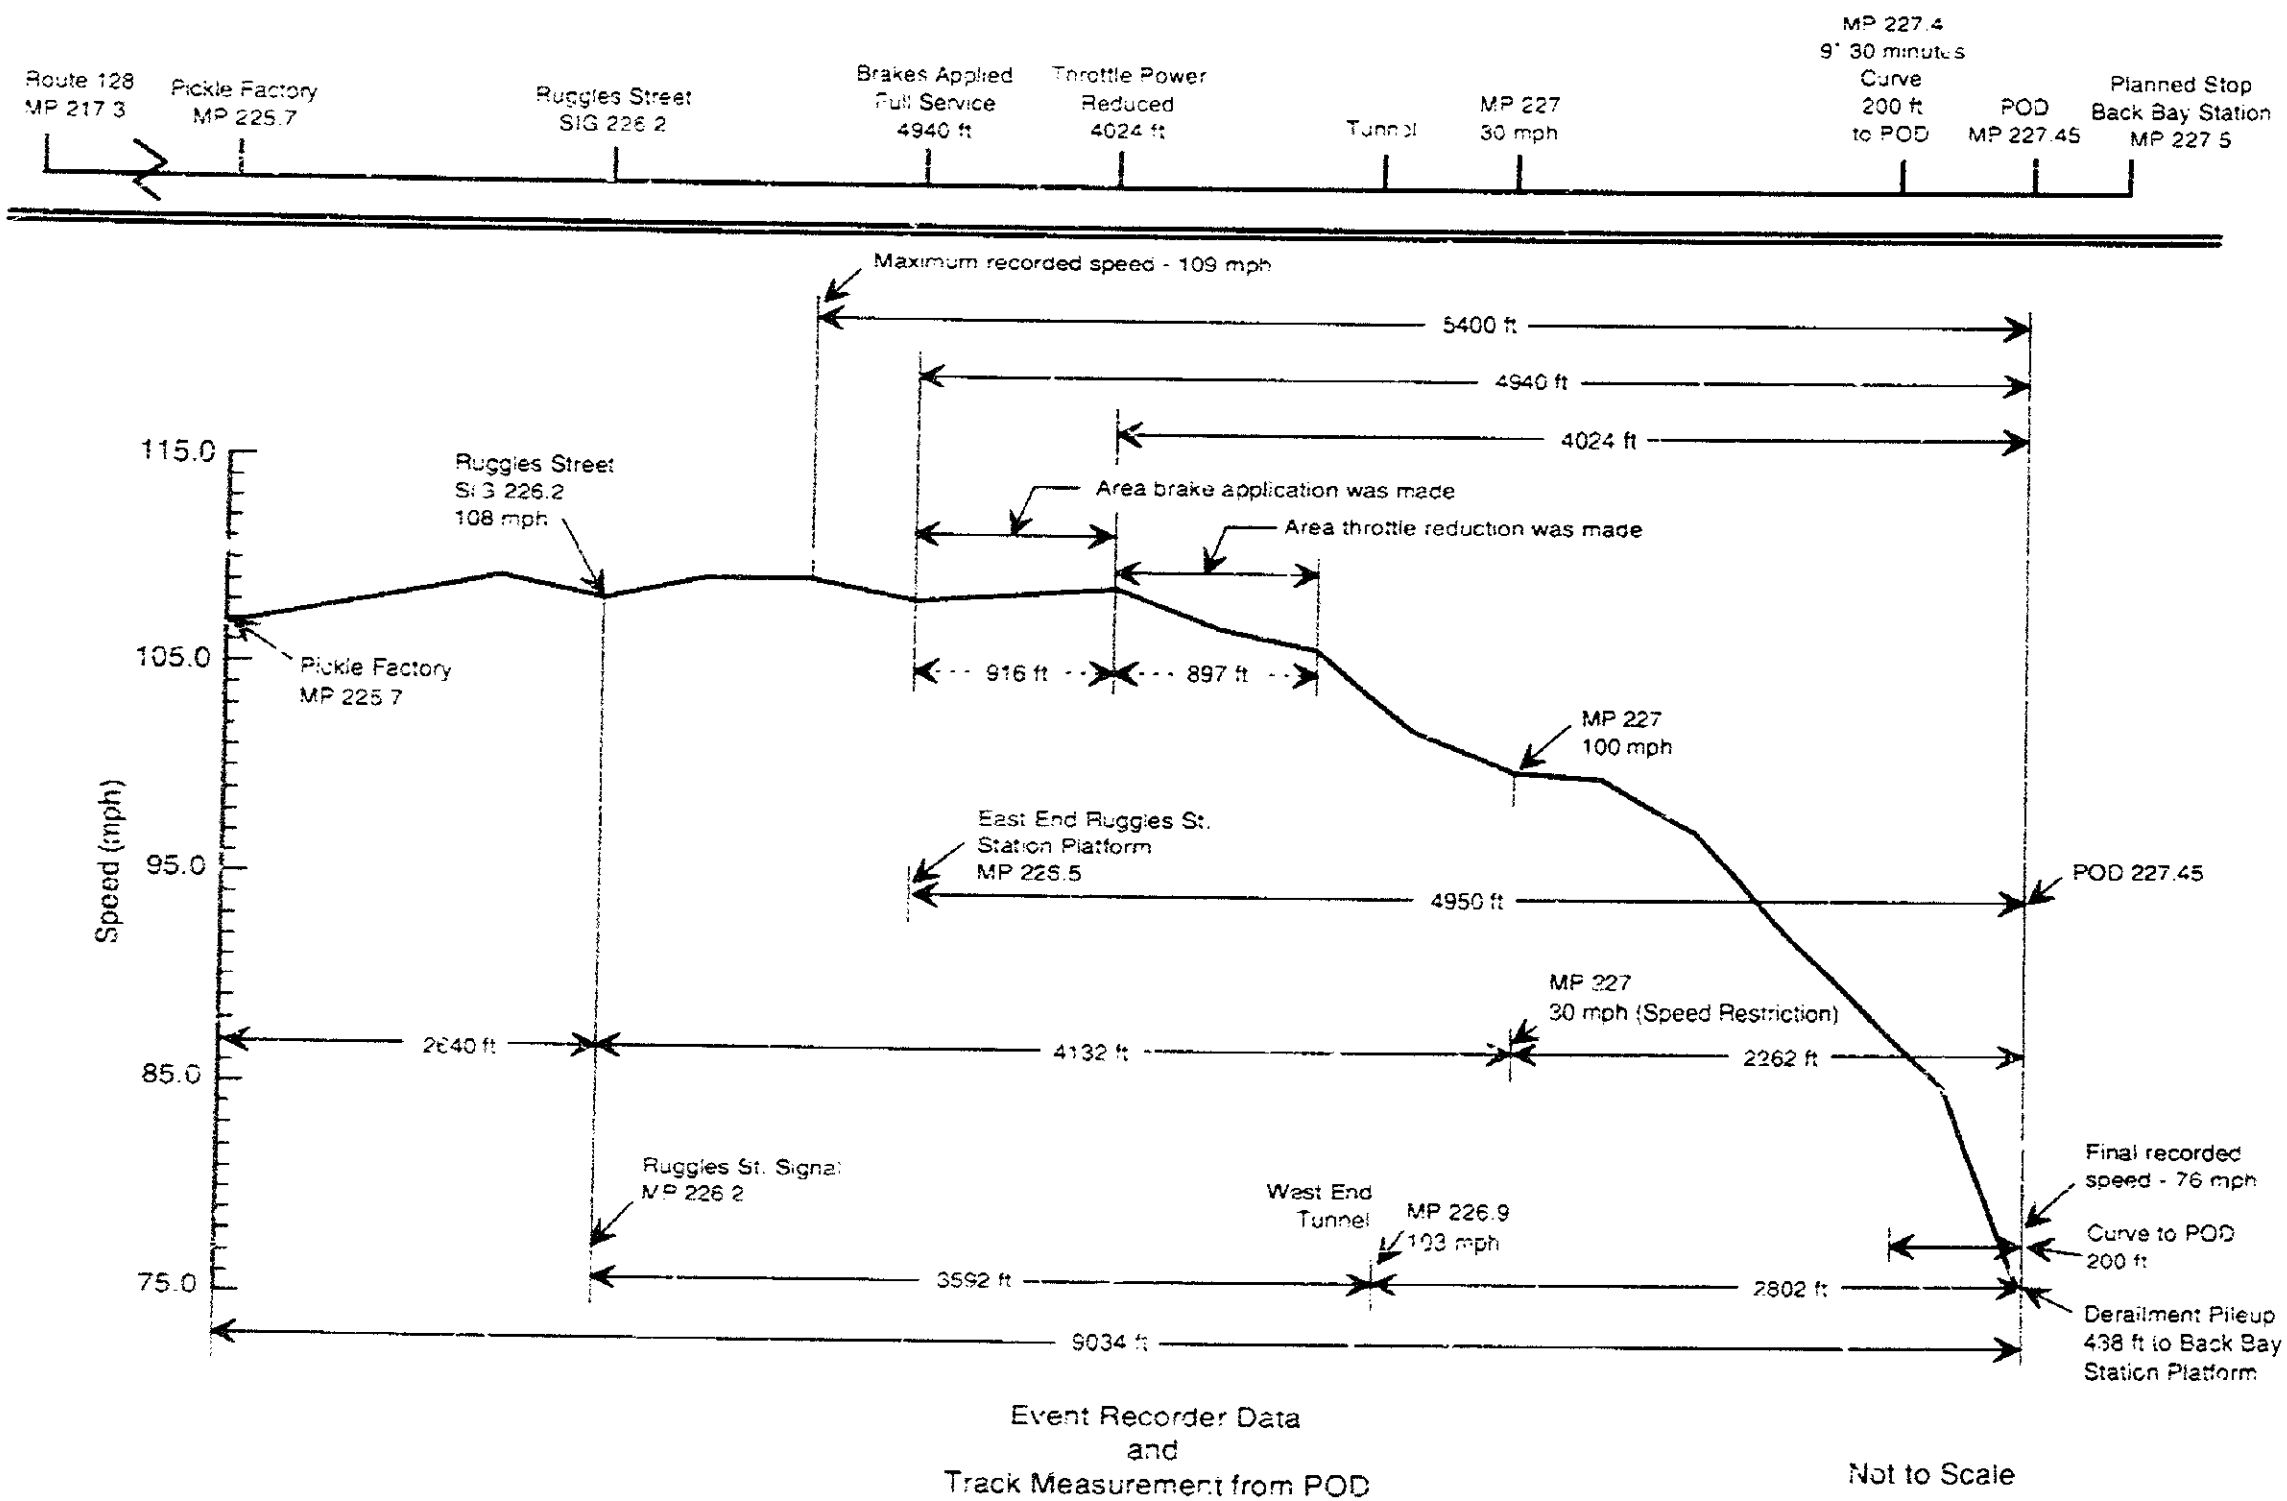
Figure 2.--Diagram of Amtrak train 66 speed and distance travelled.

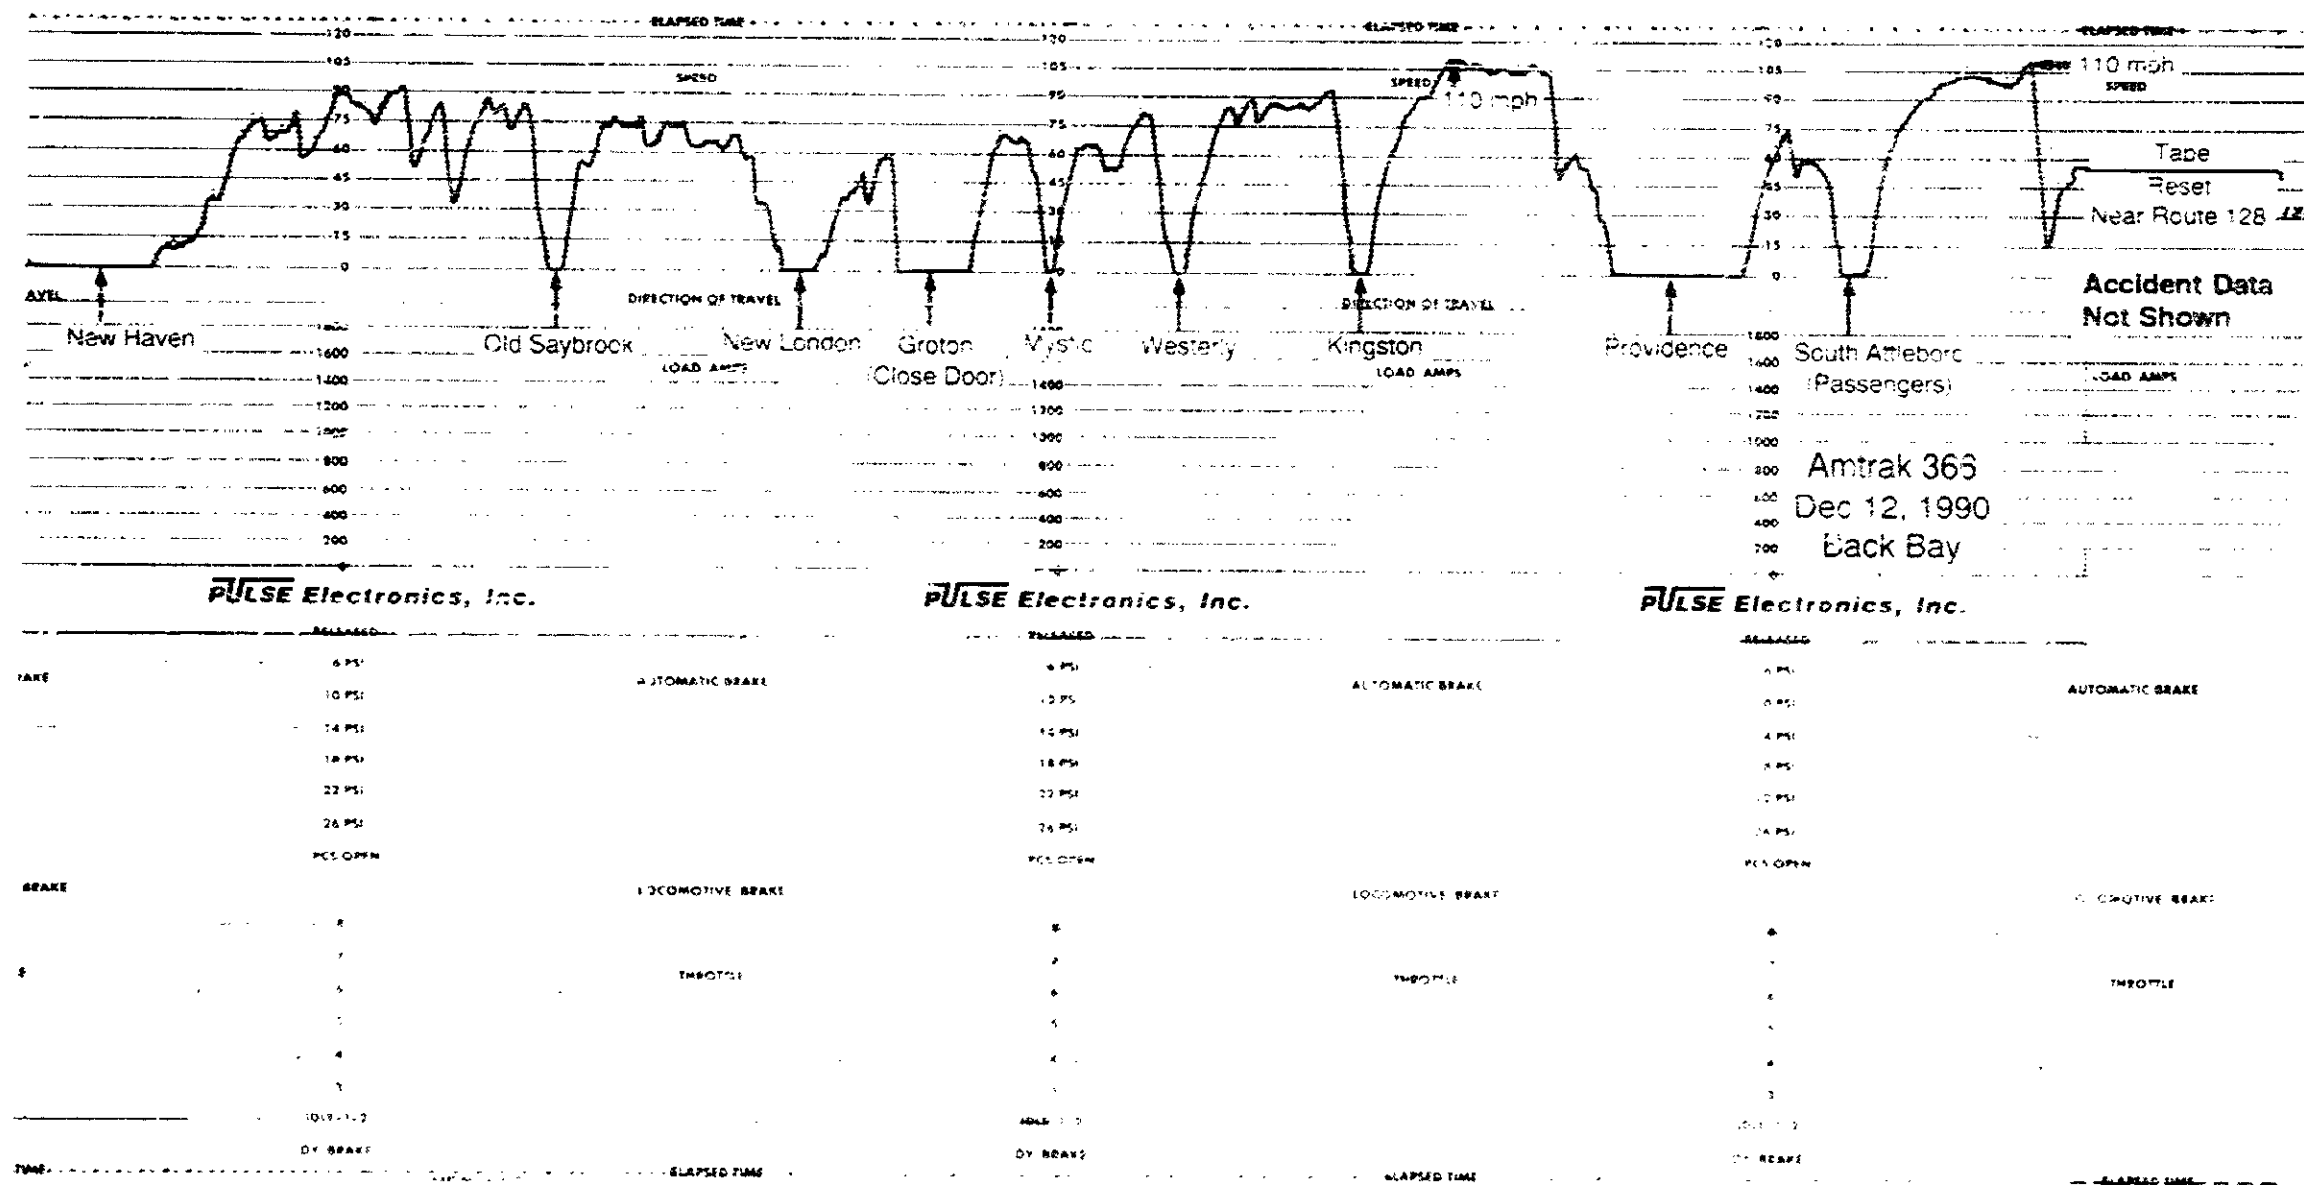
Event Recorder Tests.--The Safety Board laboratory received the Pulse data pack from Amtrak locomotive 366 for readout and evaluation on December 13. The laboratory's Pulse readout machine generated a strip chart of the data recovered. Data from the event recorder, which recorded information about every 5 3/4 seconds, showed no signs of accident damage. Safety Board engineers found an electronic end-of-tape mark<sup>5</sup> on the magnetic tape that prevented strip chart output of data from Route 128 to just beyond the accident. Data before the end-of-tape mark indicated that the train had operated at speeds up to 110 mph between Kingston and Providence and between South Attleboro and Route 128. (See figure 7 for the Pulse magnetic tape event recorder strip chart.)

Figure 7.--Amtrak train 66 Pulse magnetic tape event recorder strip chart.

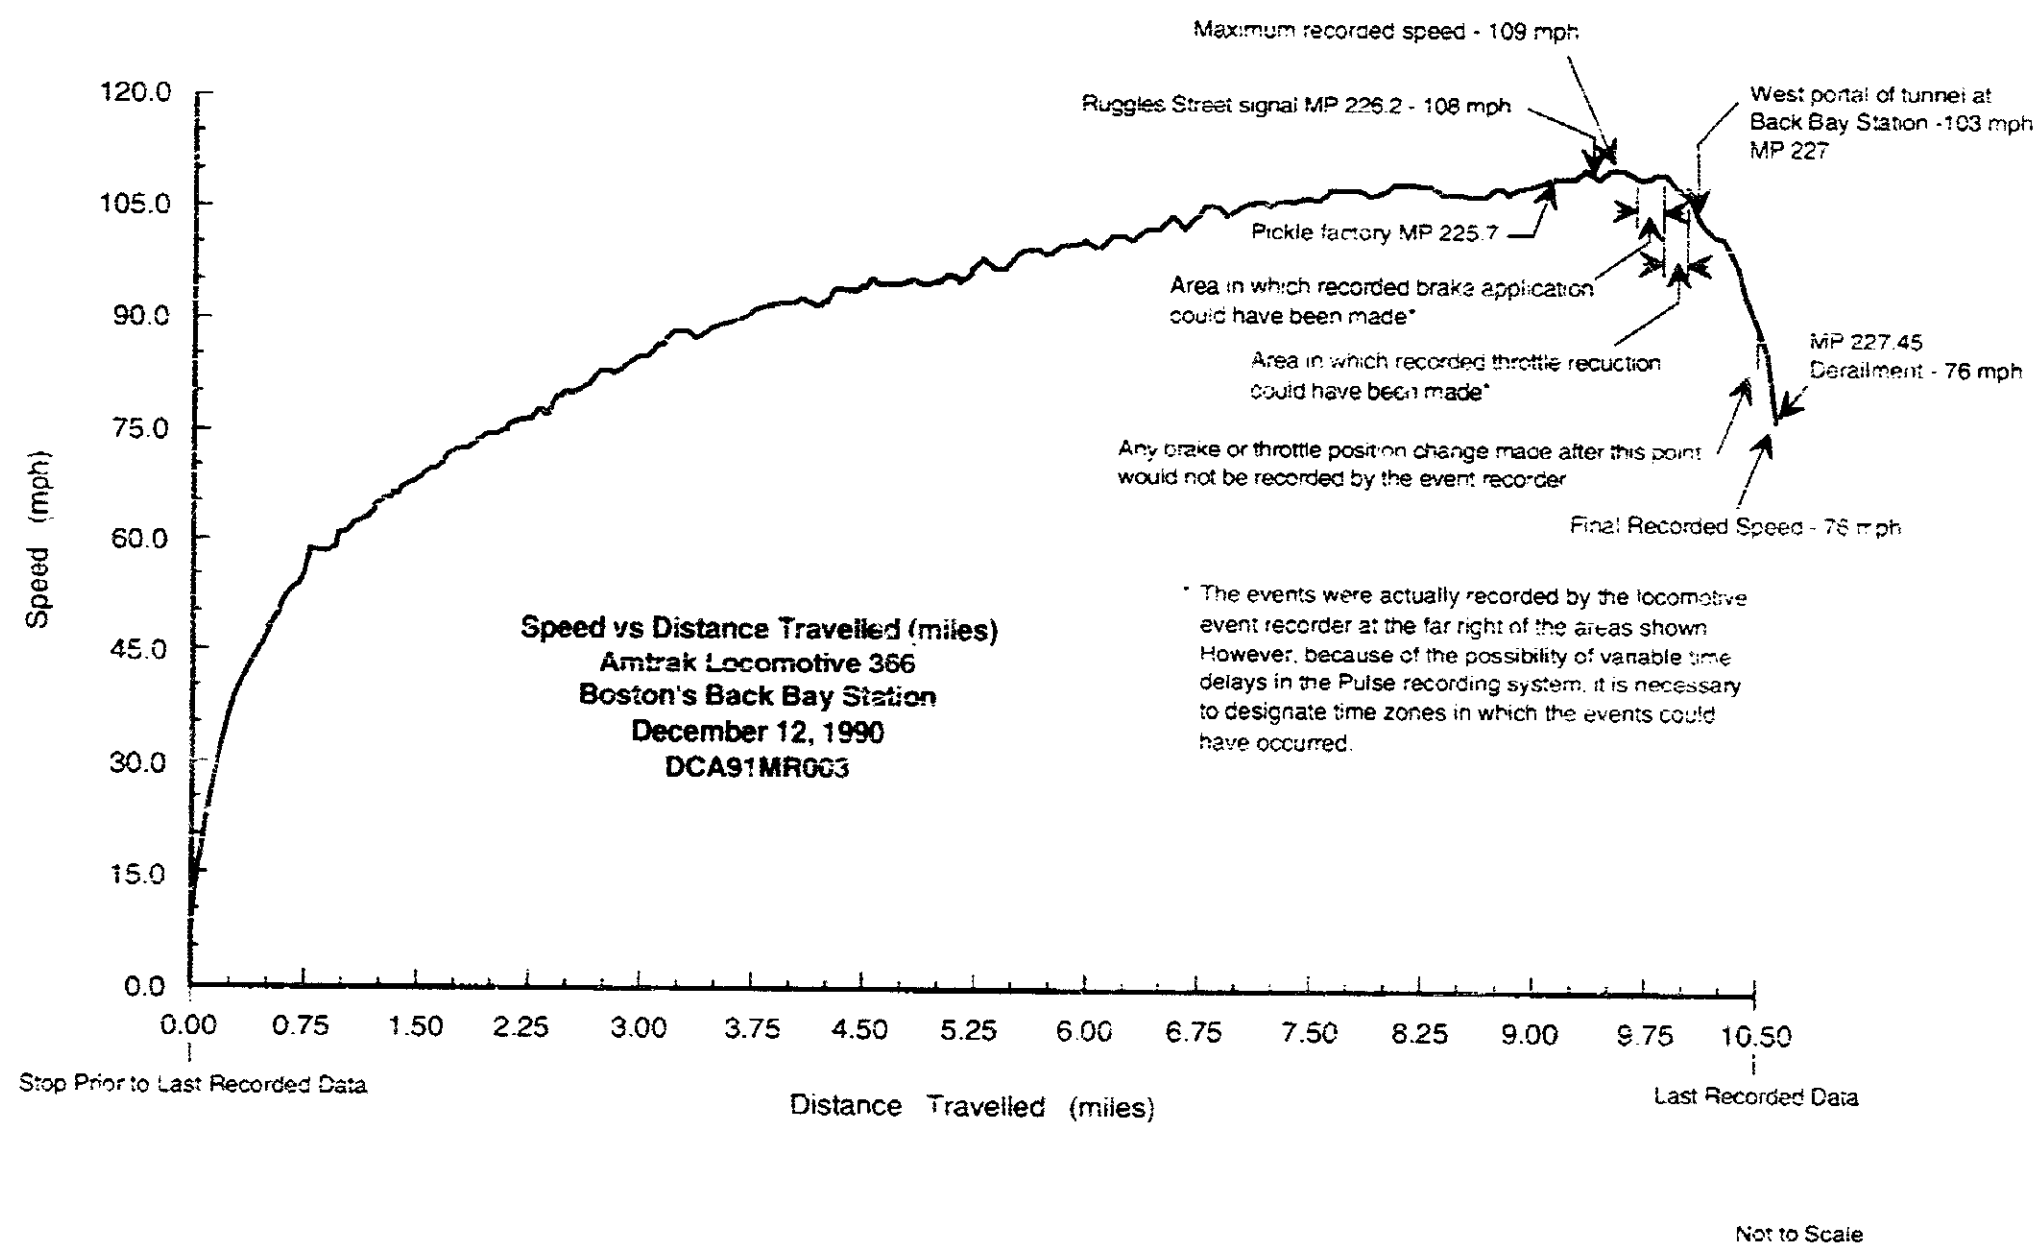
Figure 8.--Event recorder data recovered from Amtrak train 66.
