MAINTAINING AN INTERLOCKING PLANT AT HIGH TIDE

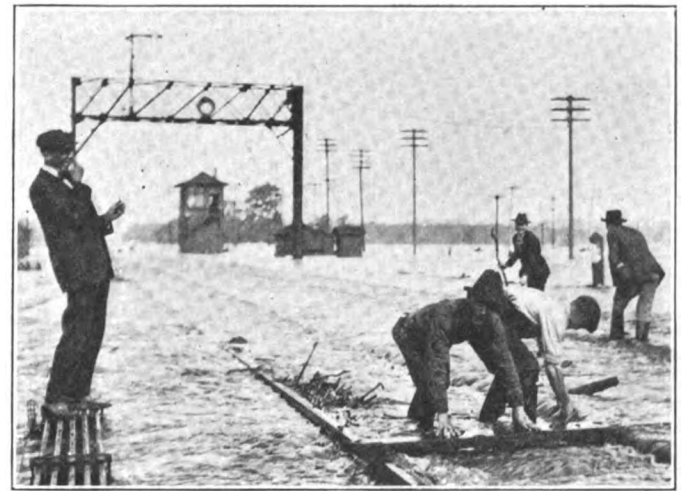
Shooting Track Trouble Under Difficulties

around concrete cable post foundations. At one location the earth around the battery well was washed away. The battery well, however, was not disturbed. The water in the tower rose to the top of the vertical cranks. The maintainers' greatest trouble was the removal of trash after the water subsided.

In the lower picture the signal formen is having a hearty laugh at the expense of one of the men, who inadvertently had the misfortune to step in a hole between the ties, receiving an involuntary ducking. If floods like this one were to occur often it would be necessary for the railroads to develop a combined motor track car and boat for the use of the maintainers so they could cover their territory.
