## REAR END COLLISION ON MICHIGAN CENTRAL

At 3:57 a. m., Saturday, June 22, an empty west-bound equipment train on the Michigan Central, consisting of 20 tourist sleepers and 1 coach, crashed into the rear of the second section of a circus train, at Ivanhoe interlocking plant, near Hammond, Ind., killing 72 and injuring 120 persons on the circus train, according to the latest available information. Trainmaster F. S. Whipple, who accompanied the second section of the circus train, was evidently killed in the accident, as no trace of him has been found. Many of the bodies recovered were charred beyond recognition and it is doubtful if the total number of killed and missing will ever be determined.

### MAINTAINING AN INTERLOCKING PLANT AT HIGH TIDE

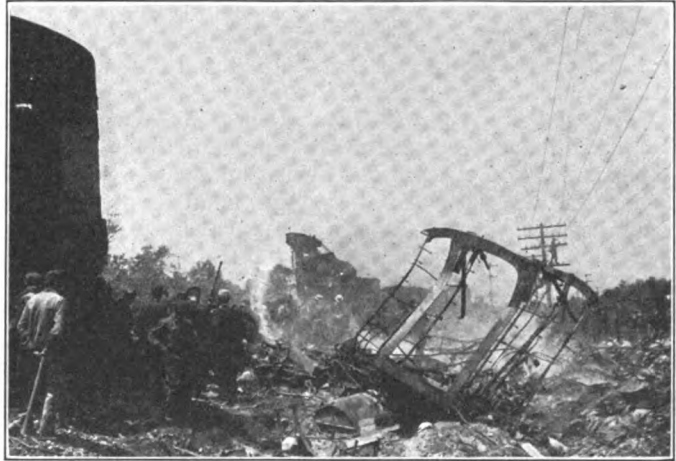
A Close View of the Burning Debris

The second section of the circus train consisted of stock cars, flat cars and four sleeping cars, which were just ahead of the caboose. These sleeping cars were converted wooden equipment. The engine plowed through the sleeping cars and after the crash these four cars and one flat car were destroyed by fire, which evidently started from the gas lighting system with which the sleeping cars were equipped. That the casualties were so large was due to the sleeping cars being of wooden construction and that they were equipped with three tiers of double deck bunkers to each car instead of two as in ordinary sleeping cars.

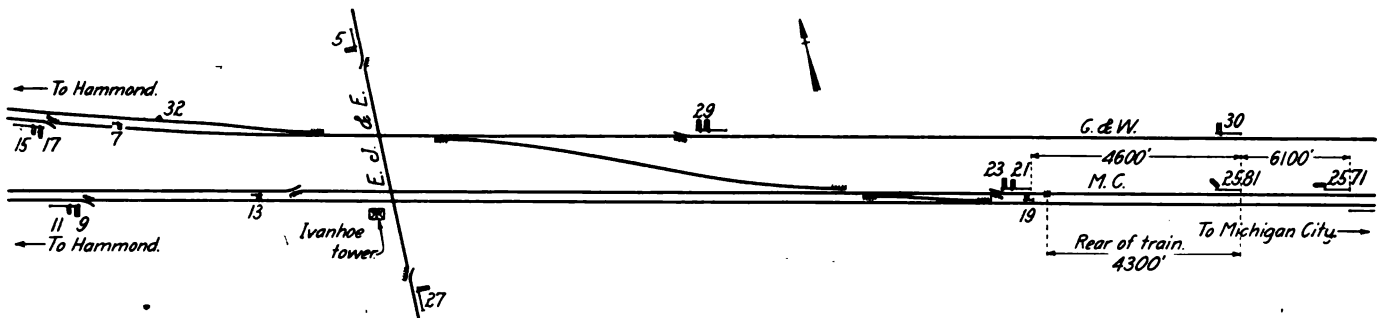
The Track Layout of the Ivanhoe Accident, Showing Location of Rear of Circus Train

This portion of the Michigan Central is a double track line completely equipped with automatic block signals. The track is on tangent for over a mile east of the point where the wreck occurred. At the point of the accident the Gary & Western tracks are parallel to and 85 ft. north of those of the Michigan Central. The night was clear, with nothing to obstruct the view, the accident occurring in the country with no manufacturing plants or factories near by. The westbound home signal for Ivanhoe interlocking plant is located 950 ft. east of a crossing of the Elgin, Joliet & Eastern and 270 ft. east of the crossover switch leading to the Gary & Western tracks.

The second section of the circus train had a blazing journal box on one of the cars and stopped, after having started to cross over to the Gary & Western tracks with the rear of the train at a point approximately 300 ft. east of the home signal of the Ivanhoe interlocking plant of the westbound main track of the Michigan Central and

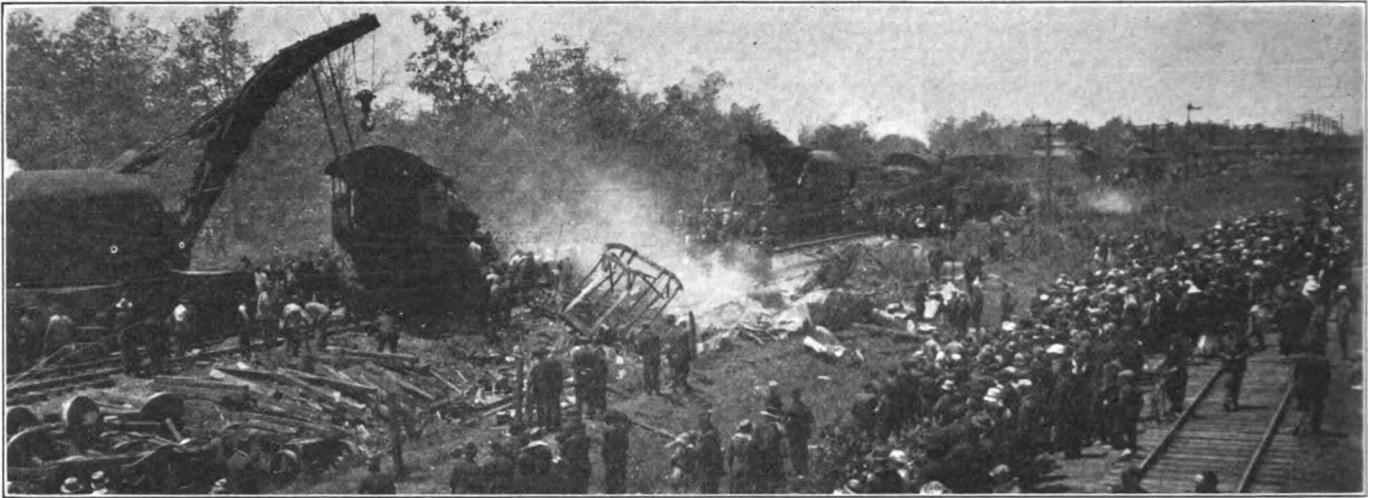
**A General View at Ivanhoe, Showing the Debris, the Gary & Western at the Right and the Home Signal in the Distance**

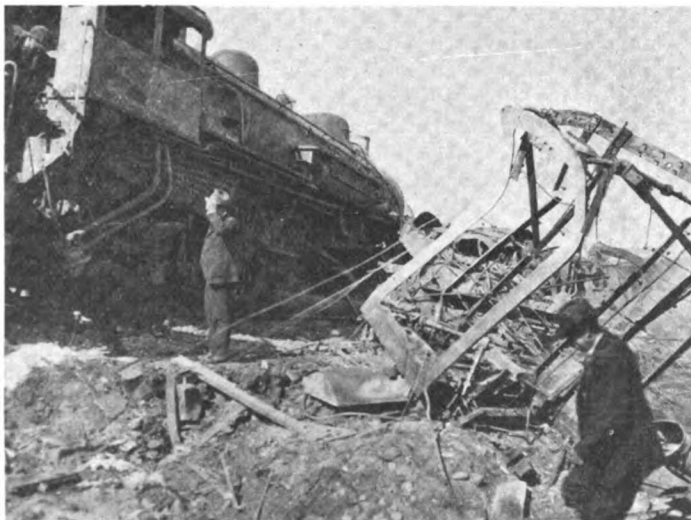
**Engine of Empty Equipment Train**

Further investigation indicates that Engineman Sargent was dozing or asleep, which was the cause of the accident. The flagman of the circus train was back from six to eight hundred feet at the time of the accident. At the coroner's inquest at Hammond on June 25, Engineman Sargent, under his constitutional rights, refused to testify at this time. Conductor Johnson stated to Sargent after the wreck, "This is quite a bad mess," and asked him what was the matter. Sargent's answer was that "I must have been dozing." Circus officers on June 25 compiled a list of dead and missing, which totals 78. Railroad officers advise they know of no changes quoted in figures in casualties as given in the beginning of this article.

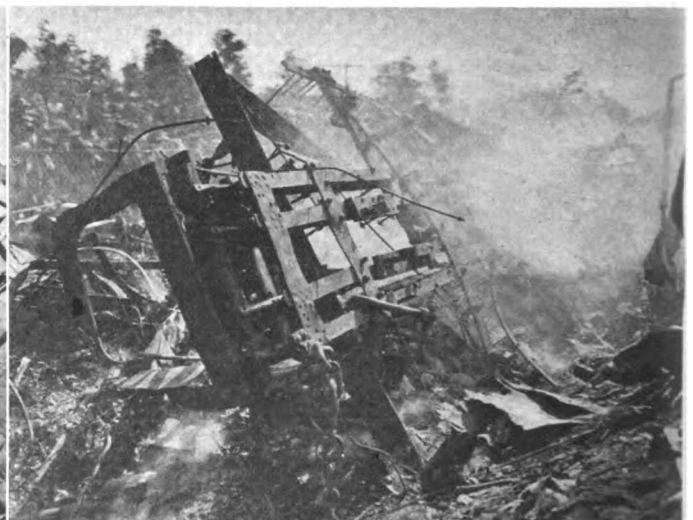
**Where a Large Number of Bodies Were Found**

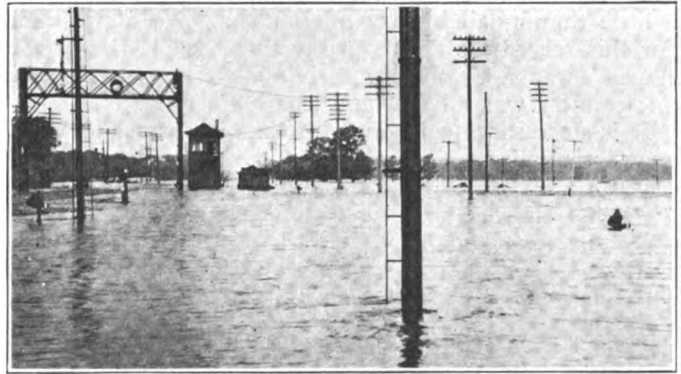
Wanted—Motor Boat to Reach Dwarf Signal

ing the ground signal poles just to the right of the center also shows a dwarf signal at the extreme right, almost submerged. The other picture shows the accumulation of trash between tracks and the pipe lines, a portion of which is shown in the bottom left-hand corner of the picture. No particular damage was done to the plant, except to throw out of line a small portion of the pipe runs. In one or two cases the earth was washed away from

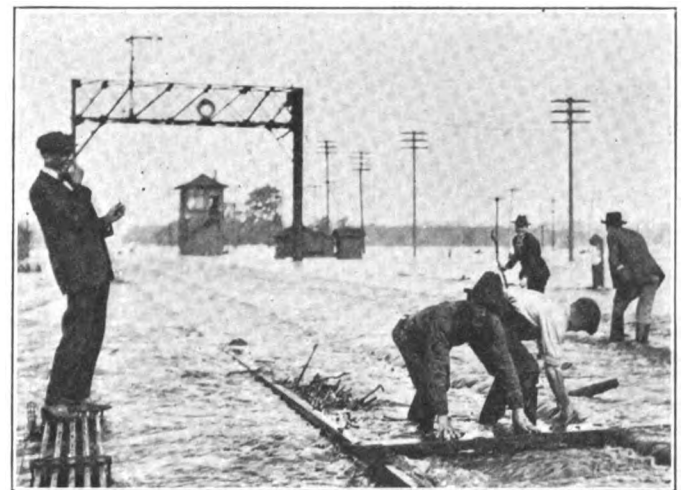
Shooting Track Trouble Under Difficulties

around concrete cable post foundations. At one location the earth around the battery well was washed away. The battery well, however, was not disturbed. The water in the tower rose to the top of the vertical cranks. The maintainers' greatest trouble was the removal of trash after the water subsided.

In the lower picture the signal formen is having a hearty laugh at the expense of one of the men, who inadvertently had the misfortune to step in a hole between the ties, receiving an involuntary ducking. If floods like this one were to occur often it would be necessary for the railroads to develop a combined motor track car and boat for the use of the maintainers so they could cover their territory.
