## PERE MARQUETTE RESORT SPECIAL IN HEAD-ON COLLISION

**I**N a butting collision between two Pere Marquette trains on Baltimore & Ohio tracks near One Hundred and Third street, Chicago, about 7:24 a. m., June 14, one employee was killed and 14 persons seriously injured. The trains involved in the accident were passenger train No. 10 westbound and an extra freight train eastbound, the Pere Marquette having trackage rights over the Baltimore & Ohio tracks from Pine Junction, Ind., to Ninety-fifth street, Chicago, a distance of about seven miles. The passenger train, known as the "Resort Special," which runs at present on a twice-a-week schedule, was making its second trip of the season from northern resort points in Michigan.

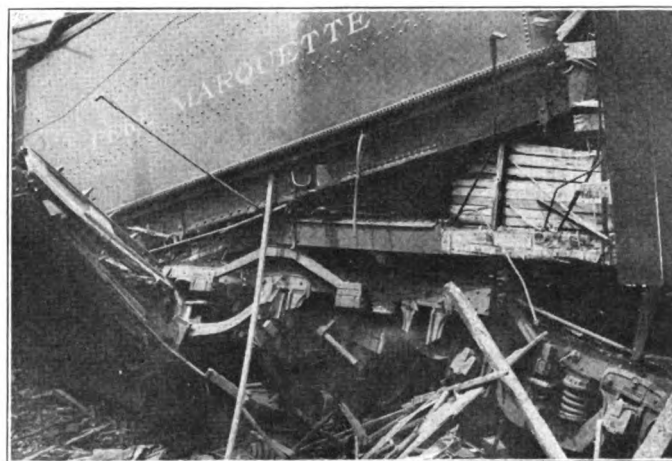
Front End of Baggage Car Telescoped on Tender

stacks and steam chests together. The impact telescoped the baggage car and one combination coach, which were of wood frame construction, between the passenger engine tender and the heavy steel Pullmans, killing the conductor, who was in the baggage car, and injuring those in the combination car. One Pullman car was slightly damaged. The tender of the freight engine was driven into the boiler head, destroying the cab; the steel frame box car back of the tender was demolished and the steel underframe was doubled back against the engine frame. A number of the weaker cars in the freight train were also wrecked.

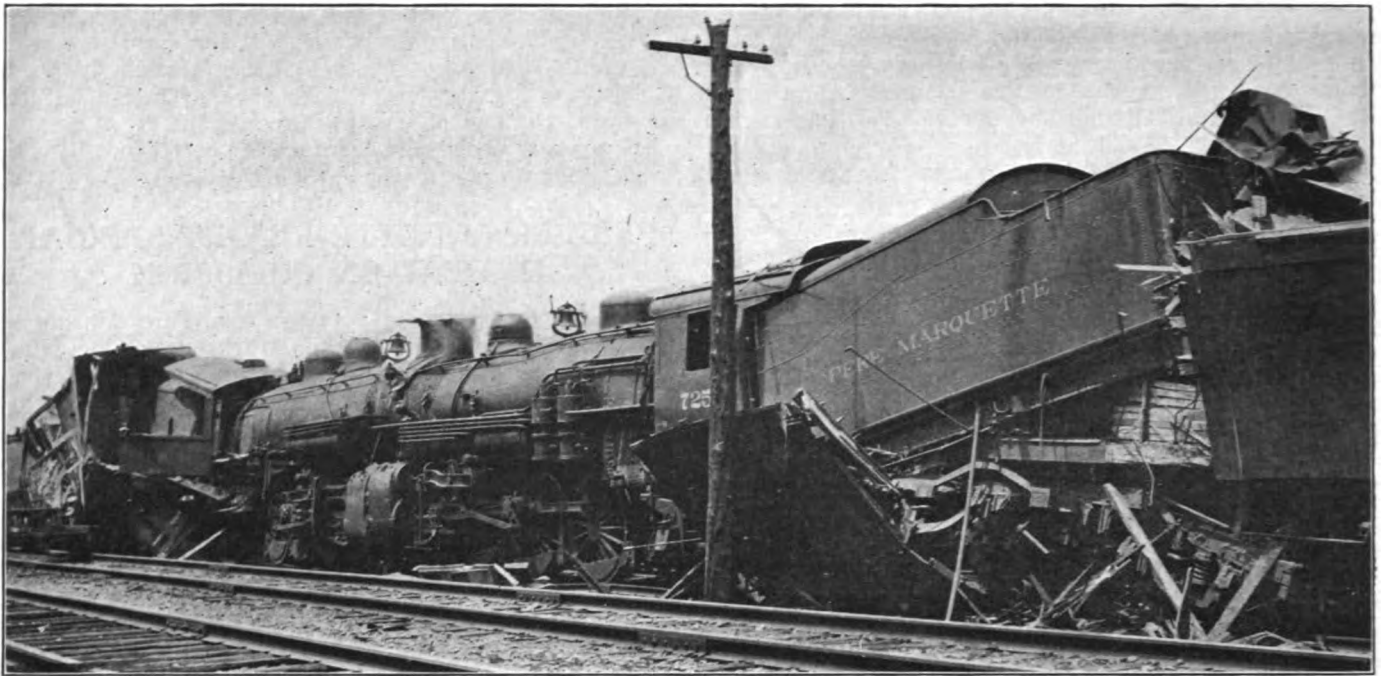
The force of the collision mashed in the front ends of the engines, which were locked in position with the smoke

The Engines After the Impact. The Telescoped Baggage Car Shown at the Right.
