ON March 4, 1921, W. P. Borland, chief of the Bureau of Safety, made a report to the Interstate Commerce Commission on the results of the investigation of the Porter, Ind., collision. This report is given in full below. A description of this accident appeared on page 88 of the *Railway Signal Engineer* for March, 1921.

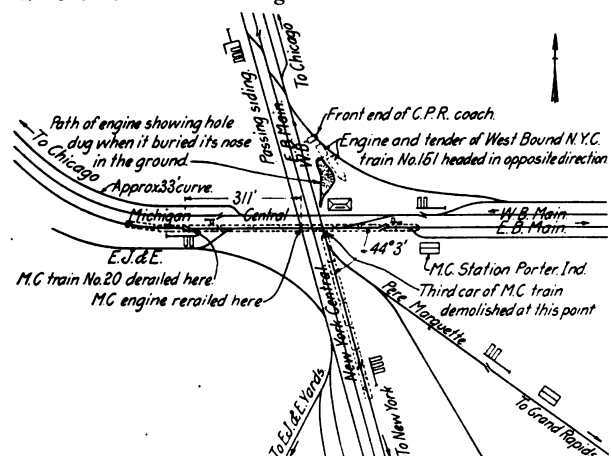
### Track Layout at Point of Accident

In the vicinity of the point of accident both railroads are double-track lines; trains are operated on both roads by train orders and automatic block-signal systems, and the crossing is protected by an interlocking plant. The line of the New York Central extends east and west, while that of the Michigan Central extends southwest

and northeast and crosses the track of the New York Central at an angle of about 45 degrees. The interlocking tower is located in the north angle formed by the tracks of the two roads.

Approaching the point of accident on the Michigan Central from the southwest, which by time-table direction is west, beginning at distant signal 2412, the line is tangent for 500 ft., followed by a 33-min. curve to the left 3,960 ft. in length; it is then tangent for about 600 ft. to the crossing and for a considerable distance beyond. Home signal 35 is located on this tangent, 366 ft. southwest of the crossing. A derail is placed in the south rail of the eastbound main track 55 ft. east of the home signal. Paralleling the eastbound main track on the south is a passing siding which begins just west of the distant signal and terminates at a main track switch between the derail and the crossing. In this vicinity there is a slight grade descending eastward.
