## FIRE THREATENED TIE UP AT GRAND CENTRAL TERMINAL

THE burning out of a 660-volt positive third rail feeder at 6:30 a. m. Sunday, May 15, at Tower U interlocking Grand Central terminal, threatened to tie up all train movements into and out of the station and in addition caused damage to the interlocking estimated at \$20,000. Trouble was first noticed when track fuses could not be kept from blowing out on one track circuit. When an inspection of the track circuit was made a thin line of smoke was noticed curling up from the ballast. Electrical department employees were notified, but before their arrival the feeder burned out and the heavy current discharge was carried through the ground, over pipes, and structural steel work in all directions.

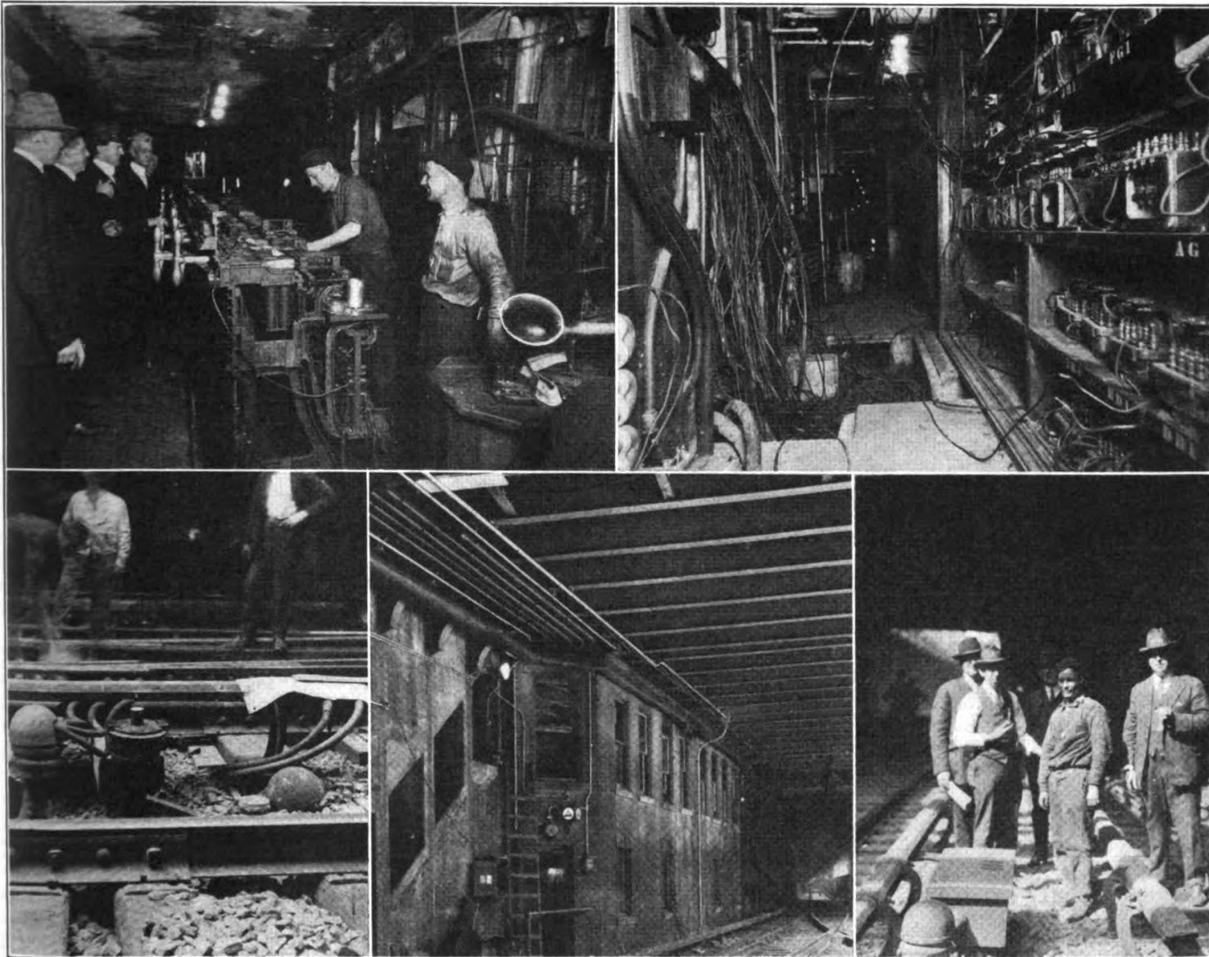
It appears that this current was carried into the interlocking tower on the steam heating pipes which, in running to the tower, are buried in ballast at this point. From these pipes the current spread to all metal parts of the tower and the insulation on the wires for all the interlocking and intercommunicating circuits was set on fire and burned fiercely, completely destroying all circuits. The city fire department on arrival completely flooded the tower, adding materially to the damage to the machine and instruments.

With the exception of the frame and the mechanical locking, the machine had to be stripped and entirely rebuilt and temporary circuits had to be run. This work was done by a force of 17 officers and men, who immediately

Reconstructing and Rewiring the Machine  
Repairing the Faulty Feeder

Tower "U" in the Retaining Wall

Wire Chase in Relay Room  
Center—E. H. Sartain, Maintainer

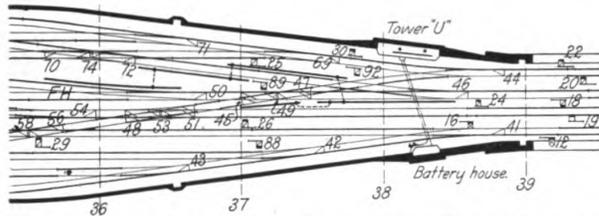
Heavy Line and Jumpers Indicate Third Rail and Faulty Feeder Location
