# I. C. C. Report on Winslow Junction Accident

## Failure of Engineman to Note that Wrong Route Was Lined Up at Interlocking Plant Results in Bad Derailment

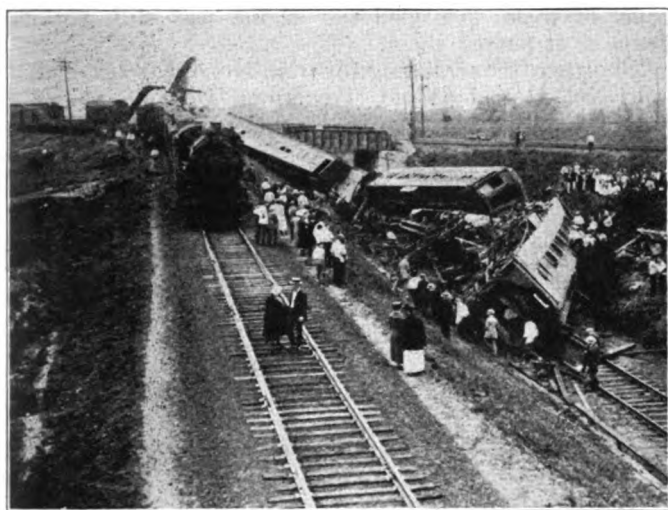
View of Wreckage on West Jersey & Seashore Tracks

"The entire train was derailed, the engine and the first four cars going down the embankment on the outside of the curve and coming to rest on the track of the West Jersey & Sea Shore, which runs nearly parallel with the Cape May branch at this point. The employees killed were the engineman, fireman, and conductor.

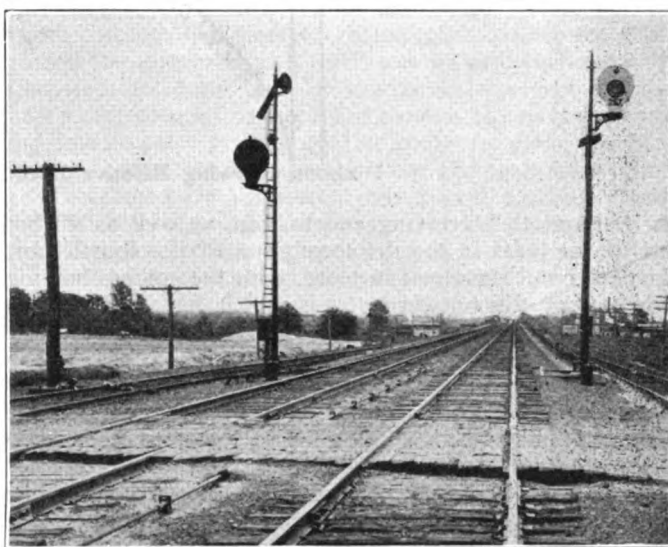
"Approaching Winslow Junction from the north, the first signal involved is distant signal 25-X, 3,131 ft. from the Cape May switch. This signal is an automatic signal of the disk type, displaying a distant indication for signal 25. Home signal 25 is located 742 ft. north of the switch, and is also of the disk type; it is mounted on the same mast with and under the two interlocking signals. The top arm of the interlocking signals, signal 48, governs the high-speed route to Atlantic City, and the bottom arm, signal 47, the diverging route to Cape May. When the high-speed route is set up and the block is clear, signal 48 displays a green indication, signal 47 red, and the automatic signal green, while the distant signal also displays a green indication; when the diverging route is set up and the block on the diverging route is clear,

View Approaching Winslow Junction, Southbound Distant Signal 25X in Foreground

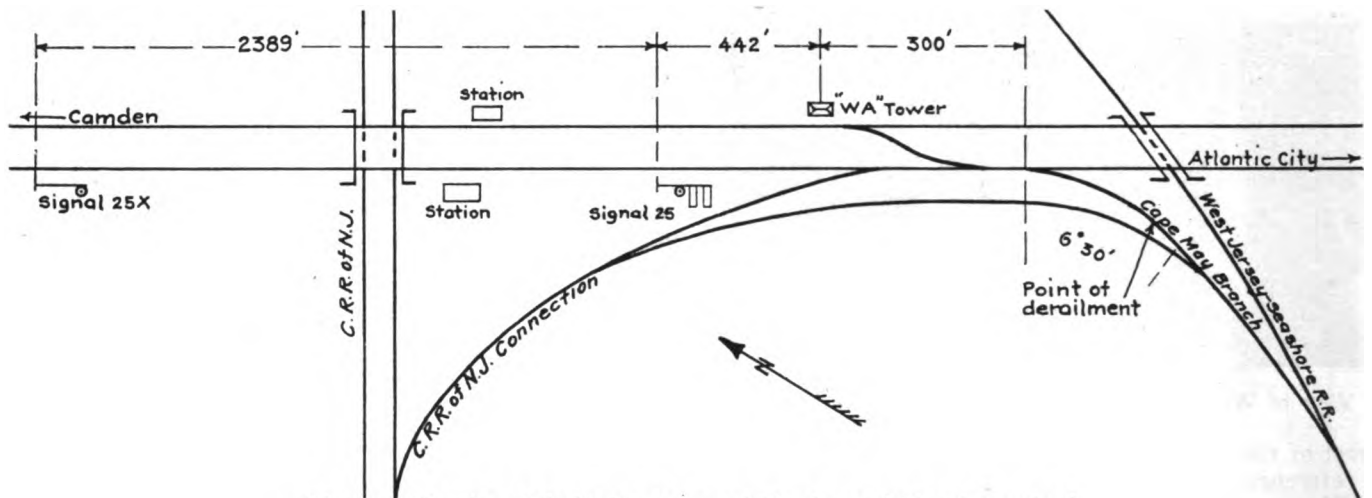
Diagram Showing Relative Location of Tracks and Signal Involved

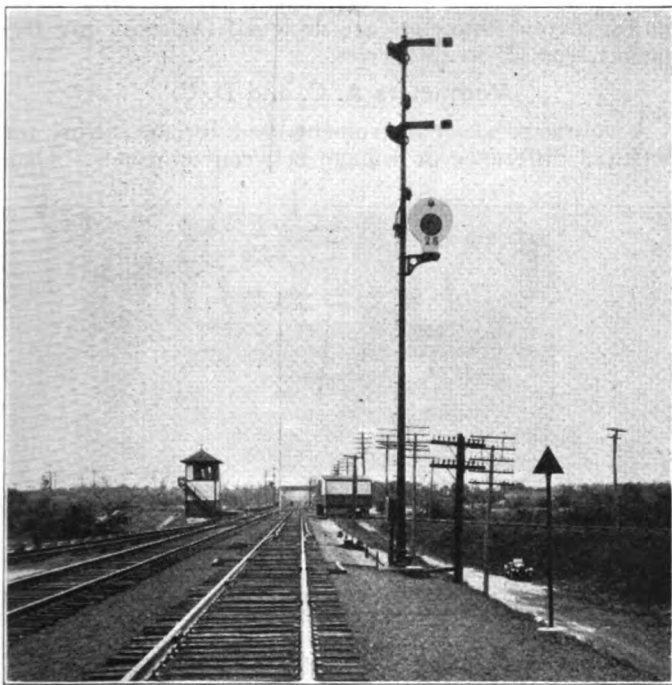
Southbound Interlocking Signal, Second Arm Governs Diverging Route, Home Automatic Signal 25 on Same Mast
