The Bryn Athyn Collision on the P. & R.

Bureau of Safety, Interstate Commerce Commission, Asks That Railroad Be Required to Install Automatic Train Control and Severely Criticizes Laxity of Supervision

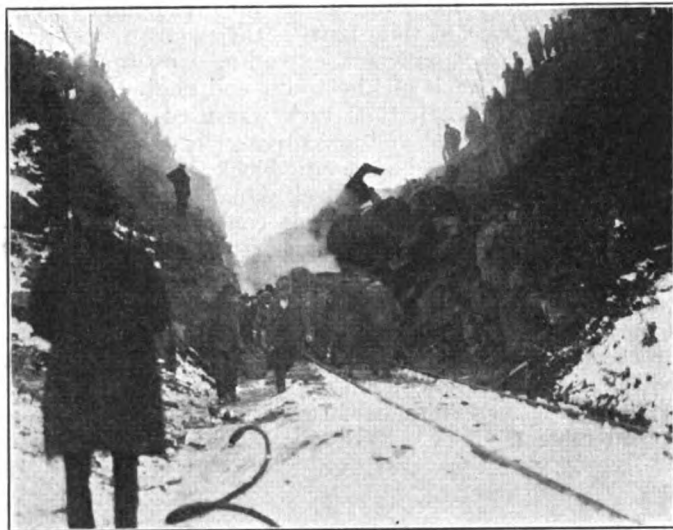
Removing Victims From the Wreckage in the Cut

The impact forced both engines upward, engine 167 of train No. 151 coming to rest bottom up, headed west and on top of its own tender, while engine 278 of train No. 156 was on top of engine 167. The combination car of train No. 151 was partially telescoped by the tender of engine 167. The forward end of the second car of train No. 151 was also partially telescoped by the rear of the combination car, while the rear car remained on the rails and was only slightly damaged. The first coach of train No. 156 was completely telescoped by the tender of engine 278. The next car was partially telescoped at its forward end by the wreckage, while the rear truck remained on the rails. The third, fourth and fifth cars of train No. 156 were practically undamaged by the collision. The wreckage took fire immediately, the first car of each train being completely destroyed. The fire spread quickly and destroyed the superstructures of the second and third coaches of train No. 156 and of the second coach of train No. 151. It is probable that many of the deaths were the result of the fire that followed the collision. The employees on duty killed were the fireman of each train.

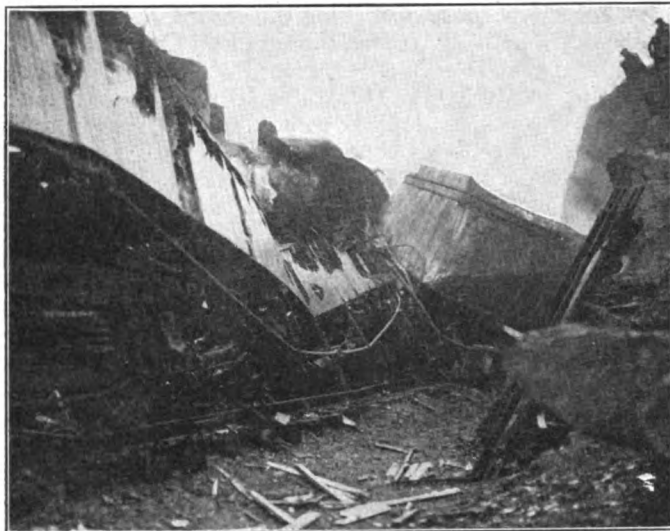
The point of collision was about 1.3 mi. east of Bryn Athyn, and 0.8 mi. west of Woodmont; it occurred in the middle of a rock cut about 200 ft. in length and having a maximum depth of 30 ft. The cut is located on a compound curve to the south about 1,000 ft. in length, having a maximum curvature of 7 deg. On account of this curve and cut the range of vision was much restricted and there was little opportunity for either engineer to see the opposing train. The weather was clear at the time of the accident, which occurred at about 7:55 a. m.

Wreckage Piled in Narrow Cut, Which Made Rescuers' Work Difficult
