Collision in Signal Territory

ON NOVEMBER 21, a rear-end collision between a freight train and an empty coach train on the Chicago & North Western, at Barrington, Ill., resulted in the death of one person carried under contract, and the injury of two employees. The accident occurred on

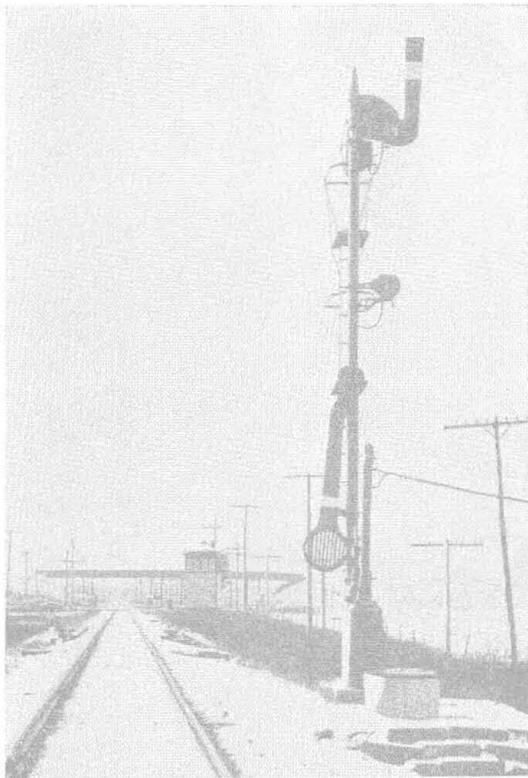
Home signal on the C. & N. W.
