Train Accident on the Erie Railroad

Use of call-on signal involved in rear-end collision

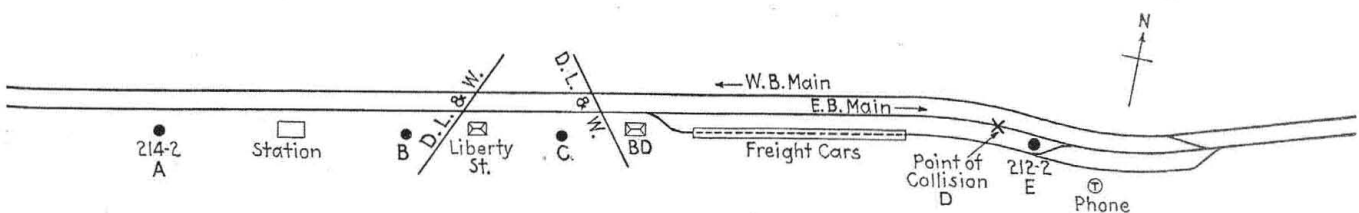
This accident occurred on the double-track main-line over which trains are operated by time table, train orders and an automatic block-signal system, supplemented by an automatic train stop of the intermittent inductive type. The signals involved, named in order from west to east, were automatic block signal 214.2 and the interlocking home signals at Liberty street and BD towers, these signals being located 11,759, 7,980 and 5,962 ft., respectively, west of the point of accident; and automatic

Sketch of territory in which collision occurred

block signal 212.2, located 893 ft. east of the point of accident. The automatic signals are of the one-arm, three-position, upper-quadrant semaphore type, the night indications being red, yellow and green, for stop, approach and proceed, respectively. The interlocking home signals are of the two-arm semaphore type; the upper arms are of the three-position upper-quadrant, semi-automatic type, displaying the same night indications as the automatic signals, while the lower arms are non-automatic, lever controlled calling-on signals, operating in two
