Accident at Automatic Plant

Evidence indicates that enginemen did not properly observe and obey signal indications

ON JUNE 13, there was a side collision between a passenger train of the Chicago, Rock Island & Pacific and a freight train of the Minneapolis & St. Louis, at Morning Sun, Iowa, which resulted in the death of one employee. An abstract of the report of an investigation of this accident by the Bureau of Safety, I.C.C., in conjunction with the Iowa Board of Railroad Commissioners, is as follows:

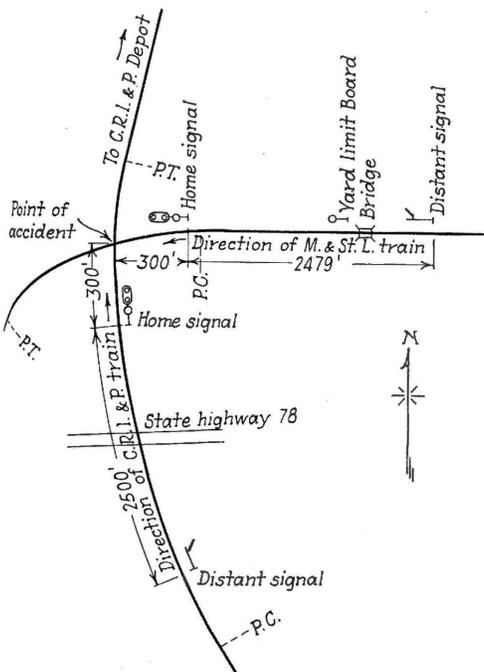
Sketch showing location of accident

red for stop, and green for proceed; a marker light, giving a red indication, is also located on the mast of each home signal, 5½ ft. below the two governing top lights. The home signal on each road is located 300 ft. from the crossing; the C.R.I. & P. distant signal is located 2,500 ft. south of its home signal, and the M. & St. L. distant signal is located 2,479 ft. east of its home signal.
