# Railroads Clean Up After Flood Waters

During March, widespread floods resulted in unprecedented damage to the railroads throughout several eastern states. By field inspection and correspondence, *Railway Signaling* has assembled information concerning the methods pursued in replacing and rehabilitating the signaling and interlocking facilities after these floods receded.

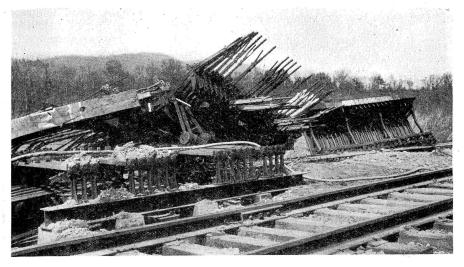
Left—The interlocking machine at Sir John's Run, Md., on the B. & O. was held by the up-and-down rods but the building floated away. Above—Demolished trunking on the Pennsylvania near Pittsburgh wires were returned to temporary service

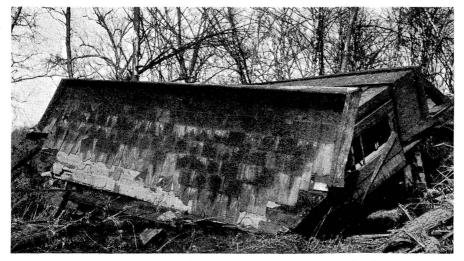
The Sir John's Run tower on the B. & O. was found three miles down stream.

At Sir Johns Run, 11 miles east of Orleans Road, the electro-mechanical interlocking was completely demolished by the flood, which rose to a depth of 19 ft. 7 in. over the tracks at this point. The frame tower was washed away, one half of the building being found 3.2 miles down the river. The relays, battery, etc. in the tower are gone beyond recovery. The upand-down rods held the interlocking machine as shown in one of the illustrations. The westbound distant signal bridge was washed out and fell on the tracks. Extended sections of the track and pipe lines were washed out, and the pole line was completely demolished for a distance of about a mile east of the tower. In view of the fact that this interlocking was so completely destroyed, it is not to be replaced in kind, but plans are being prepared to install power switches and signals and to control the layout remotely from the Hancock interlocking 5.6 miles east. In the meantime, handthrow switch stands operated by switchmen are in service at Sir Johns Run, automatic block signal protection being provided for the layout.

As a part of the new remote-control installation, the automatic signals between Sir Johns Run and Hancock are to be respaced, using two bridges instead of the four formerly in this territory. On the 5.6 miles of fourtrack line between Sir Johns Run and Hancock, the pole line was washed away in various sections and the signaling was restored to service on the two passenger tracks April 9 by installing polarized track-circuit control.

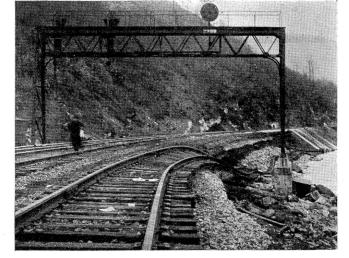
Signal bridge foundation and No. 3 main line undercut near Johnstown, Pa. ing on this territory, were all flooded and so seriously damaged that there was no hope of securing power from these sources for several days or perhaps longer, after the flood receded.

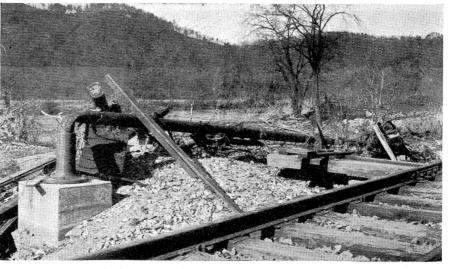
An instance on the Baltimore & Ohio where the foundation held but the signal mast bent over

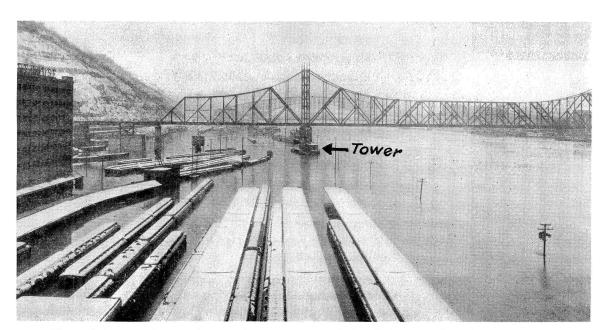
The track layout and interlocking on the P. & L. E. at Pittsburgh, Pa., were flooded more than 8 ft.

was the necessary attention required to clean and dry out the relays. Track transformers, reactance coils, traincontrol wayside inductors, and wiring in the towers and cases as well as over the plants, were all returned to service requiring less labor than relays for reconditioning. However, when a relay is full of mud and water there is no choice but what it must be opened, cleaned and dried before returning it to service.

Temporary relay repair shops were set up in the electrical shop at McKees Rocks, at Montour Jct., and at Pittsburgh. The relays, which were fouled with mud, were taken apart, cleaned and the parts were placed in sheetmetal ovens which were set on gas and coal-burning stoves set up temporarily in the towers, switch shanties or other buildings. The advantage claimed for the use of an oven, as compared with the method of placing parts on racks around a stove, is that in an oven each part is subjected to even temperature of heat all over, and there is not so much likelihood of overheating the insulation on coils.
