# Ohio Flood Damages Signaling

AS THE worst flood in history of the Ohio river and several of its tributaries subsided last week, more than a dozen railroads began the task of rehabilitating signal and interlocking equipment which had been inundated for periods varying from several days to as much as two weeks. Fed by excessive rains which fell on half-frozen ground, the headwaters of the Ohio river and many of its tributaries reached flood stages about January 15 and continued to rise for another 12 days. As the crest of the flood moved downstream, high-water marks far in excess of all previous records were established successively at Wheeling, Parkersburg, and Huntington, W. Va., Portsmouth and Cincinnati, Ohio, Louisville, Ky., Evansville, Ind., Paducah, Ky., and Cairo, Ill. Except for a few rare instances, the damage

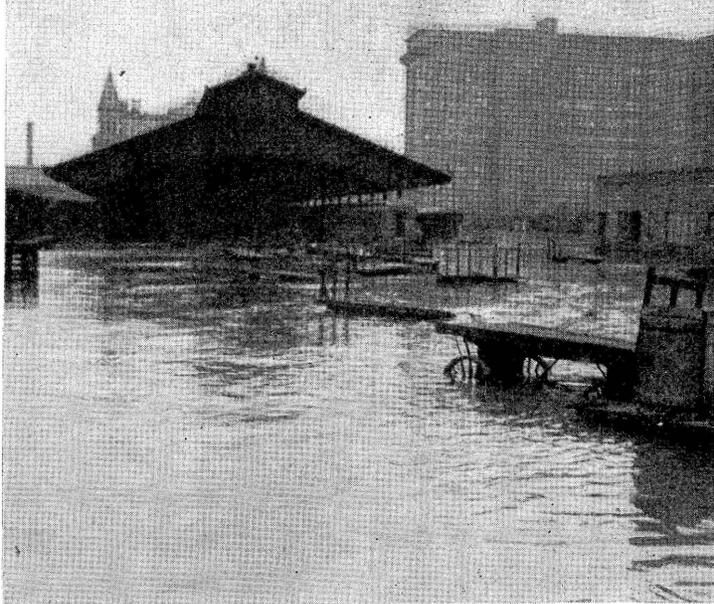
Station at Louisville, L. & N. general office building at the right

At Louisville, the flood reached a stage of 57.1 ft., or 10 ft. higher than in 1884. The Louisville & Nashville abandoned service on January 22, when the tracks in the station at Tenth and Broadway were flooded several feet, as shown in one of the illustrations. On the Louisville-Cincinnati line of the L. & N., the tracks were flooded at Worthville, Ky., and Eagle, and at numerous places on the Louisville, Ky.-Evansville, Ind., line. The L. & N. office building, adjacent to the station, was surrounded by water, all heating, power and communication facilities being cut off. Communication was so badly disrupted and so much of the railroad was affected by water that at the time of this writing, February 8, it was difficult to learn the extent of the damage to signal facilities.

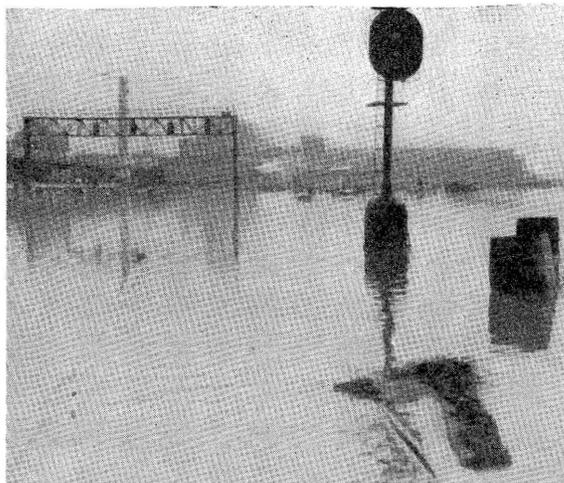
Home signal on C. & O. of Ind. on the approach to Cincinnati Union Station from the north

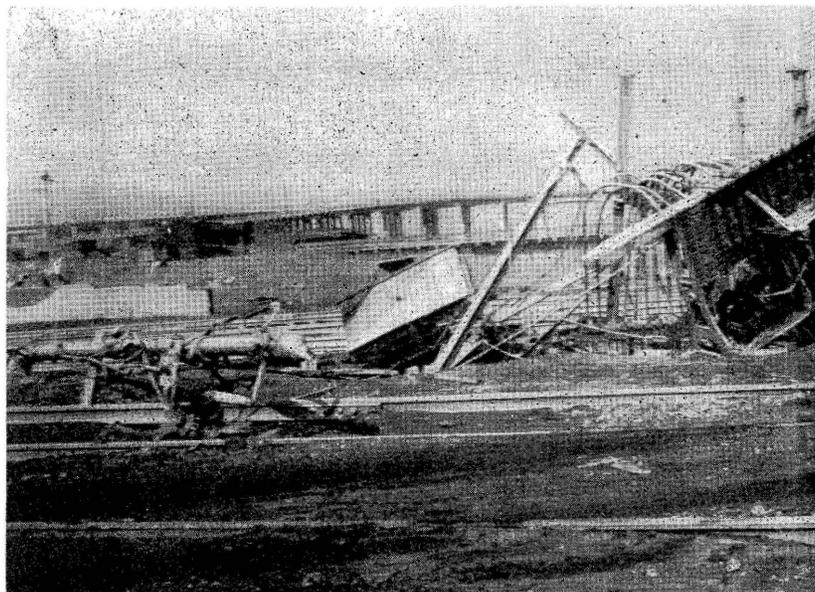
Wreckage of mechanical interlocking machine with tower washed away at Oklahoma plant on Big Four in Cincinnati

control relays, batteries, etc., were salvaged by placing them in the loft of the tower. The "Stores" plant consists of mechanical switches and power home signals with top-mast motor signals. The battery, consisting of 55 lead cells, the lever locks, relays, etc., at this point were all under water, and one of the home signals was broken off at the base of the mast, presumably by floating wreckage. At "Oklahoma," which was a mechanical plant controlling 3 switches and 2 sets of movable point frogs, the tower was broken up and washed away, the signals were knocked down, and the interlocking machine transformed into a mass of twisted wreckage.

No service was possible on this line, therefore C. C. C. & St. L. trains bound for Cincinnati were routed by way of Ansonia, where a connection was made with another line. Trains were run as far as Lockland, about 7 miles out of Cincinnati. As soon as the tracks are clear and safe operation possible, operation is contemplated under manual block rules until the signals are back in service. Switches are to be rolled over and spiked, it not being planned to install switch stands.

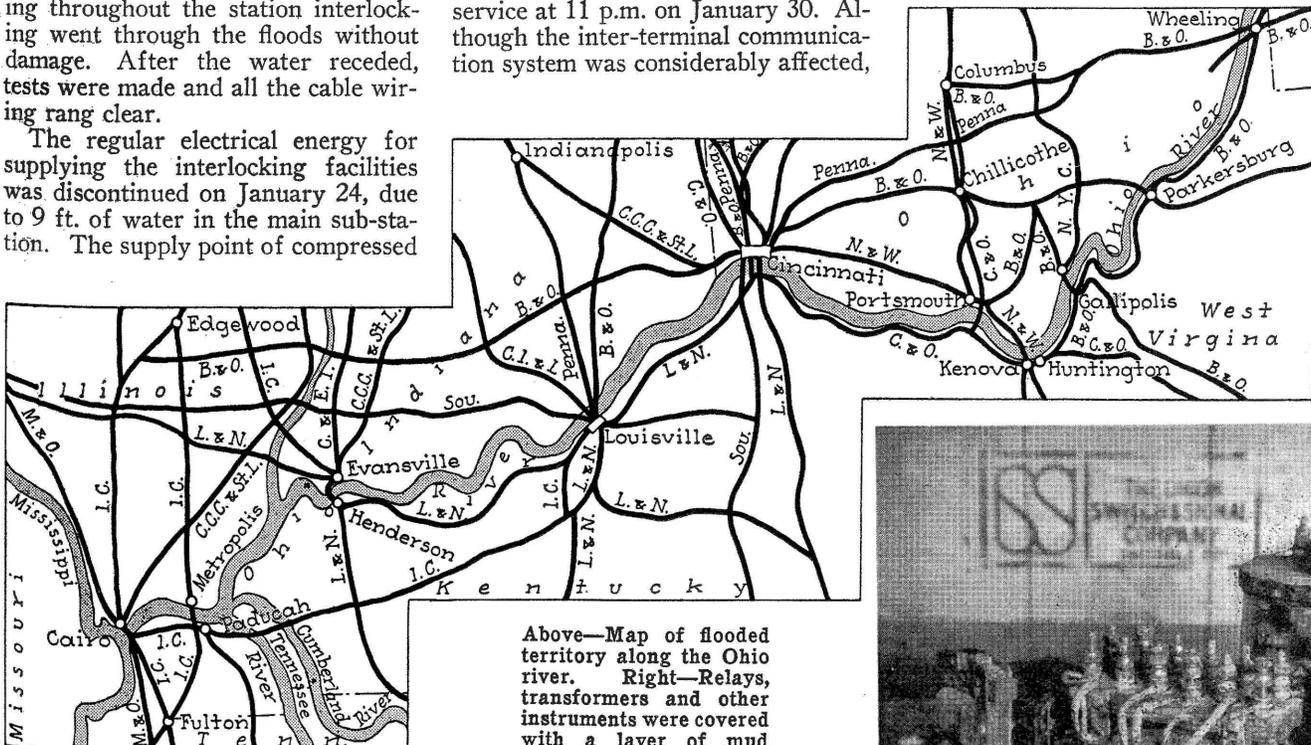
Above—Map of flooded territory along the Ohio river. Right—Relays, transformers and other instruments were covered with a layer of mud

Color-position-light and semaphore signals with storage battery track circuits were subject to water as high as 12 ft. above the tracks. Since this was all back-water from the Ohio, there was no current, considerable dirt and silt being left when the water receded. Dry-plate rectifiers, relays, transformers, etc., in this territory were all submerged, although in some cases efforts had been made to get equipment out of the way. Battery wells were filled with water to prevent them from floating away. The relays and rectifiers are being sent to the B. & O. signal shop at Zanesville, Ohio, for cleaning and drying.

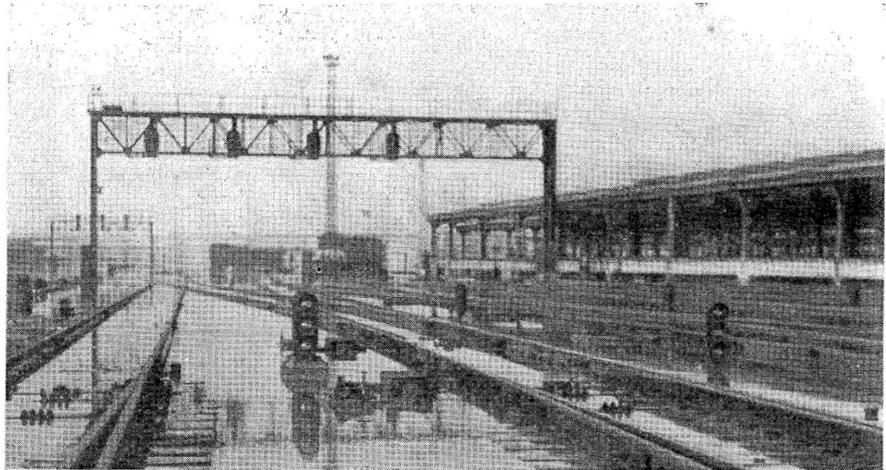
On the Union Station interlocking proper, 90 switch machines of the Union A-5 type were flooded. Before the water rose, signalmen retrieved 75 C.P. valves and the rotors of the circuit controllers. In some cases, the rapidly rising water did not allow time for disconnecting the wires, so that many of the valves were pulled out hurriedly, the wires being cut or pulled loose. This equipment was stored out of reach of the flood waters.

View at Cincinnati Union Station showing north throat as water receded. Note that the CP valves have been removed

The track circuits, switch valves and rotors were placed in service as soon as possible after the waters receded. Relays and other equipment were replaced from stock, and the wet equipment repaired in the shops. The entire interlocking was returned to service at 5 p.m. on February 2. Regular air service was resumed at 10 a.m. on February 4. As soon as the water receded at Hoppel street, the Baltimore & Ohio tracks to Ivorydale Junction were clear for traffic by the Pennsylvania, the Cleveland, Cincinnati, Chicago & St. Louis, the Norfolk & Western, and the Baltimore & Ohio. Any inbound trains which were able to reach Ivorydale Junction were handled into the station, effective midnight, February 3. Outbound service was resumed at noon, February 4.

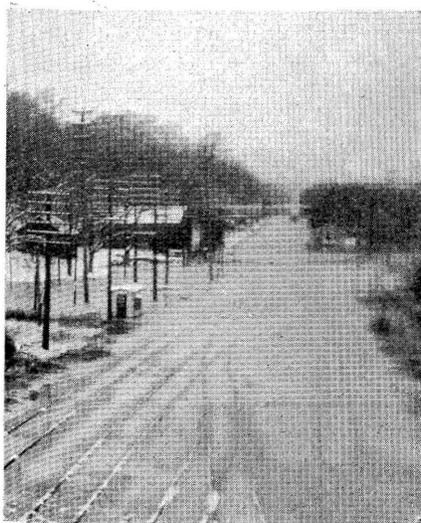
The remotely-controlled switch machines and instruments at Rendcomb Jct. on the Pennsylvania were flooded

The instrument houses at Red Bank and Rendcomb Junction were cleaned out with a Homelite pump of the type normally used for pumping out man-holes, the outlet side being reduced to produce a force stream of water. The M-2 switch motors were baked out by a motor repair shop in downtown Cincinnati, while a 1,500-watt oven was used to dry the rectifiers, relays, coding units, etc. Rectifiers were used to recharge the batteries. Equipment in this territory was removed from service as the water receded, other signalmen following up immediately and putting the new equipment in service. As a temporary arrangement to open up service through Red Bank and Rendcomb Junction, communication and a 440-volt line was re-established between these points and Clare, and knife switches provided for the operation of the switches. Rendcomb Junction was placed in service under this plan two days after the water was off the tracks. Wiring of the Line B section of the control machine, about 50 per cent of the re-wiring job, was completed and placed in service on February 4.

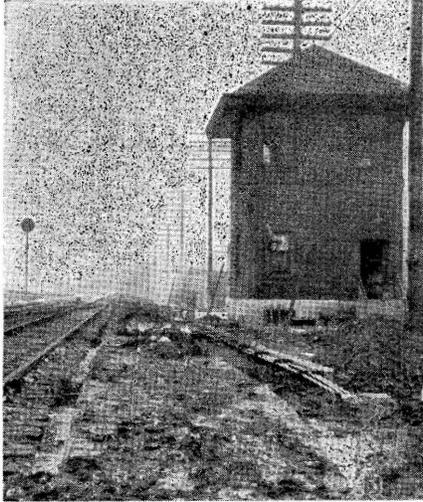
Probably the greatest damage to Pennsylvania signaling in the Cincinnati territory occurred at a C.T.C. installation, the control tower of which is located at Clare, at a crossing and connection of the Pennsylvania and Norfolk & Western, approximately 12 miles east of Cincinnati. The two-story tower at this point, which houses a mechanical interlocking plant for the operation of Type G switch and lock mechanisms at this location, as well as a 25-lever C.T.C. machine, was flooded to a height of 1 ft. above the second floor, the water coming to a point just below the locking bed of the mechanical machine. The C.T.C. machine at Clare was operated until the water rose to a point where the machine became shorted. A lot of the equipment was removed and salvaged by boat as the water rose, the code units and graph of the C.T.C. machine being cut loose from the machine proper when it became evident that it might be submerged. Many relays, etc., on the first floor of the tower, however, were caught in the rising water. Chemicals, from unknown sources, present in the water throughout this area, which apparently were acid in nature,

caused considerable damage to metal parts of the relays and to the straps of the terminals. A considerable quantity of mud was deposited on the tracks at this interlocking, primarily due to slides from higher ground about 200 ft. in the rear of the tower. When the water receded, the Type G switch mechanisms, switch points,

At Clare interlocking on the Pennsylvania the flood water came up to the locking bed in the interlocking machine—  
Note mud left on switch layouts

pipe line, and other equipment were heavily caked with dirt. Freezing temperatures further complicated the rehabilitation of the plant.

manufacturers as soon as the water receded. At Clare, the signalmen worked on the second floor before the water was out of the first floor. Later, two stoves were installed to heat the downstairs and melt ice which had formed. Two men from the Union Switch & Signal Company were called in to rewire the C.T.C. machine. The remote stations on Line B were placed in service almost immediately with full-circuit protection by knife switches, the knife switches being so inserted in the circuits at each remote station as to take the place of the final code selection under normal operation.

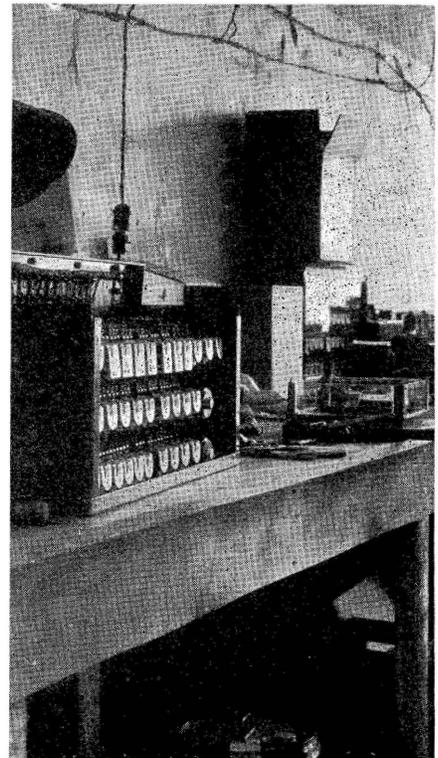
The Pennsylvania established an emergency repair shop in an empty store building on high ground
