Accident Involving Rule 93

ON MARCH 14, 1938, there was a head-end collision between two freight trains on the Illinois Central at North yard, Carbondale, Ill., which resulted in the death of two employes. An investigation of this accident was made by the Bureau of Safety, Interstate Commerce Commission, in conjunction with the Illinois Commerce Commission. A digest of the report on this accident is as follows:

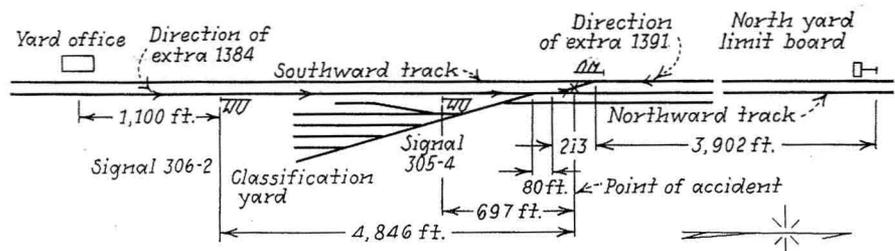
This accident occurred on that part of the St. Louis division which extends between Centralia, Ill., and Ballard, Ky., a distance of 113 miles. In the vicinity of the point of accident this is a double-track line over which trains are operated by time table, train orders and an automatic block signal system. The accident occurred within yard limits on a crossover connecting the northward and southward main tracks, located near the north end of the yard. The crossover is 213 ft. in length and the turnouts are facing-point switches for trains moving with the current of traffic. Southbound trains enroute from the Centralia district to the Johnson City district move through the crossover involved to the northward main track, continue on this track for a distance of 80 ft. and then proceed through another switch leading to the tracks of a classification yard.

The automatic block signals involved are signals 306-2 and 305-4, governing northward movements, and are located 4,846 ft. and 697 ft., respectively, south of the point of accident. These signals are of the 2-arm, 2-position, lower-quadrant, semaphore type; night indications are green over green for proceed, green over yellow for proceed at medium speed prepared to stop at the next signal, and red over yellow for stop; then proceed. The track circuits are so arranged that when either crossover switch is open an approach indication is displayed by signal 306-2 and a stop-and-proceed indication by signal 305-4.

Extra 1384, a northbound freight train, departed from Cairo Junction, 54.73 miles from North yard, at 3:05 a.m., passed Carbondale, 1.29 miles from North yard, at 4:51 a.m., passed the yard office at North yard at 4:54 a.m., passed signal 306-2, the indication of which is in question, passed signal 305-4 displaying a stop-and-proceed indication, entered the open crossover switch and struck Extra 1391 while traveling at a speed estimated to have been between 25 and 30 m.p.h.
