# Splicing a Submarine Cable

## Chicago Rapid Transit utilizes special clamp in splicing damaged submarine cable, carrying interlocking circuits under the Chicago river at a drawbridge

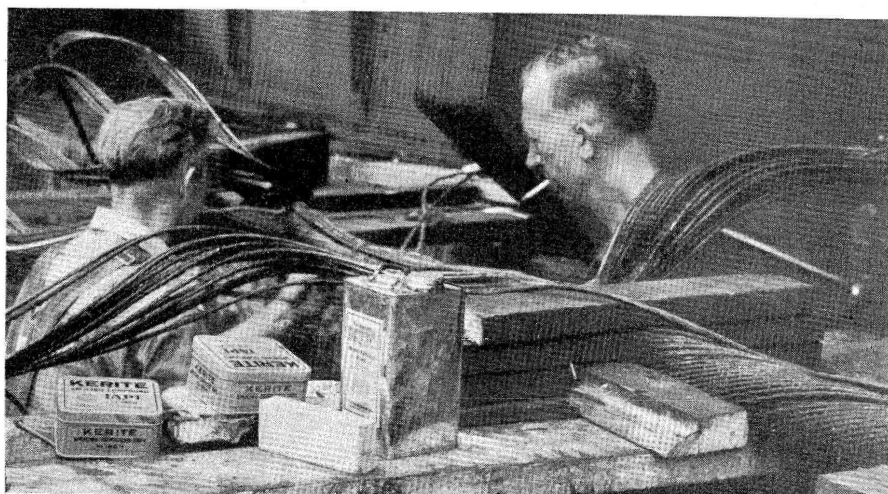
The first step in splicing the 63-conductor submarine cable was to strip back the outer protective covering of armour wire, jute and tape. Signalmen shown splicing individual conductors and grouping the same. Each group of the conductors was taped

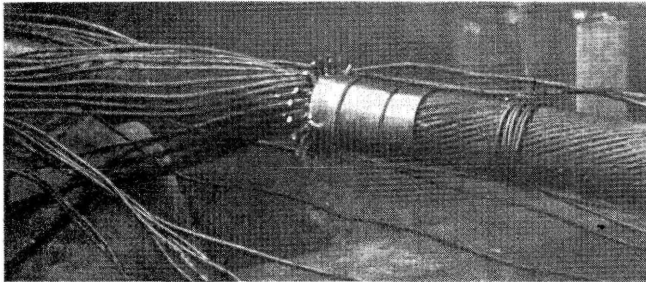
All of the conductors spliced, the next step was to arrange the armor wires for applying the clamp. Note the copper strip around the cable for protection against the heat of the hot babbitt

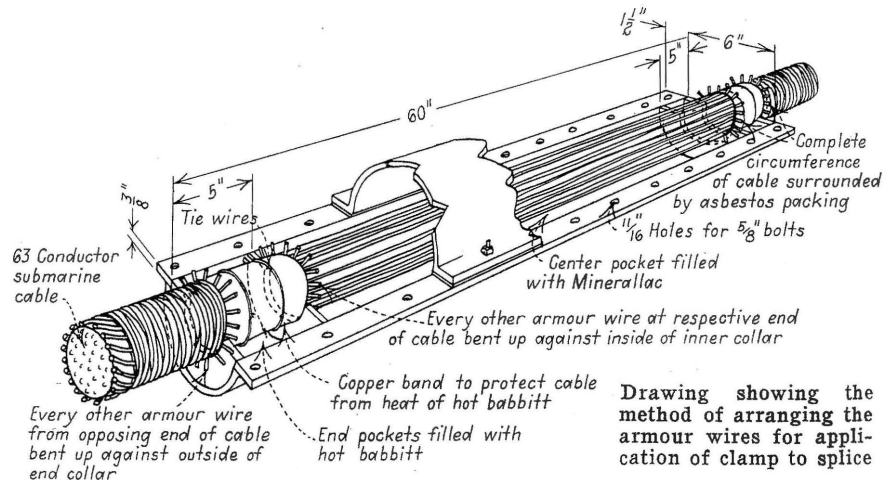
Drawing showing the method of arranging the armour wires for application of clamp to splice

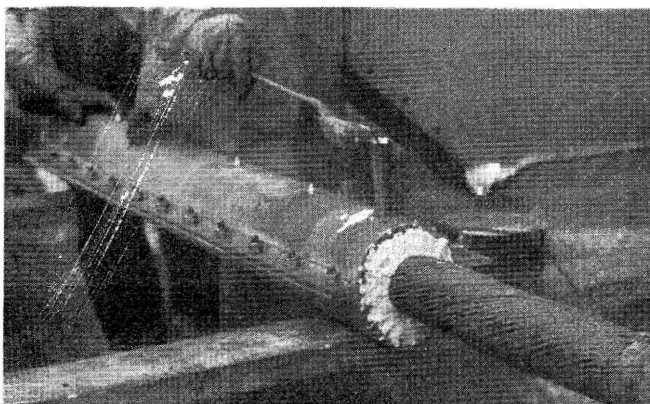
The clamp bolted in place, hot babbitt was poured into the end pockets through a ¾-in. hole in the top

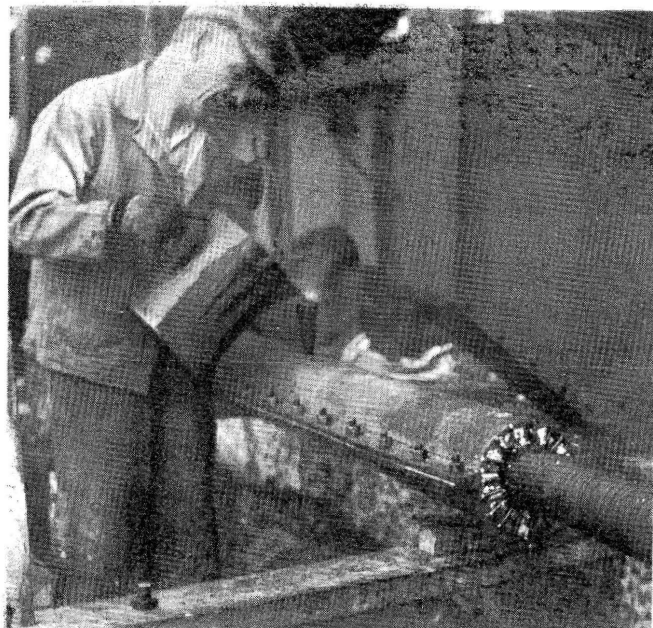
The final step in the splicing operation was filling the center pocket with hot Minerallac through a  $\frac{3}{4}$ -in. tapped hole in the top. The bolt plug for this hole is shown on a plank in the lower left.
