Accident at Movable-Point Crossing

On January 2, 1945, there was a derailment of an Erie passenger train at a movable-point crossing in an interlocking at Sterling, Ohio, which resulted in the death of the engineer, and the injury of the fireman. The Interstate Commerce Commission report of this accident is abstracted as follows.

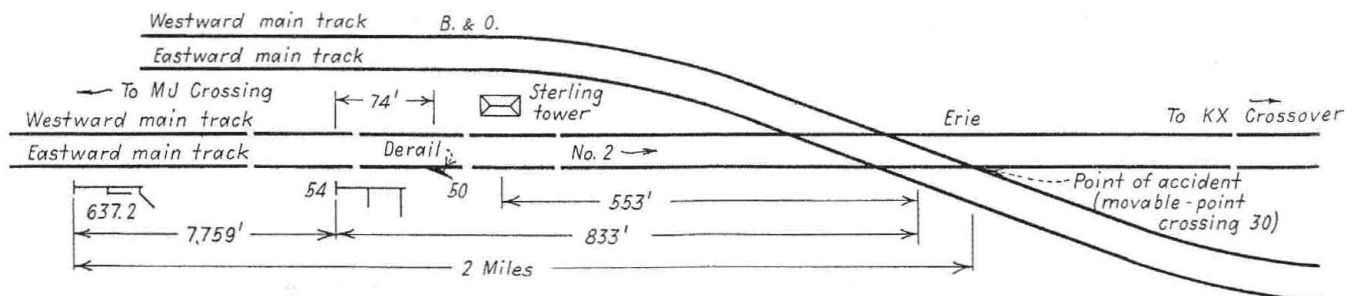
The investigation disclosed that when the accident occurred, crossing 30 was lined for movement on the B. & O. westward main track, but derail 50 on the Erie eastward main track was in non-derailing position and home signal 54 displayed approach for No. 2. Examination disclosed that the south trailing point of crossing 30 had been forced open, the lock rod and the operating rod were broken, and the north facing point was broken. The circuits were so arranged that, when the route was lined for movement on the B. & O., the derails on the Erie tracks would be in derailing position and the home signals governing movements on the Erie tracks would display stop. Since crossing 30 was lined for movement on the B. & O., derail 50 on the Erie eastward main track should have been in derailing position and home signal 54 should have displayed stop.

It is found that this accident was caused by making the indication displayed by the home signal and the position of the derail not in accordance with the position of the movable-point crossing.

Track and signal layout of the interlocking at the crossing of the Erie and the Baltimore & Ohio at Sterling, Ohio
