Collision Entering C.T.C. Line Due to Inadequate Signal

What was termed "an inadequate centralized traffic control installation" in the report of the investigation of the Interstate Commerce Commission was found to have caused a rear-end collision on the Central of Georgia at Macon Junction, Ga., August 31, which resulted in the death of one employee and the injury of 34 passengers, one person carried under contract, and 5 employees. The investigation was conducted under the supervision of Chairman Patterson.

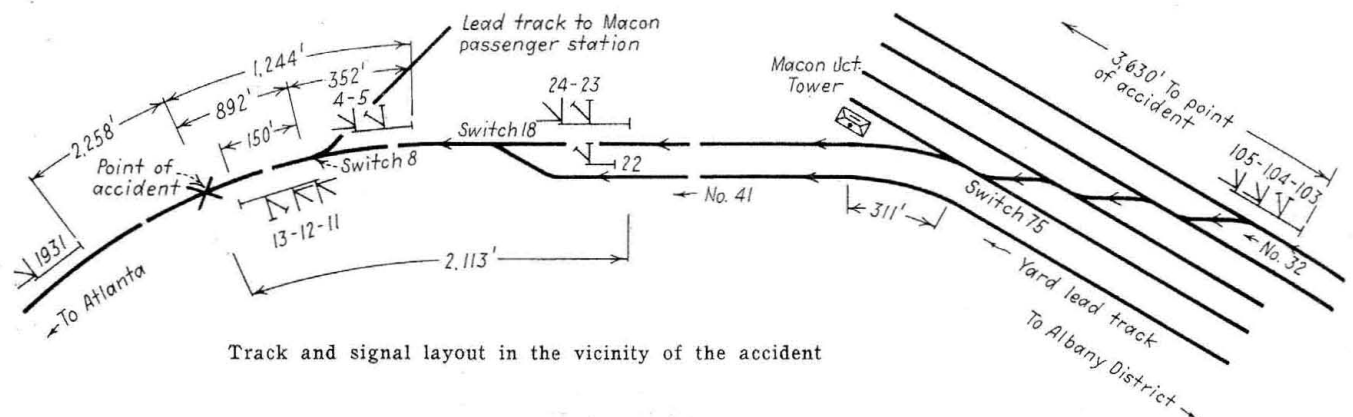
Track and signal layout in the vicinity of the accident

Signal Lay-out—Approaching the point of the accident from the east, No. 32 passed, in order, an interlocking signal (displaying proceed-at-slow-speed-prepared-to-stop), a switch by which it entered the Atlanta district main line, and then, at points 2,113 ft. and 1,244 ft., respectively, east of the point of collision, two interlocking signals, each displaying proceed-at-slow-speed-prepared-to-stop. The latter signal, designated as No. 4-5, was of the two-arm, upper-quadrant semaphore type. The upper unit was connected into the Atlanta district C.T.C. system and authorized movement to signal 1931 (at which the freight had stopped). The lower unit of signal 4-5 was not controlled by a track circuit, but its operating lever was provided with an electric lock, operative in normal position, and its control extended about 2,000 ft. beyond signal 1931.

Dual-Purpose Signal—After the freight had passed signal 4-5, which had displayed slow-speed-prepared-to-stop for it also, the leverman should have returned the signal to normal position, as required by the rules, the commission's report explained, but "in accordance with past practice, he permitted it to continue to display the same indication for the passenger train. This signal was so arranged that if he had returned it to stop position after the preceding train passed it, he would have been unable to change the indication as long as the track between that signal and signal 1931 was occupied. "Signal 4-5 was used both as an interlocking signal and as the signal governing

entrance to centralized-traffic-control territory. Section 405 of the Commission's order of April 13, 1939, prescribing rules, standards, and instructions for centralized-traffic-control systems, requires that signals shall be automatically controlled by continuous track circuits on main tracks and on other tracks where medium speed is permitted. The lower arm of signal 4-5 was not provided with track-circuit control, and, therefore the centralized-traffic-control installation was in violation of the Commission's order. Under the conditions which existed at the time of this accident and the practices which were being followed at this point, this signal displayed the same indication regardless of whether the track immediately beyond it was occupied. If this signal had been arranged to indicate track occupancy as required by the Commission's order, a stop indication would have been displayed for No. 32, and the accident would have been averted.

"It is found that this accident was caused by an inadequate centralized-traffic-control installation."
