Accident on Siding Results in I. C. C. Recommendation for Locks

ON September 23, 1945, there was a head-on collision on a siding between two passenger trains on the Northern Pacific at Prosser, Wash. The following information concerning this accident is taken from a report of the Interstate Commerce Commission.

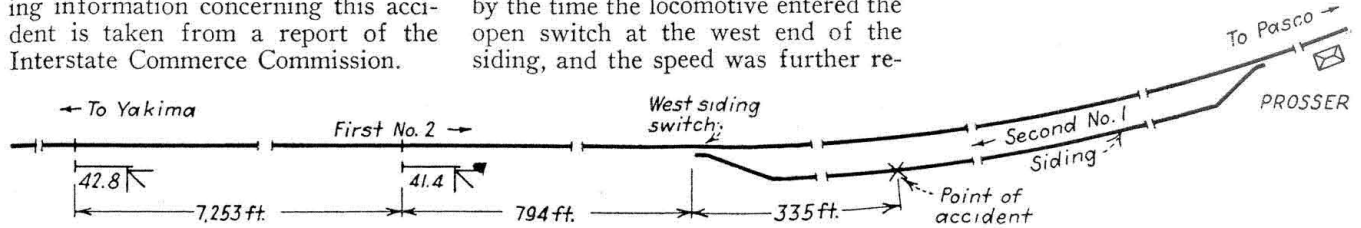
Track and signal plan of layout at Prosser, Wash.

This accident occurred on that part of the Idaho division which extends between Pasco and Yakima, Wash., 89.5 miles, a single-track line in the vicinity of the point of accident, over which trains are operated by timetable, train orders and an automatic block-signal system. At Prosser, a siding 3,224 ft. in length parallels the main track on the south. The east switch and the west switch of this siding are, respectively, 350 ft. and 3,574 ft. west of the station. The accident occurred on the siding at a point 335 ft. east of the west switch.

The automatic block-signal system is arranged on the absolute-permissive principle and consists of double-location signals near sidings and intermediate signals between stations. Signals 42.8 and 41.4, governing eastbound movements, are, respectively, 8,047 ft. and 794 ft. west of the west siding-switch. These signals are of the one-arm, three-position, upper-quadrant, semaphore type, and are approach lighted.

"It is found that this accident was caused by a switch being opened immediately in front of an approaching train.

"It is recommended that the Northern Pacific Railway Company install electric switch-locking at main-track hand-operated switches in high-speed automatic block-signal territory."
