Lock Bypass Causes 2 Accidents

● The following is an abstract of Report No. 3861 of the Interstate Commerce Commission of two accidents on the Illinois Central at Kensington, Ill., on June 25 and October 21, 1959.

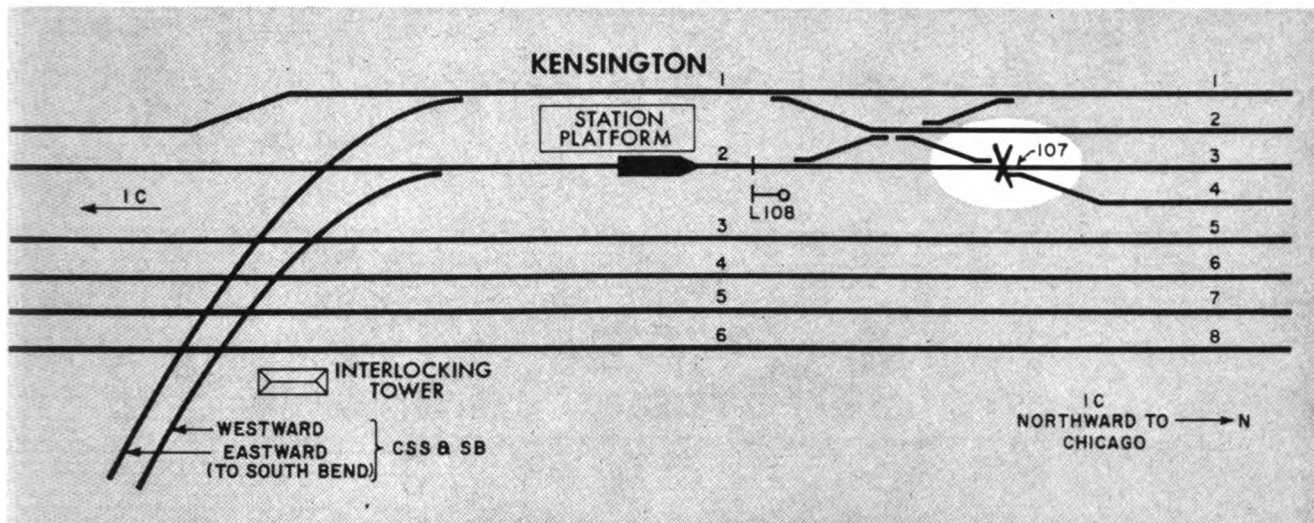
The investigation of this accident disclosed no defect of the interlocking which would permit switch No. 107 to be moved while the track circuit of that switch was occupied; provided, that the contact arm of the emergency release device was in the normal position. The signal maintainer and the interlocking operator said that they had not opened the emergency release device to release the electric locking of switch No. 107 at any time of the day of the accident. It is apparent, therefore, that the emergency release device was placed on the contact connected to the electric locking circuit of Switch No. 107 at some time prior to the time of the accident, and that it had not been returned to normal position. This nullified the electric locking protection normally provided switch No. 107 and permitted the signal maintainer to operate switch No. 107 to reverse position during the movement of No. 290 over that switch.

The investigation disclosed that the emergency release devices associated with the interlocking machines were used not only in emergencies as required by rules and instructions, but that it was a practice of the interlocking operators to use those devices to expedite movements in the interlocking when emergencies were not involved. When the contact arm of the emergency release device was placed on the stationary contactor connected to the electric locking circuit of switch No. 107 at some time prior to the date of the accident, the record and notification relating to this use of the device were not made as required by instructions. The contact arm was not restored to normal position as required, and it is apparent that the signal maintainer was unaware that the contact arm was in position to release the electric lock-

ing protection afforded switch No. 107 when he moved the interlocking machine lever controlling that switch, thereby causing the derailment.
