Collision due to signal failure

A rear-end collision between two westbound Southern Pacific freight trains . . . "was caused by a false proceed signal indication due to an undesired electrical connection between control circuits of associated signals." In report No. 4035, the Interstate Commerce Commission's Railroad Safety and Service Board reported on its investigation of the accident which occurred at Emigrant Gap, Calif., on Jan. 7, 1965, about 5 pm, resulting in injuries to nine train-service employees.

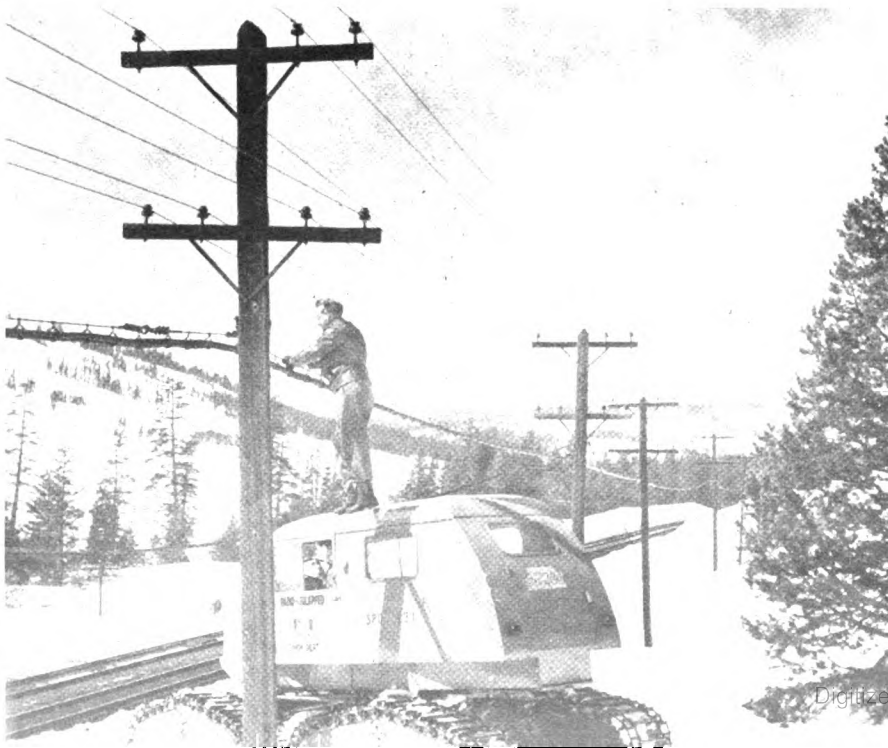
In the accident area this is a double-track line over which trains moving with the current of traffic operate by signal indications of an automatic block signal system, supplemented by an intermittent inductive train-stop system. The territory is in the Sierra Nevada mountains, between Sparks, Nev., and Sacramento, Calif. In the vicinity of the accident, there are a series of short tangents and curves in the track, and the average grade for westbound trains is 1.78% descending. Because of track curvature and sidehill cuts in the accident area, the range of vision between the collision point and an approaching westbound train is materially restricted. Automatic signals involved are shown on the diagram.

"Examination after the accident disclosed that snow on the ground in the area of the signal instrument housing at signal 1725 had accumulated to a height of 8 ft, leaving the ventilator at the top of the housing exposed. Snow had blown or drifted into the instrument housing through the ventilator and moistened the surfaces of the 19 lightning arresters carrying signal line circuits, includ-

"Tests and examinations revealed that current from the energized circuits apparently leaked over the damp surfaces of the 19 lightning arresters from their circuit terminals to their ground terminals. Because of this current leakage and the damp surfaces of the lightning arresters, electrolytic action occurred between the arrester circuit terminals and ground terminals. This caused a conductive substance to form on the surface of the arresters, bridging the arrester spark gaps and establishing an undesired circuit between the circuit terminals of adjacent arresters carrying the circuits for signal 1735 control relay and signal 1743 control relay.

cuit to energize the signal 1735 control relay circuit. This caused signal 1735 to indicate proceed for Extra 6397 West although the block of that signal was occupied by the rear portion of Extra 6238 West.

As part of its findings, the Commission's report states: "As a result of the control circuits of signals 1743 and 1735 being bridged by the conductive substance in the signal instrument housing at signal 1725, signal 1735 displayed a proceed aspect for Extra 6397 West although its block was occupied by the rear portion of Extra 6238 West. When Extra 6397 West entered the block of signal 1735, it was authorized by the proceed indication of signal 1735 to proceed in the block at not exceeding 30 mph, the maximum authorized speed in this territory as prescribed in the timetable . . .

"As a result of the accident, the practice in the territory involved of using rails to ground lightning arresters was discontinued and only earth grounds are now used for this purpose."
