# Indication locking

Ex Parte No. 244  
Chicago, Burlington and Quincy Railroad  
Montgomery, Ill.  
September 27, 1964

# adequate says ICC in report

## ICC ACCIDENT REPORT

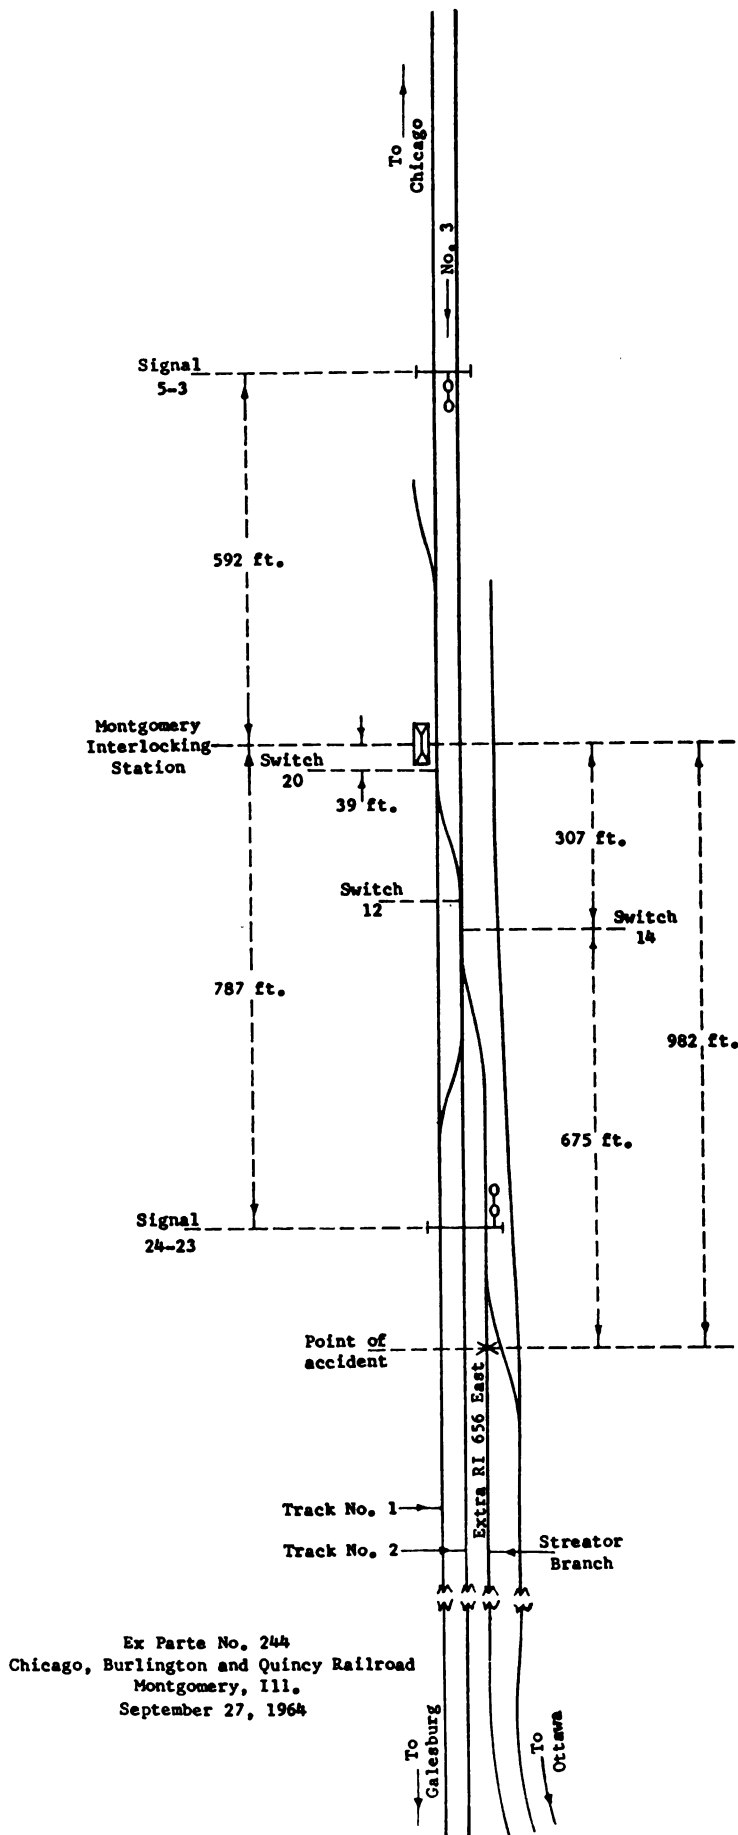
The accident occurred on the Streator Branch main track 982 ft west of Montgomery interlocking station and 675 ft west of switch 14.

A signal bridge spans tracks No. 1 and No. 2 at a point 592 east of the interlocking station. Semi-automatic signal 5-3, fixed to a mast on this signal bridge, governs westbound movements through the interlocking on track No. 2 and westbound movements from track No. 2 to the Streator Branch main track via switch 14.

A signal bridge spans the Streator Branch main track and tracks No. 1 and No. 2 at a point 787 ft west of the interlocking station. Semi-automatic signal 24-23 governing east-bound movements from the Streator Branch main track to tracks No. 1 and No. 2, is fixed to a mast on this signal bridge.

The Montgomery interlocking was of the mechanical pipe-operated type. Approach, route and indication locking were provided. The interlocking machine had 24 mechanical working levers in a 28-lever frame. Levers 3, 5, 23 and 24 were four of the signal levers and each controlled its corresponding numbered interlocking signal unit. Levers 14, 12 and 20 were three of the switch levers and each controlled its corresponding numbered interlocking switch. Lever 15, one of the locking levers, controlled the locking of switch 14. At the time of the accident, Montgomery interlocking was being converted to the electrical power-operated type for remotely controlled operation under a forthcoming traffic control system. Switches 14, 12 and 20 had been converted to power-operated switches and were controlled through circuit controllers operated by the corresponding numbered interlocking machine levers.

Tests made after the accident revealed that when switch 14 was in reverse position and interlocking machine lever 14 was operated to move switch 14 to normal position, it took 2.6 seconds for the switch motor to start moving the switch to normal position. If the latch of locking lever 15 was operated within 2.6 seconds after the operation of lever 14, the motor of switch 14 became de-energized and the switch remained locked in reverse position. In such event, the red indicator light associated with switch 14 remained illuminated to indicate that switch 14 was in reverse position. However, the operator could operate lever 5 and cause signal 5-3 to indicate Proceed with switch 14 in improper position.

It is evident in this case that switch 14 was in reverse or improper position for the intended route through the interlocking, and that the circuits of signal 5-3 were not arranged as required so that signal 5-3 would indicate proceed only when switch 14, and other switches in the intended route, were in proper position. It is also evident that the indication locking of the interlocking did not conform with the Commission's regulations, and that the indication locking provided did not prevent manipulation of levers that would result in an unsafe condition for a train movement when switch 14 failed to move to normal position after lever 14 was moved to that position. The absence of indication locking for power switch 14 permitted the operation of signal 5-3 after switch 14 did not make the required movement to normal position.

locking operator failed to heed the handwritten notice attached to the panel bearing the indicator lights associated with switch 14, and operated locking lever 15 and cleared signal 5-3 while the red indicator light was indicating that switch 14 was still in reverse position. However, had the interlocking system conformed to the Commission's regulations, the operator would not have been able to clear signal 5-3 while switch 14 was in improper position and the accident probably would have been averted.

We find that: (1) The trains involved were operated in conformity with the CB&Q operating rules. (2) The interlocking operator failed to determine that switch 14 was not in proper position when he cleared home interlocking signal 5-3 for No. 3. (3) Signal 5-3 indicated Proceed although a switch in the interlocking route was not in proper position. (4) The indication locking of the interlocking was not sufficiently adequate to prevent an unsafe condition for a train movement through the interlocking. (5) The accident was caused by failure to maintain the Montgomery interlocking in a safe condition for train movements.
