SIGNAL ENGINEERING INSTRUCTION
10 July 2006
ESI 06 04A

Westinghouse LED signal modules

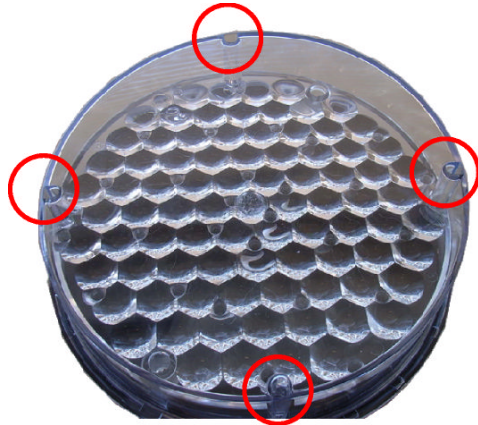
Figure 2: Signal Face showing the four pillars

The signals can be visually identified by looking at the four mounting pillars as shown in Figure 2.

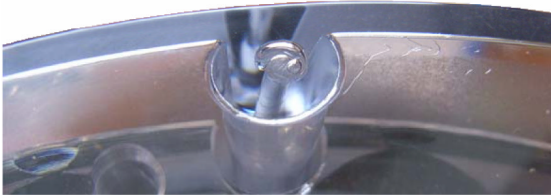
There are three versions covers manufactured recently. Signals that are not at risk have a full seal on the top of these pillars, as shown in Figure 3 and Figure 4

Figure 3: Older cover, with full surface seal

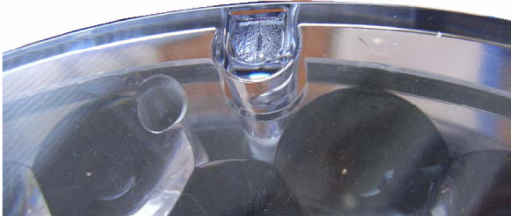
Figure 4: Latest cover with slightly recessed Seal.
