DEPARTMENT OF THE ENVIRONMENT

RAILWAY ACCIDENT

Report on the Collision that occurred on 26th October 1975 at Lunan Bay, between Montrose and Arbroath

> IN THE SCOTTISH REGION BRITISH RAILWAYS

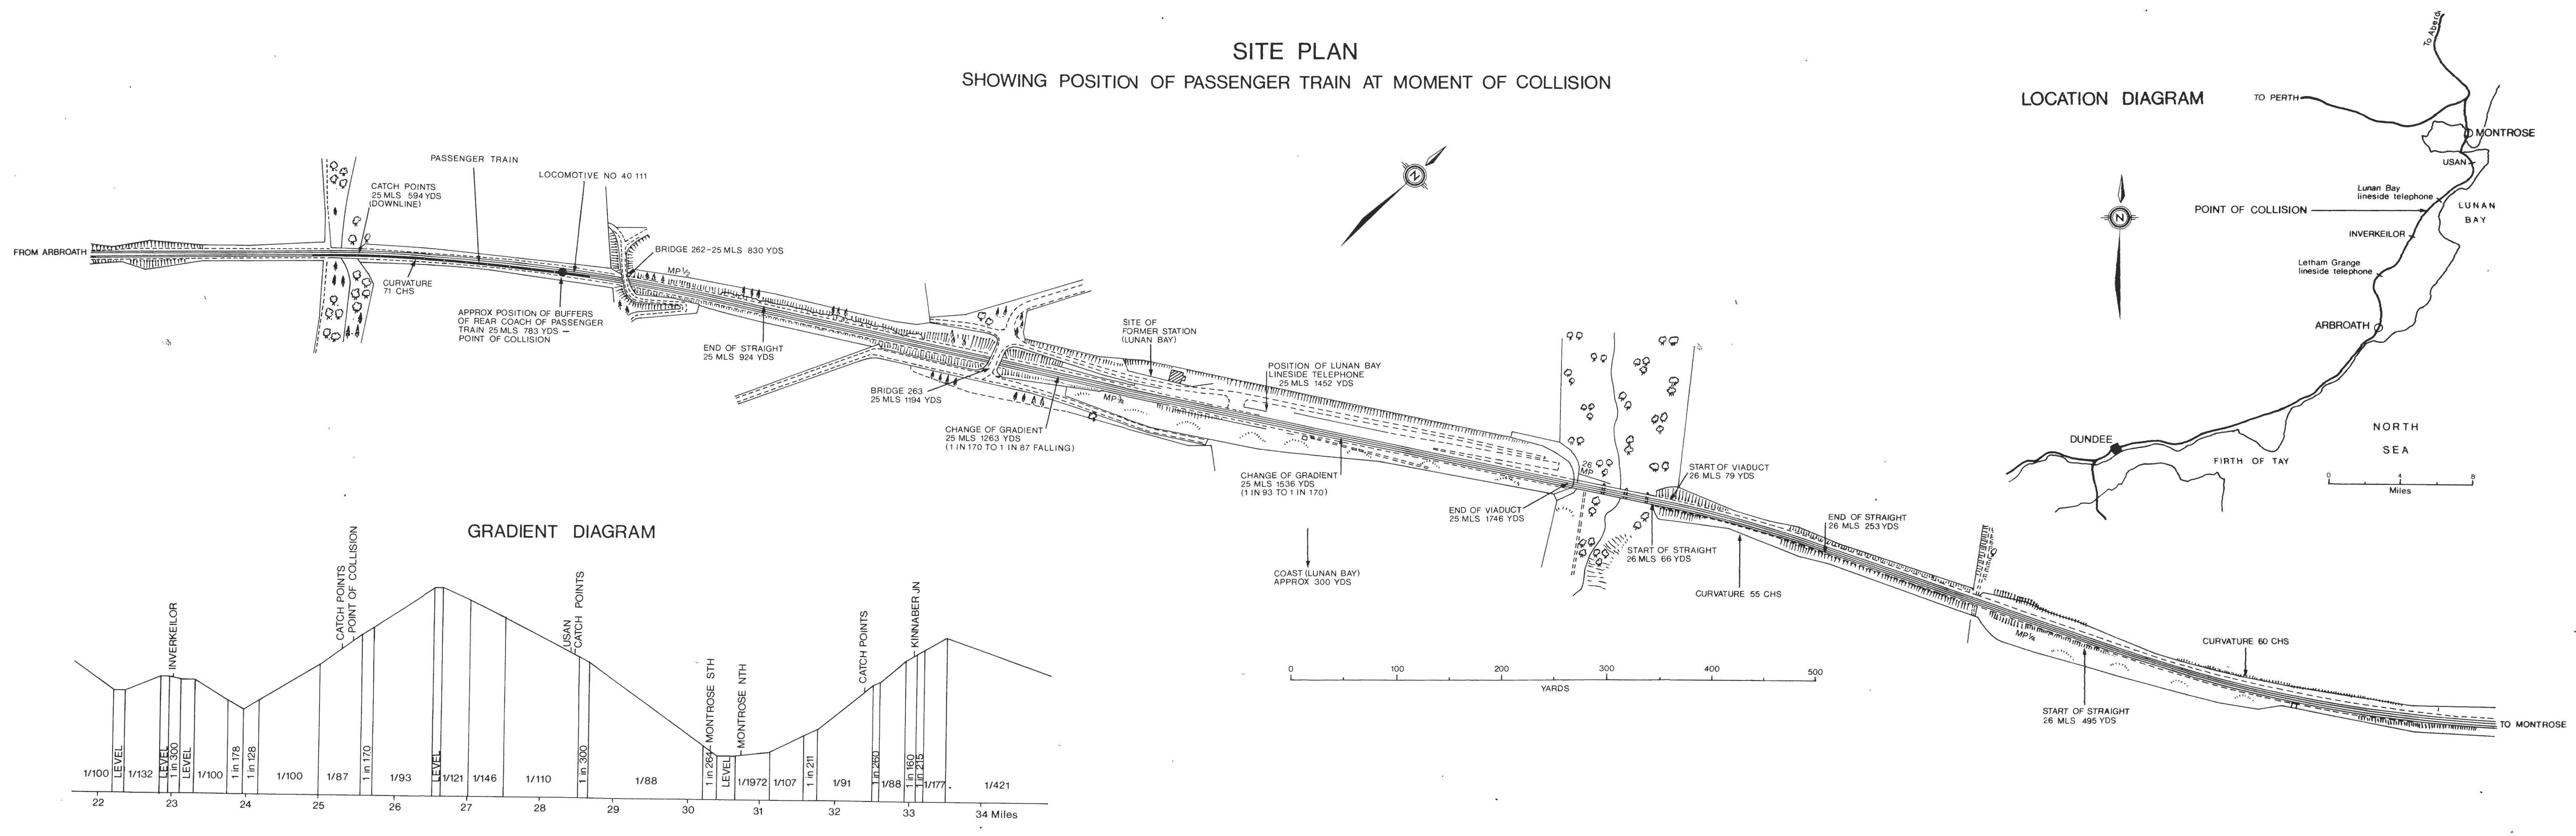
1. The site of the former Lunan Bay Station is about $4\frac{3}{4}$ miles south of Montrose on the main Aberdeen to London East Coast Main Line. At this point the line consists of two tracks and runs in a shallow cutting from north-east to south-west in the Up direction, towards London. Lunan Bay Station was closed in 1930 and only parts of the station buildings remain. Just to the north, on the Down side of the line, steps in the side of the cutting lead to a wooden cabinet mounted about 7 ft above rail level and containing the circuit telephone. At the time of the accident this cabinet was marked only by a black St. Andrew's cross on a white background. The telephone was close to the site of the former Lunan Bay Signal Box which had been closed and removed in 1964. From alongside the telephone cabinet there are clear views of the line to the north and south and also of Lunan Bay itself, the coast being only some 300 yards from the line at this point. Looking north, an approaching train can first be seen at a distance of 650 yards.

3. The maximum permissible line speed at Lunan Bay is 70 mile/h. There is a permanent speed restriction of 60 mile/h over curves between 27 miles 88 yards and 26 miles 1254 yards. At and approaching the site of the collision the Up line was laid with 113 lb/yard flat bottom continuously welded rail secured to concrete sleepers with Pandrol clips.

4. Approaching Lunan Bay viaduct from the north the line is on a 55 chains left-hand curve as far as the start of the viaduct. Thereafter it runs straight in a shallow cutting past the Lunan Bay telephone box and the site of the former station, continuing under a road bridge as far as 25 miles 924 yards. From this point the line curves left at 71 chains radius, passing under a second road bridge to the point of impact at 25 miles 783 yards.

5. Approaching Lunan Bay telephone box the line falls at 1 in 170 as far as 25 miles 1263 yards where the gradient steepens to 1 in 87 falling as far as and beyond the point of collision.

6. Details of the line and the surrounding topography are shown on Drawing No. 1 at the back of the report.
