INTERSTATE COMMERCE COMMISSION

REPORT OF THE DIRECTOR BUREAU OF SAFETY

ACCIDENT ON THE SOUTHERN PACIFIC RAILROAD

INVESTIGATION NO 2375

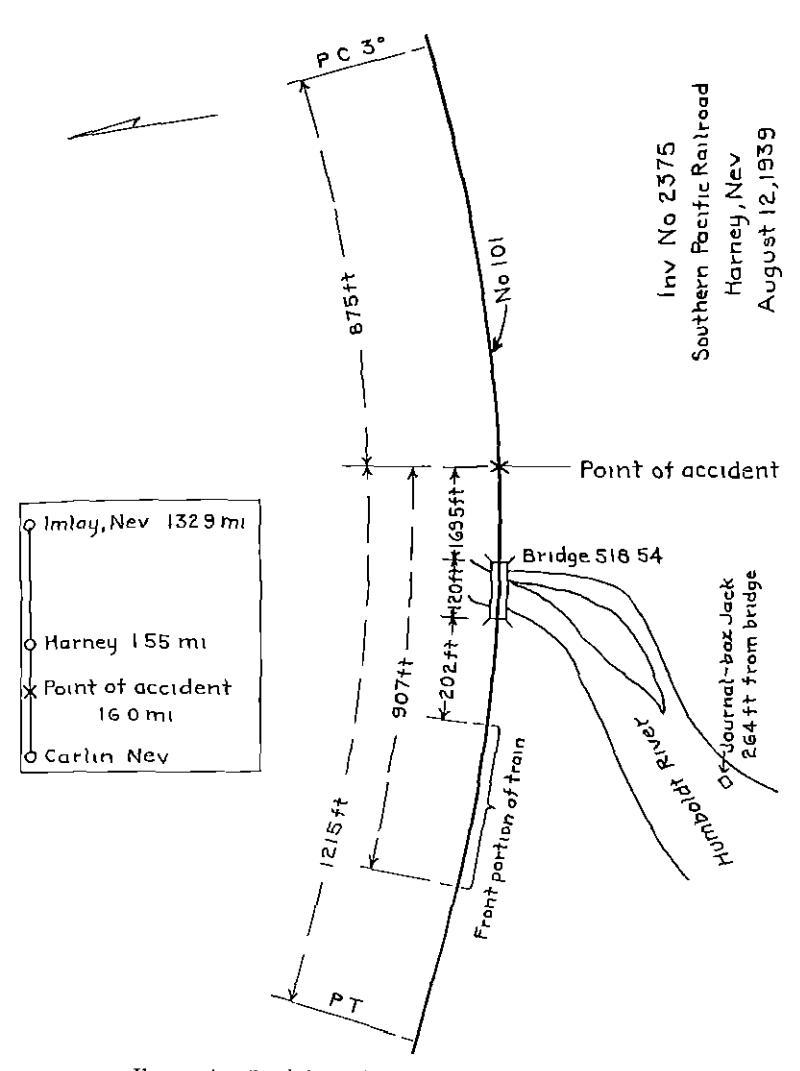
FIGURE 1 - Frack by out in vicinity of point of accident

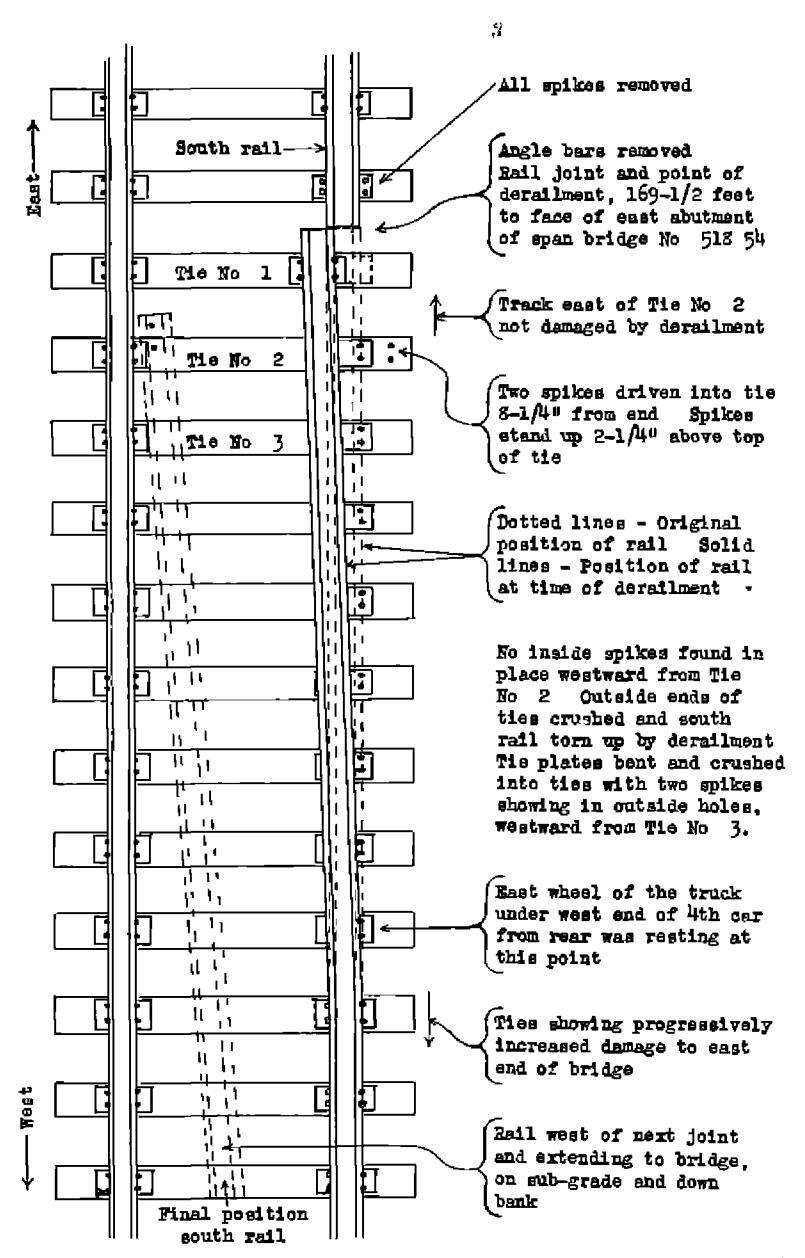
FIGURE 2 -Sketch showing normal mistlined and final positions of rul involved

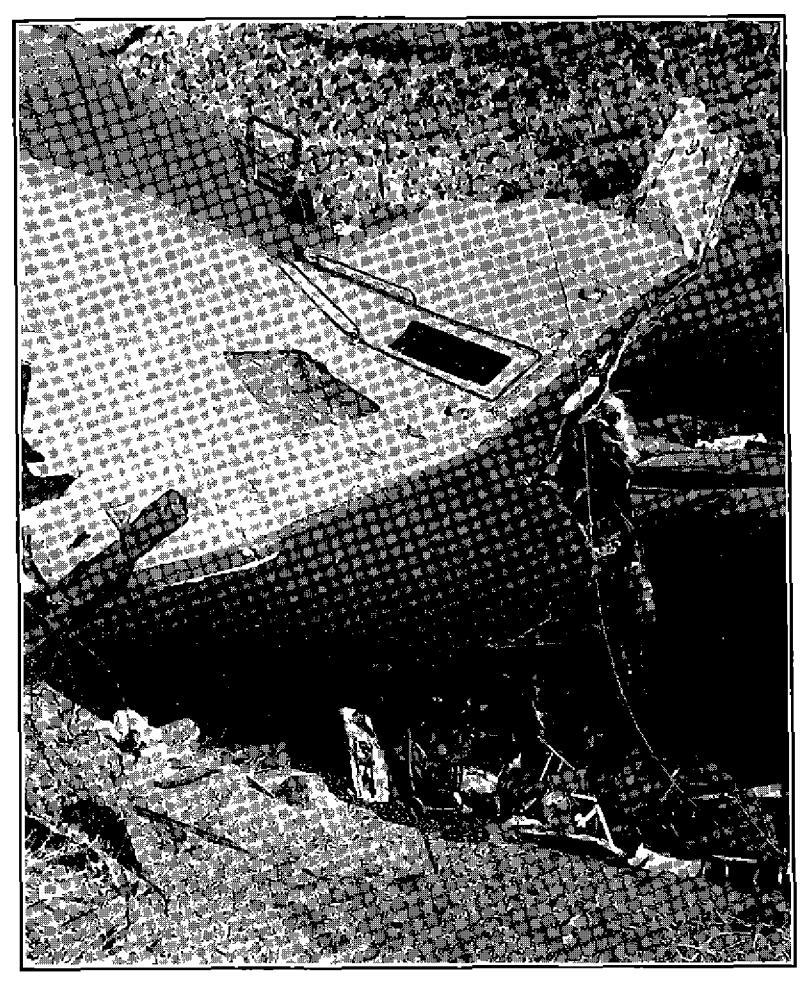
FIGURE 5 -View of "Presidio,' sixth unit showing dimaged condition of roof

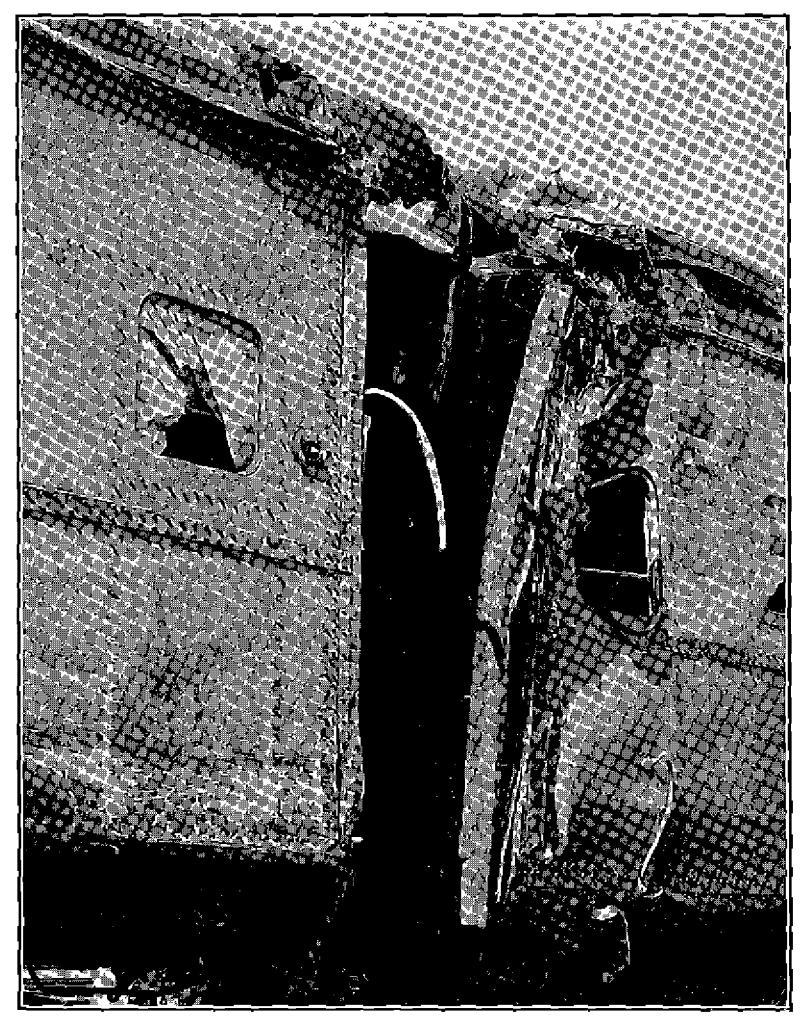
FIGURE 12-View of fourth and fifth units showing results of starking budge trass
