REPORT NO. 3577
CHICAGO, AURORA & ELGIN RAILROAD COMPANY
IN RE ACCIDENT
AT FOREST PARK, ILL., ON
JUNE 17, 1954

Accident at Forest Park, Ill., on June 17, 1954, caused
by an open switch.

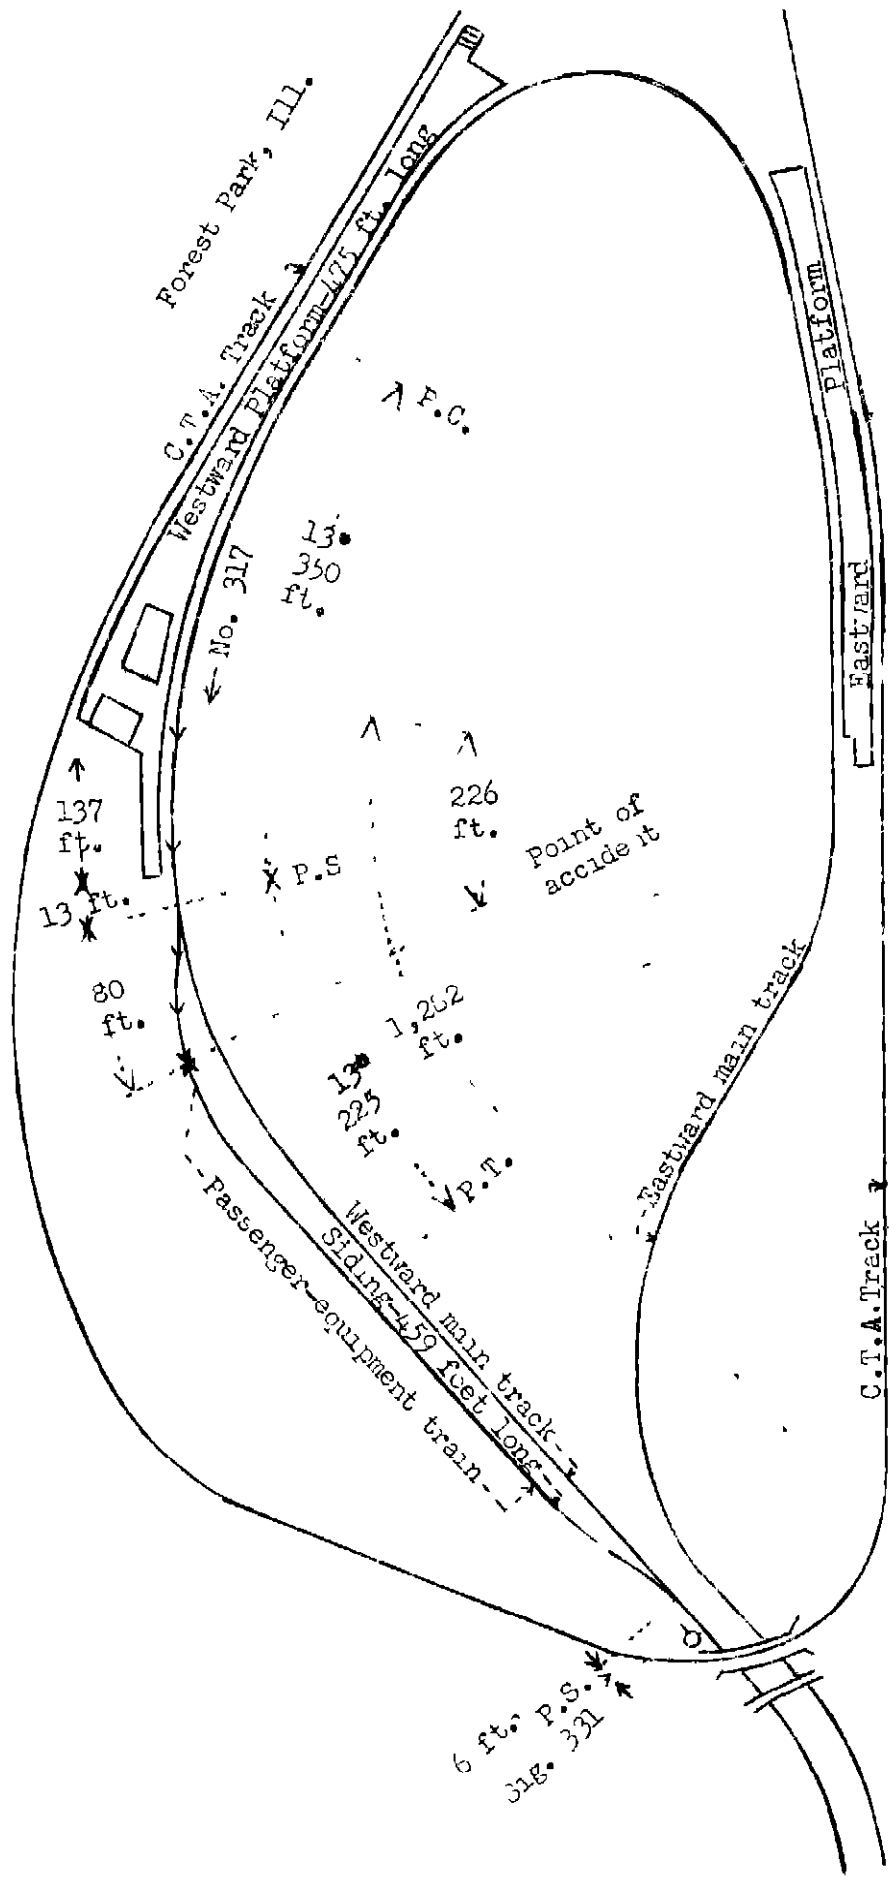
Report no. 3577
 Chicago, Aurora and Joliet Railroad
 Forest Park, Ill.
 June 17, 1954

X Forest Park, Ill.
 (Point of accident)
 15.6 mi.
 • Wheaton, Ill.

Yard limit sign
