Semaphores Replaced By Color-Light Signals on 55 Miles of I. C.

Gas Mechanisms Removed, Poles Cut Off and Light Heads Installed

to Complete Modernization,
Leaving Primary Battery As
Power Source

By *H. G. Morgan*

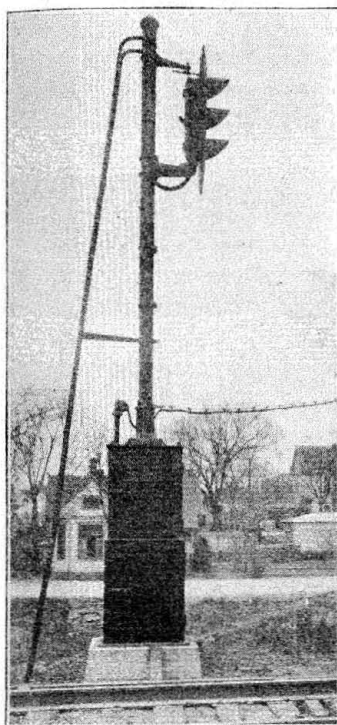
Signal Mounting on Old Mast

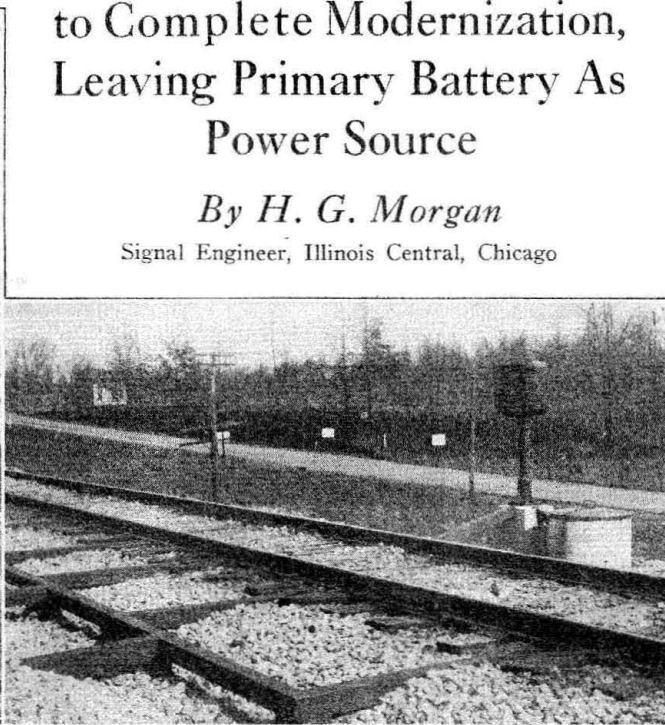
No Changes Were Made at the Cut-Sections

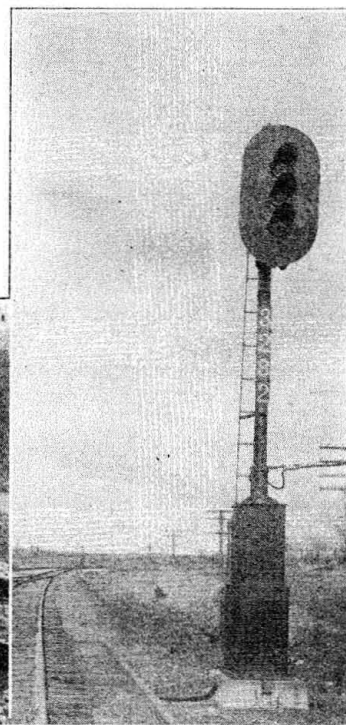
New Light Signal in Service

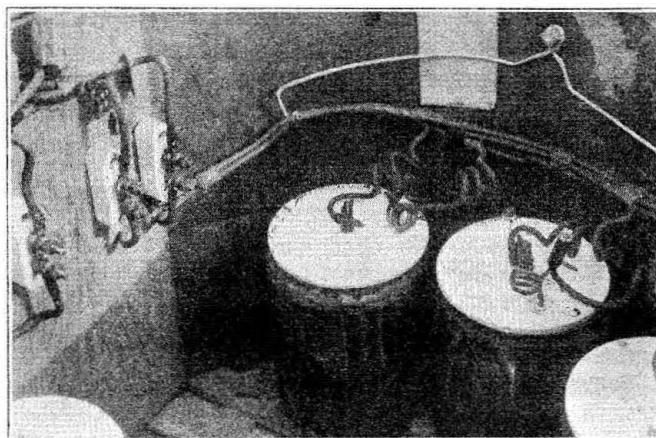
Track Battery in Small Tub at Cut-Section

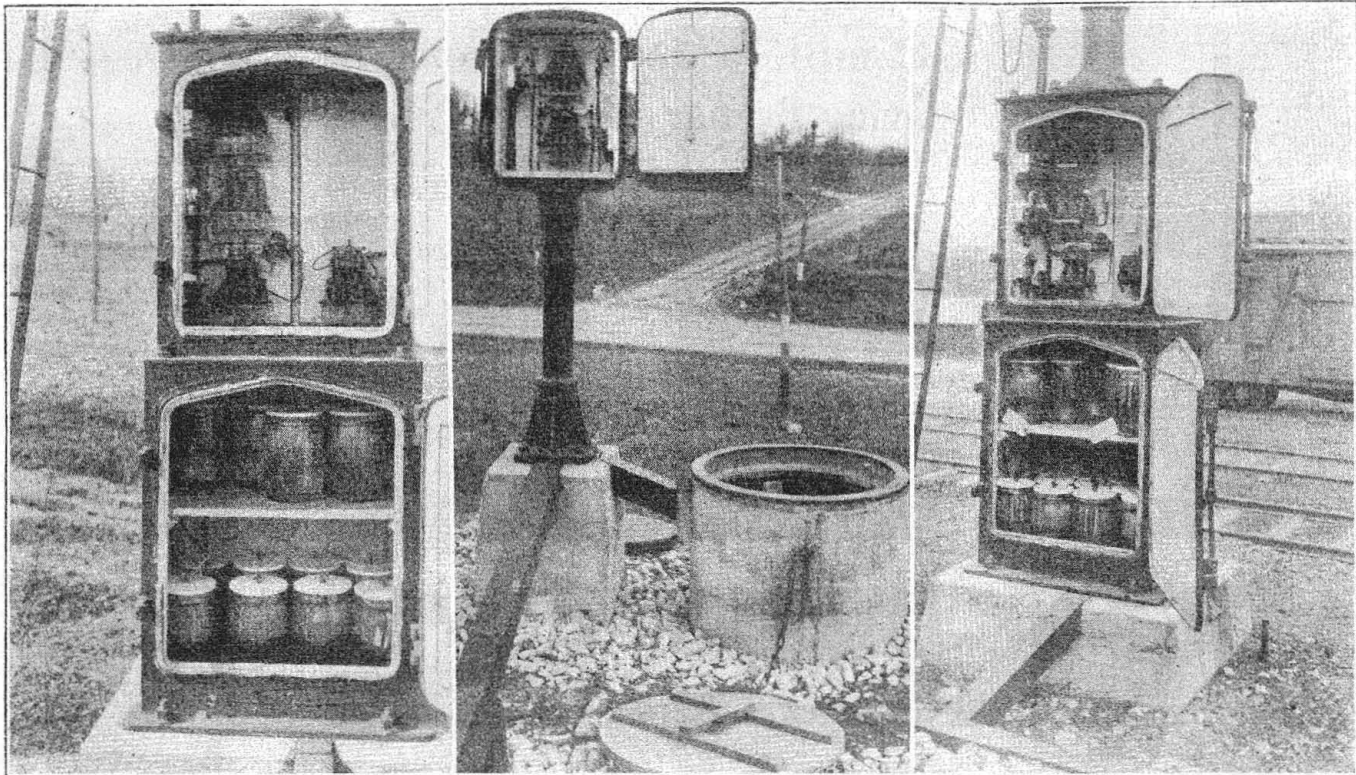
Typical Case for Straight Primary Location

A Double Track Cut-Section

A C.-Primary Case with Cut-Over Relay
