# Chicago South Shore & South Bend Changes Signal Equipment

Union Model-R color-light signals replace upper-quadrant semaphores—High-speed spring switches installed at passing tracks

*By B. L. Smith*

Signal Supervisor, Chicago South Shore & South Bend

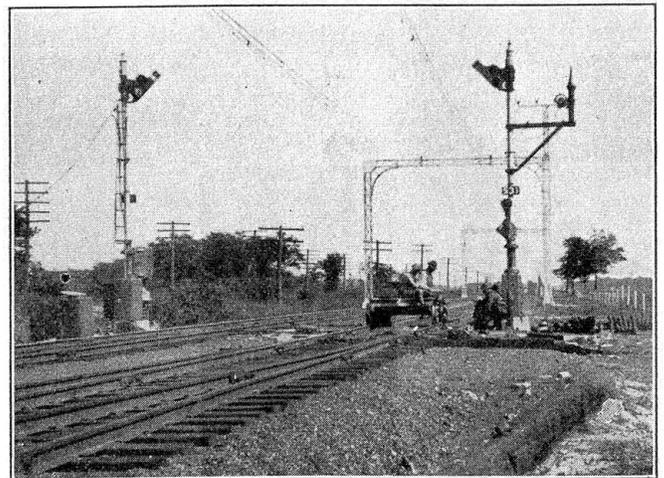
A pair of 60 degree two-position, upper-quadrant signals which were converted to color-light type

done and Union Style-B, 60 deg., two-position, upper-quadrant signals were installed. These functioned satisfactorily until allowed to deteriorate through lack of maintenance. When the road was taken over by the new management there were from 10 to 50 signals out of service each day and in some locations signals were not working at all.

These signals were put in operating condition even though they were considered inadequate for the faster and more frequent service contemplated. All mechanisms were completely overhauled and worn parts replaced. Cable and trunking was re-

newed, cases were rewired, and relays repaired. All poles were re-painted and broken roundels replaced.

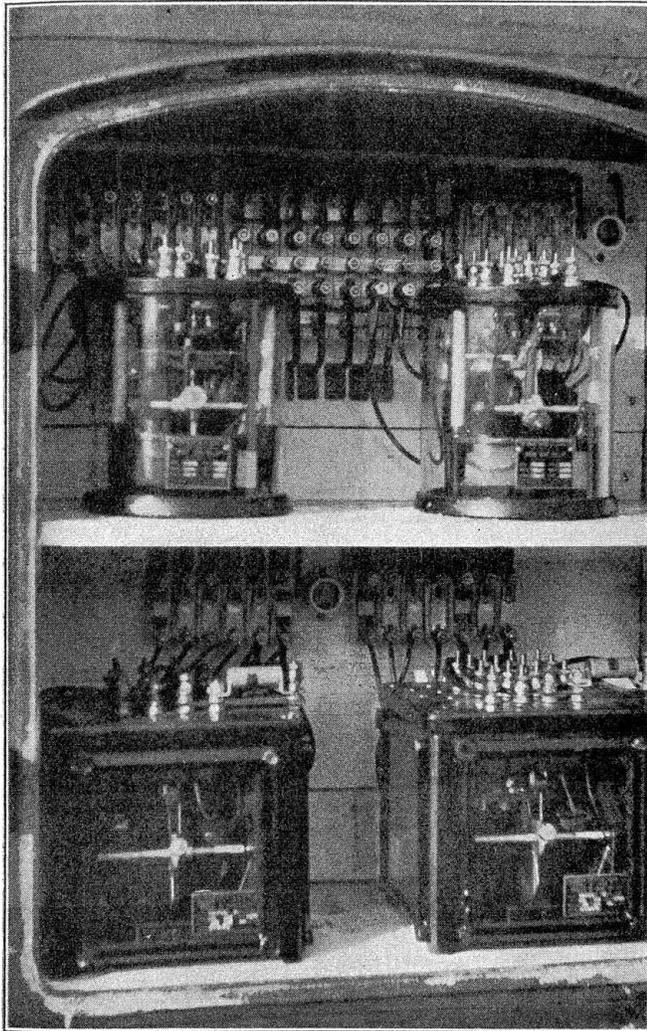
New relays were installed in the old mechanism cases

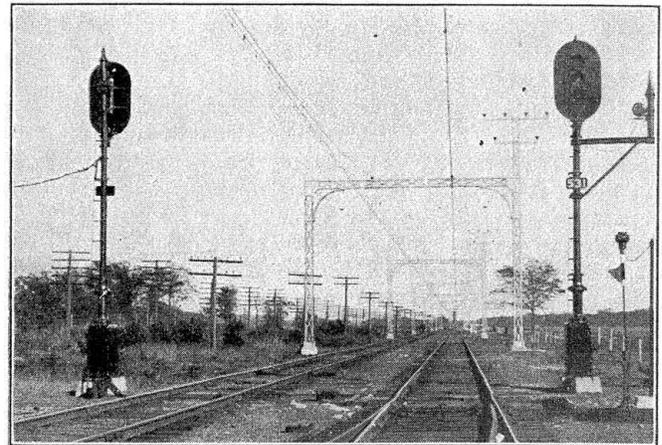
Union Model-R two-position color-light signals were mounted on the old poles

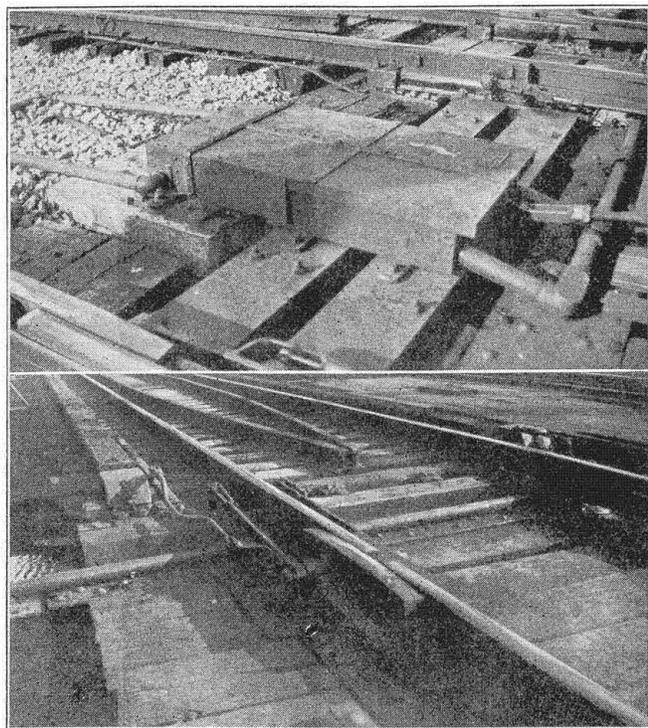
Top—Bridge circuit controller at Calumet river interlocker.  
Below—Close-up of power rail locks

The 28-lever mechanical plant at Shearson, Ind., was completely rebuilt. All old wooden pipe carrier bases were replaced and new Kenley tops and Universal carriers installed. New foundations for cranks and compensators were laid and all old pipe renewed. The electric plant at the Calumet river bridge was entirely rebuilt. The old signals were replaced with General Railway Signal Model-2A, 60-deg., upper-quadrant signals. A new G-R-S switch machine was installed and the old split point derails were replaced with Morden lift type. New Morden rail locks of solid cast steel were installed. These locks, which slide back and forth across the rail ends, were built with risers

on the outside, thus giving the car wheels a continuous unbroken passage across the 4-in. rail break in the bridge which has been left for expansion and swing. This also relieves a great deal of noise and jar which would otherwise be felt in the car when passing over the break. Rail locks are connected with G-R-S Model-5 switch circuit controllers adjusted to set signals with  $\frac{1}{4}$ -in. movement of the rail locks. The bridge circuit controllers are of the latest type furnished by the T. Geo. Stiles Company. The bridge box is mounted on two 8-in. by 6-ft. channel irons and the shore box is embedded in solid concrete making movement of these parts impossible. The interlocking machine was rebuilt and new polar relays were mounted on the back of the board. All open control wires are placed in an aerial cable which terminates at junction boxes mounted on poles at either end of the bridge. All wire is carried from junction boxes to circuit controllers and from circuit controllers to machines in conduit. The interlocking plant is powered by a 110-
