Call-on Signal Involved In Accident

On January 29, 1935, there was a rear-end collision between a multiple-unit electric passenger-equipment extra and a multiple-unit electric passenger train on the Delaware, Lackawanna & Western at Harrison, N.J., which resulted in the injury of 79 passengers and 14 employees. Following is an abstract of the report of an investigation made by the Bureau of Safety of the I.C.C.

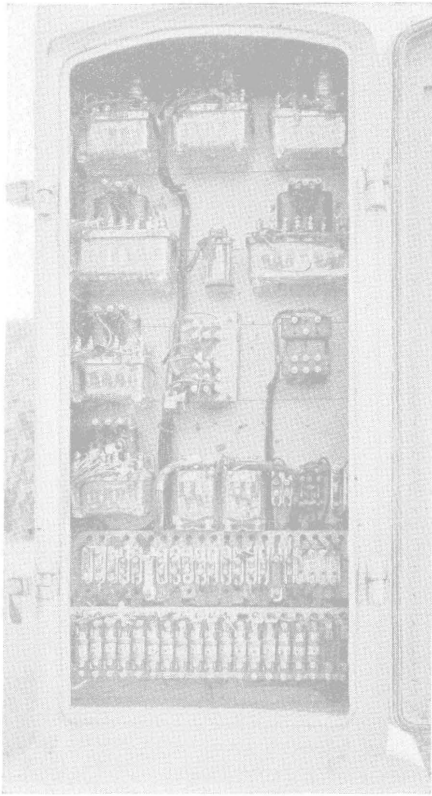
Instrument case at signal near Tower 80
