Accident in Automatic Block Signal Territory

ON JULY 5 there was a rear-end collision between a passenger train and a freight train on the Michigan Central near Wayne Junction, Mich., which resulted in the death of one employee and the injury of three passengers, one mail clerk and one employee. This accident was investigated by the Bureau of Safety, Interstate Commerce Commission, in conjunction with a representative of the Public Utilities Commission of Michigan. An abstract of the report of the investigation follows.

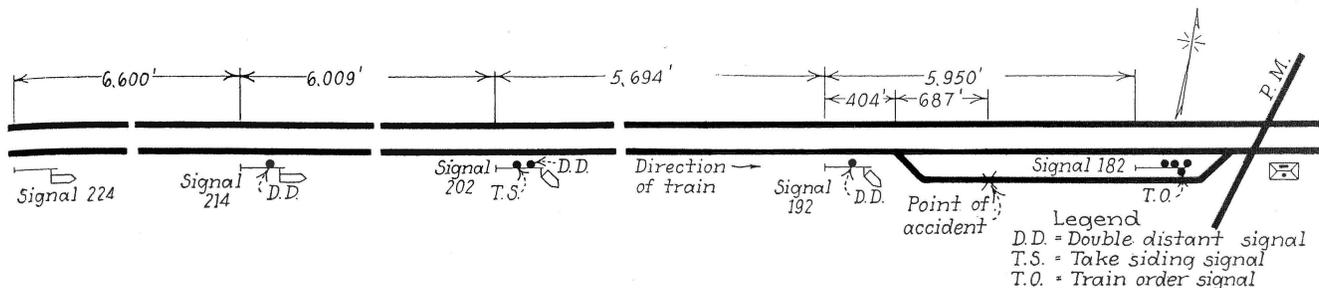
The signals directly involved in this accident are automatic signals 192, 202 and 214, located 404, 6,098 and 12,107 ft., respectively, west of the passing-track switch. These signals are of the upper-quadrant, three-position, semaphore type, approach lighted. In addition, these three signals are equipped to display three-block indications by the addition of a yellow light to the left

Track and signal plan of territory
