Milwaukee Rehabilitates Large Plant

Excellent example of complete replacement of old equipment with modern facilities and improved circuit arrangements to increase safety and facilitate operation

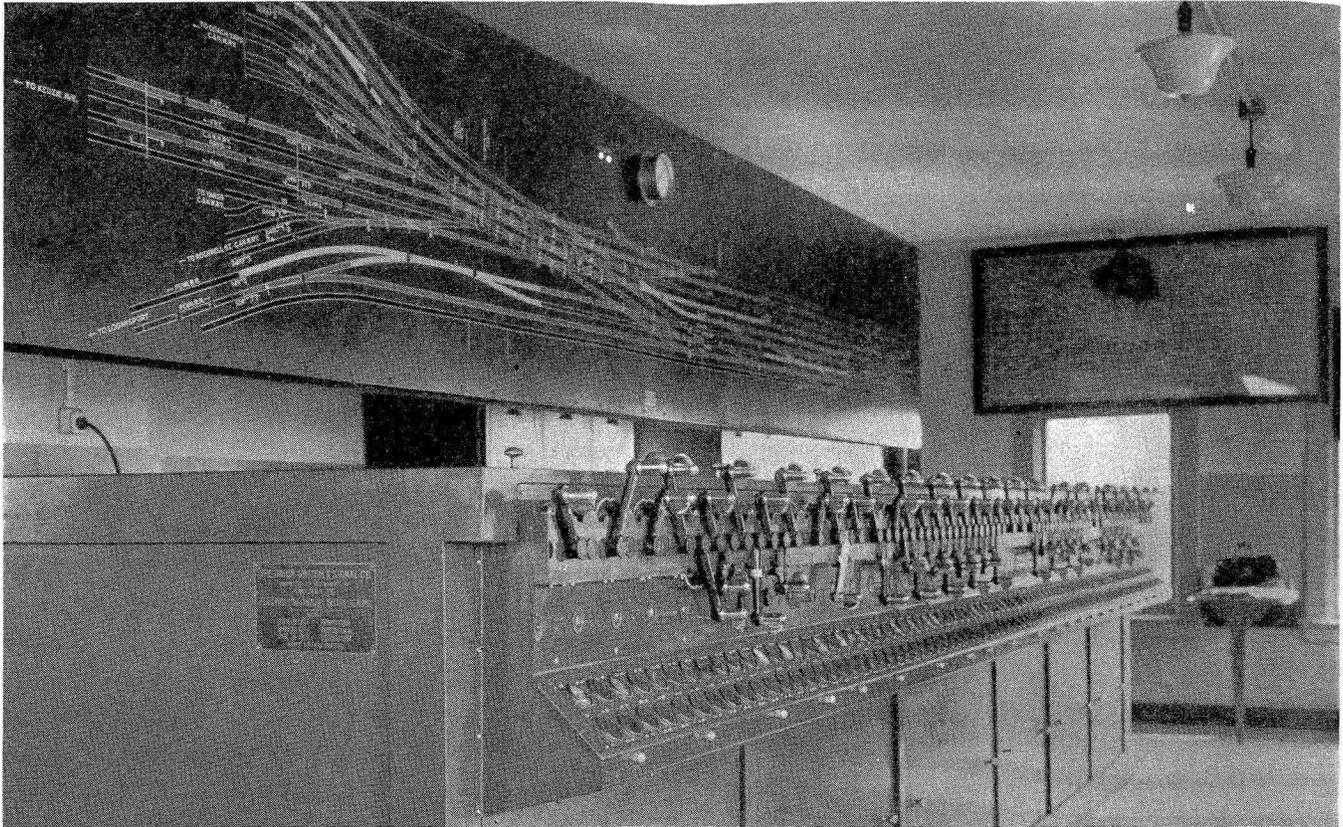
The new machine was set up and connected before the old machine was taken out of service

The old interlocking machine was worn beyond the stage of being rehabilitated economically, and the application of electric locks and controllers, required under the new circuit arrangement, was not practicable. Therefore, a new Model-14 interlocking machine was provided, which has an 83-lever frame using 69 working levers, as compared with 88 working levers in the previous layout. This machine has 2 levers for releases, 22 signal levers to control 47 signals, and 45 switch levers to control 30 single switches, 8

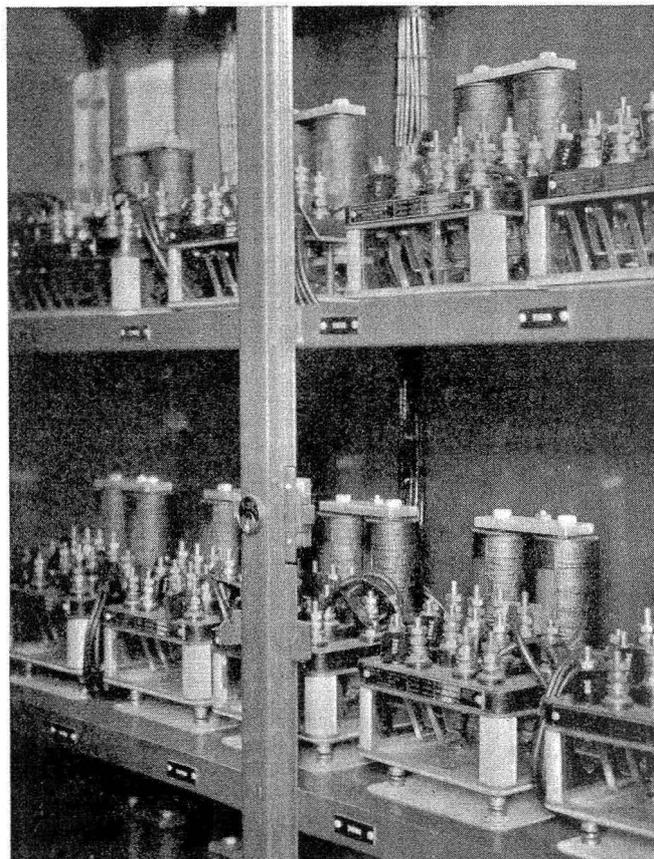
The relays in the tower are housed in sheet-metal cabinets with glass doors hinged at the sides

The relays and other instruments in the tower are arranged in new sheet-metal cabinets, of the enclosed type fitted with doors, all of this equipment being housed in a separate room 12 ft. by 14 ft. at the east end of the ground floor of the tower. The wiring between the machine and the relay cabinets, as well as the runs leading outside of the tower, are all in sheet-metal fireproof chases. All control circuits inside the tower are in No. 14, 19-strand flexible wire with 2/64-in. insulation and single braided covering, about 100,000 ft. of this wire being required.

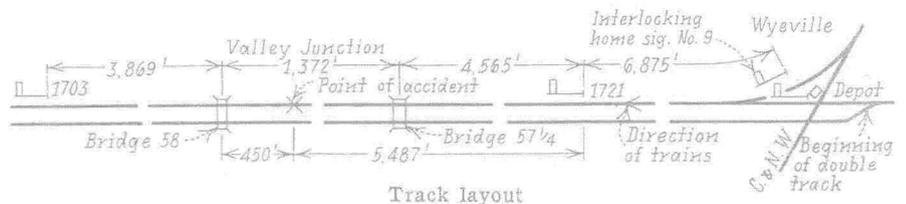
Both the engineman and the fireman of First 405 stated that signal 1721 was displaying a clear indication as their train approached it, and it was found to be displaying a clear indication with the block occupied when the maintainer arrived at about 8 o'clock. Several tests were made, and it was found that the H and D control relays would become energized and the signal would clear with second track circuit shunted. By means of further tests, it was determined that this was caused by a cross between 1721H and 1721D line control wires in the fourth span east of the cut section location between the first and second track circuits, or approximately 3,100 ft. west of signal 1721. At point of cross, the insulation on these wires was worn and the wires had been twisted together by wind. With this cross existing, the signal would go to stop with the first

track circuit occupied, but as soon as the train passed into the second track circuit, the signal would go to clear. If this cross condition existed at the time of the accident, signal 1721 would be in the clear position for First 405, assuming that as First 405 approached the signal No. 515 was out of the first track circuit west of the signal. After the cross was removed, the signals resumed normal operation.

This accident was caused by a false-clear signal indication given by the automatic signal governing the use of the block within which the accident occurred, and failure to provide proper flag protection for the first train.
