Lap Order Results In An Accident

On December 11, 1942, a head-on collision occurred between two freight trains near Tebbetts, Mo., on the Missouri-Kansas-Texas. The following information concerning this accident was abstracted from a report by the Interstate Commerce Commission.

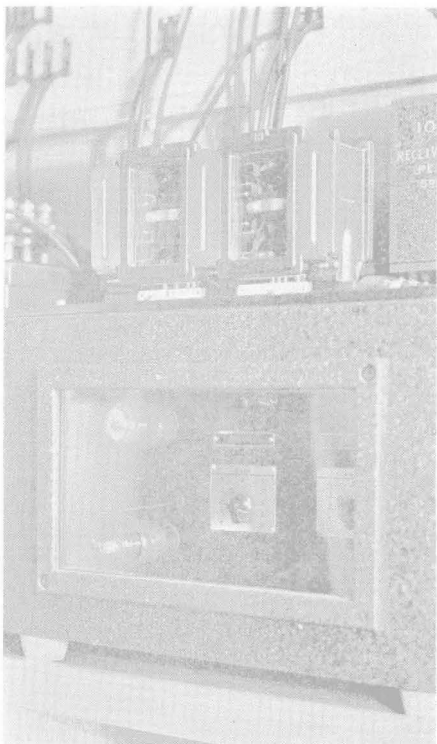
Oscillator-amplifier unit
in the carrier system

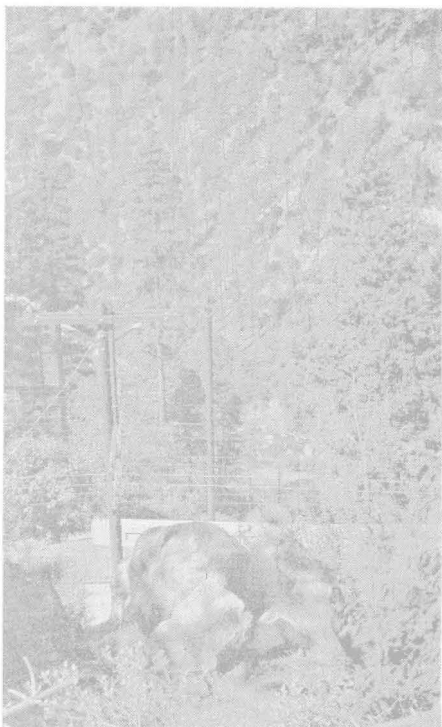
Pole line down mountainside
