Short Track Circuit Causes Accident

• On March 8, 1960, a Southern freight train struck the first car behind the locomotive of a Central of Georgia switching movement at Rome, Ga. This abstract of the Interstate Commerce Commission's report No. 3878 relates the sequence of events which led to this accident.

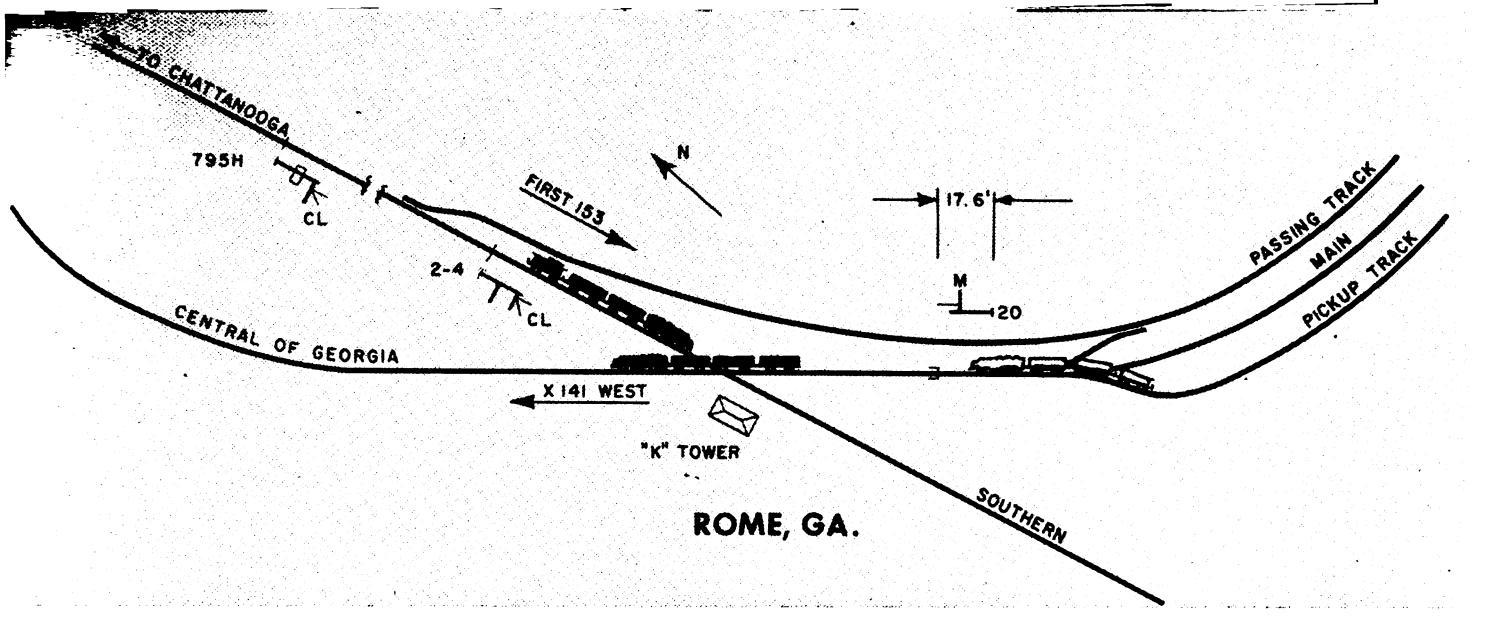
After setting off cars on the pickup track, the CofGa train moved onto the crossing, where it was struck by the SOU train.

During this operation, the towerman had heard the annunciator sound indicating the approach of First 153, a southbound first-class Southern freight train. When the track model board indicated that the CofG movement was clear of the interlocking, the towerman set signal 20 to Stop and cleared signal 2-4. The towerman was not aware that the CofG track circuit did not extend entirely through interlocking limits.

When the air brake system of the cut of cars on the CofG had charged, the engineer moved this cut westward further into the interlocking. The engineer said that he did not look at signal 20 again prior to this westward movement as the locomotive had remained within the limits of the interlocking and he thought the authority for the locomotive to occupy the interlocking could not be removed until the locomotive with the cut of cars had cleared the interlocking by moving eastward beyond signal 20. As the movement proceeded westward to clear the switch of the pick-up track, it moved over the crossing and stopped with the first car to the rear of the locomotive on the crossing.

Of the CofG movement, one car was destroyed and two were damaged. All five of the Southern's locomotive units left the track with heavy damage to the first unit. The interlocking tower was struck by derailed equipment and was heavily damaged. The two South-

The investigation also disclosed that the interlocking was maintained and operated by the Southern, and that the CofG track circuit extended east ward in the interlocking to a point 17.6 ft west of signal 20, instead of the this home signal as required under the Commission's rules, standards and instructions governing interlockings. the CofG track circuit had extended throughout the interlocking as required, the locomotive of Extra 141 West would have occupied this track circuit when it stopped after the coupling was made to the cars on the pickup track. The interlocking operator would thereby have been unable m cause signal 2-4 to indicate Proceed for the movement of First 153 through the interlocking, and the accident would probably have been averted In this case, the Commission has taken appropriate action to obtain com-pliance with its rule requiring track circuits and route locking to be provided throughout interlocking limits
