# Proceed Authority exceeded by train 9337N

Junee, NSW | 20 August 2013

**ATSB Transport Safety Report**  
Rail Occurrence Investigation  
RO-2013-022  
Final – 19 December 2013

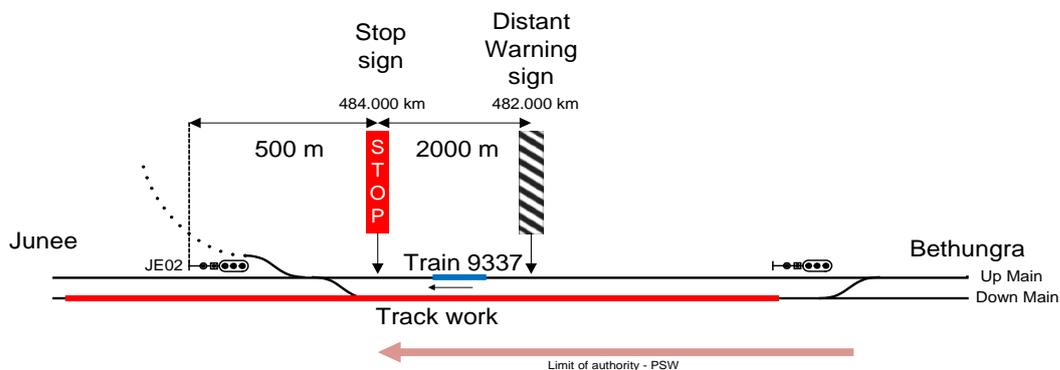
**Figure 2: Bethungra - Junee section under pilot staff working**

There were several worksites on the Down Main line between Bethungra and Junee. Consequently, both up and down rail traffic were required to travel on the Up Main line. As the track was not signalled for bi-directional movements, pilot staff working<sup>2</sup> was in force between Bethungra and Junee. The limit of authority for rail traffic travelling under pilot staff working in the down direction was marked by a Stop sign placed at the 484.000 km point (just before Junee), with a Warning sign placed 2000 m in advance of the Stop sign (Figure 2). Train crews were advised of the implementation and details of pilot staff working via a SAFE Notice, in this case, SAFE Notice 2013 Number 2-1933.

Note: Only relevant details shown (Not to scale)

At Cootamundra, the train crew received a Condition Affecting the Network (CAN) notice advising them that pilot staff working was in force between Bethungra and Junee. Train 9337N was to travel in the down direction on the Up Main line. At Bethungra, a Qualified Worker (acting as a signaller) diverted train 9337N from the Down Main line to the Up Main line. The train crew were given a Pilot Staff Notice and issued with a Pilot Staff ticket as authority to travel through to the Stop sign. The train departed Bethungra at 0926.

While travelling towards Junee, the train crew's attention was drawn towards the track works on the Down Main line. Consequently, the crew did not notice the distant Warning sign located at the 482.000 km point, 2000 m prior to the Stop sign. At about 0955, while approaching Junee at a speed of approximately 50 km/h, the train crew observed the Stop sign ahead and immediately placed the brake handle into the emergency position. The train passed over the 3 detonators placed at the Stop sign and came to a stand approximately 75 m past their limit of authority.
