TRANSPORTATION SAFETY
BUREAU

FINAL REPORT

2006-0161-5 RAILWAY ACCIDENT

**Between Szolnok and Újszász stations
12 December 2006**

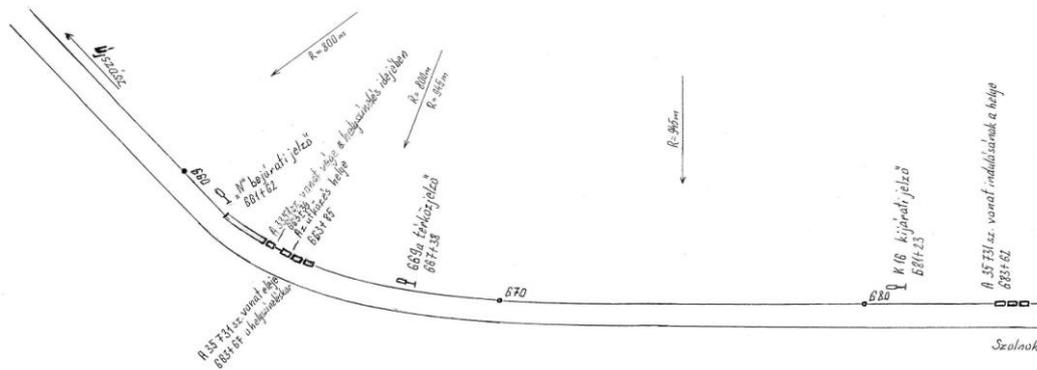
After the exit points of Szolnok station, the rail track runs in a 950 metre-radius bend in a 1002 metre distance, beyond that it runs in a 800 metre-radius bend. The rail track lies on a 1.1 ‰ slope from the points to section no. 664+50, beyond that it lies on a 0.5 ‰ downward slope until section no. 660+00.

Figure 3: The schematic picture of the location of the accident

An automatic block signal operates on the line which is capable of train-control. Szolnok „CD” junction is (remote-) controlled by Szolnok I. centre by a D 55 type signal box which can be operated manually or can be set to operate automatically. In this section at CD junction, there is an “N” entry signal which controls the points on the left track, and the other points are controlled by “J” signal.

Block signal AT 669 separates the line between Szolnok station and CD junction into two block sections. From Szolnok towards Újszász, the first “T2” block section is 684-metre and the second, “T1” is 576-metre long. The signals were operated in automatic remote-controlled mode by a computer. All movements and changes are recorded and stored in the memory of the computer.

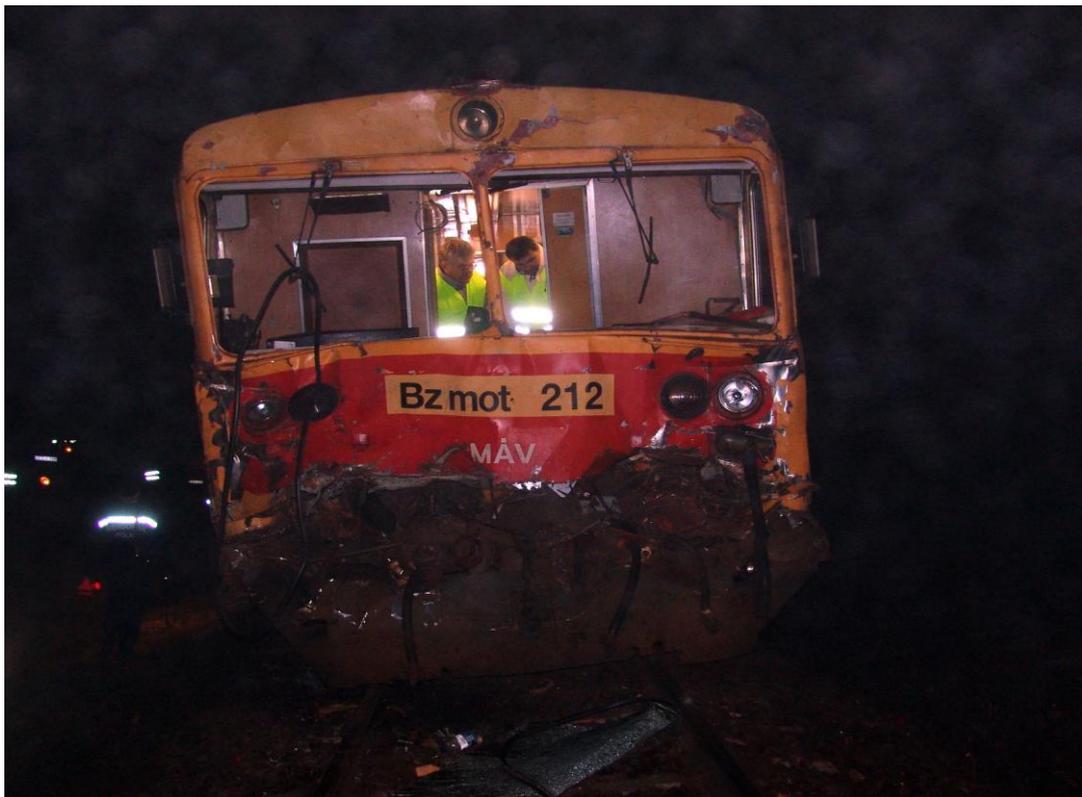
20-22 seconds after this, at approximately 22 hours 28 minutes, train no. 35731 collided with the rear of train no. 3351.

Figure 8: Motor coach no. Bzmot 212 after the collision

- The front of Bzmot 212 motor coach of train no. 35731 was in section no.663+67. The front of the locomotive thoroughly broke and the driver's cab became crushed. The lever of the D2 type brake valve was found in emergency brake position.

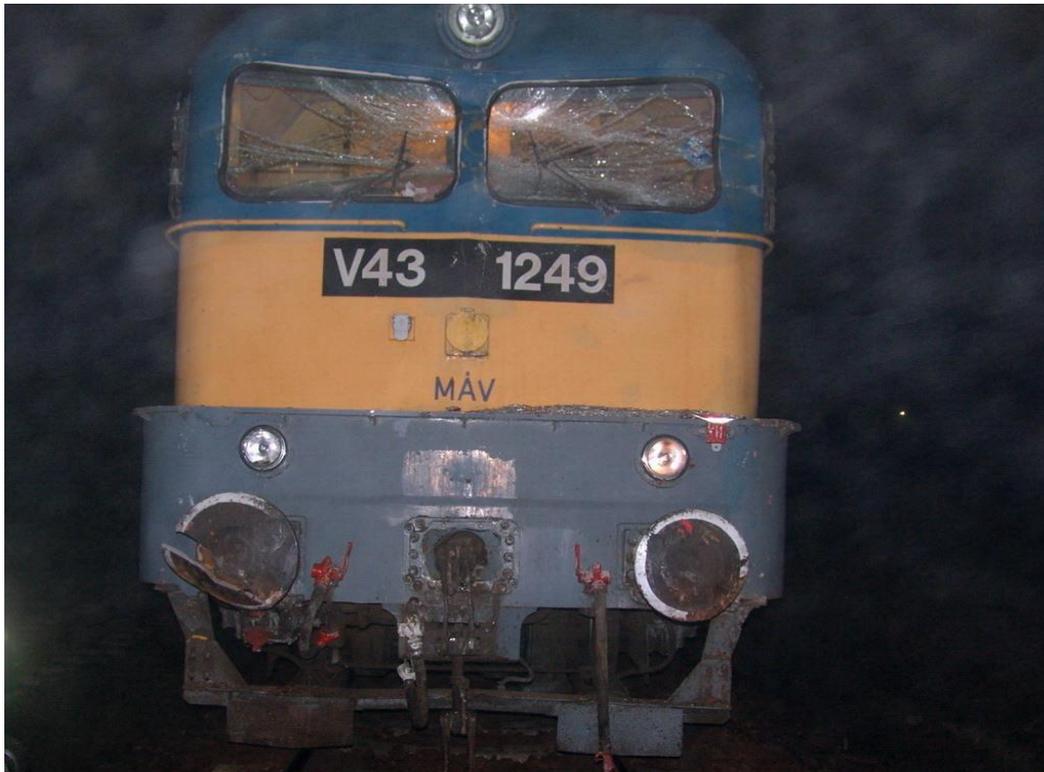
- The front of train no. 3351 was standing 5 metres beyond signal "N" indicating "Stop" (towards Budapest). The rear of the train was in section no. 663+39. The right hand side rear light of locomotive no. V43-1249 was intact and provided white light. The also intact red glass light-cover was found in the tall grass beside the rails the following day. The tail marker disk was broken but still on the rear of the damaged locomotive.

Figure 10: Locomotive no. V43-1249 after the collision

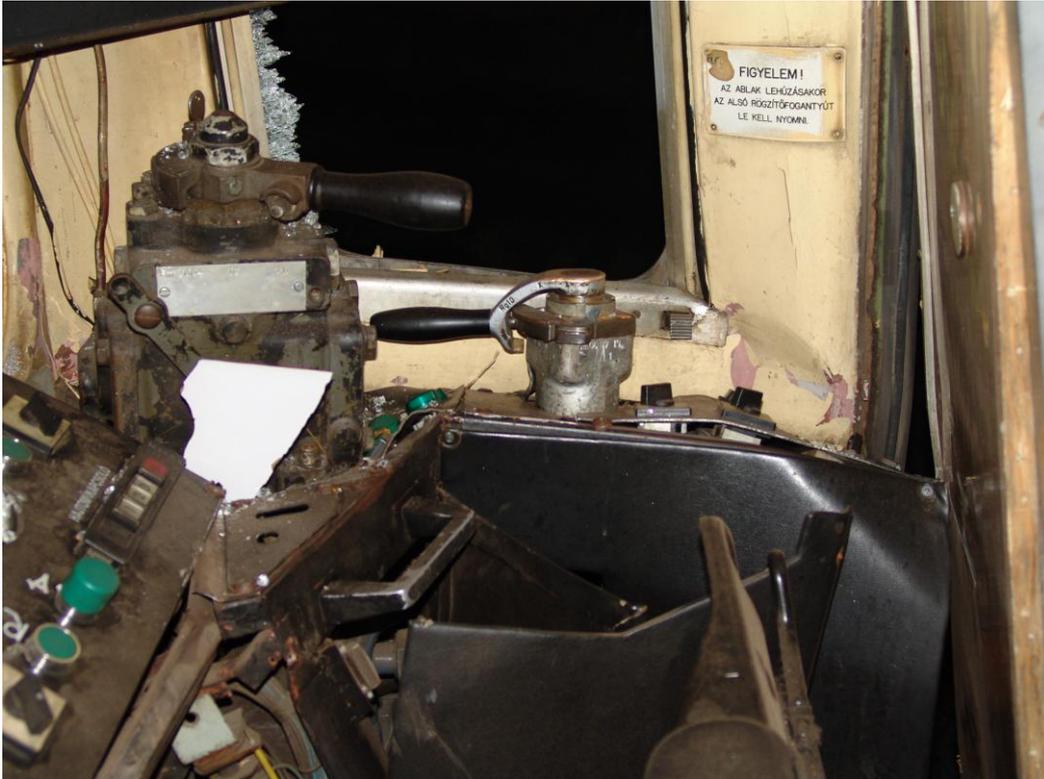
Figure 11: The driver's cab of Bzmot 212 motor coach after the collision

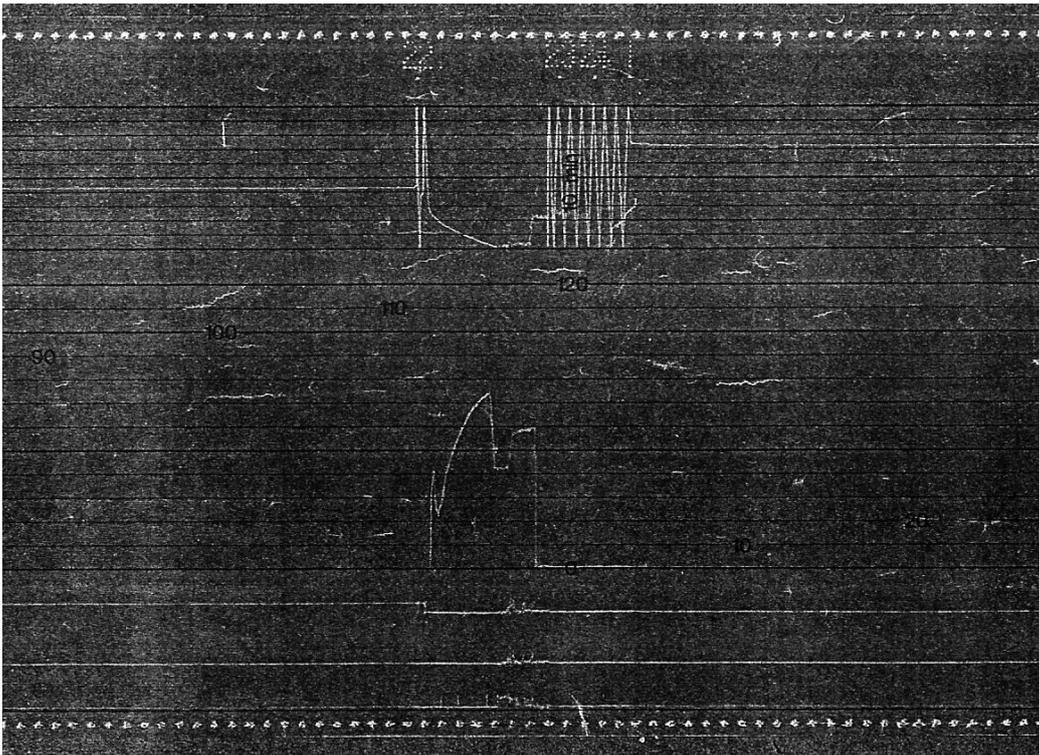
Figure 12: The strip chart recorder of Bzmot 212 motor coach

- Train no. 35731 departed from Szolnok station at 22 hours 25 minutes, with a 3-minute-delay. After departure, the train accelerated to 42 km/h and then following the brake test, it decelerated to 22 km/h.
- Afterwards it gradually increased the speed to 75 km/h and then decelerated by applying the brake.
- The collision occurred at the speed of 42 km/h at 22 hours 28 minutes. It is most likely that the effect of the emergency braking prior to the collision could not develop by this time.
